Technical Service Information

NISSAN RL4RO1A FALLS OUT OF FOURTH GEAR

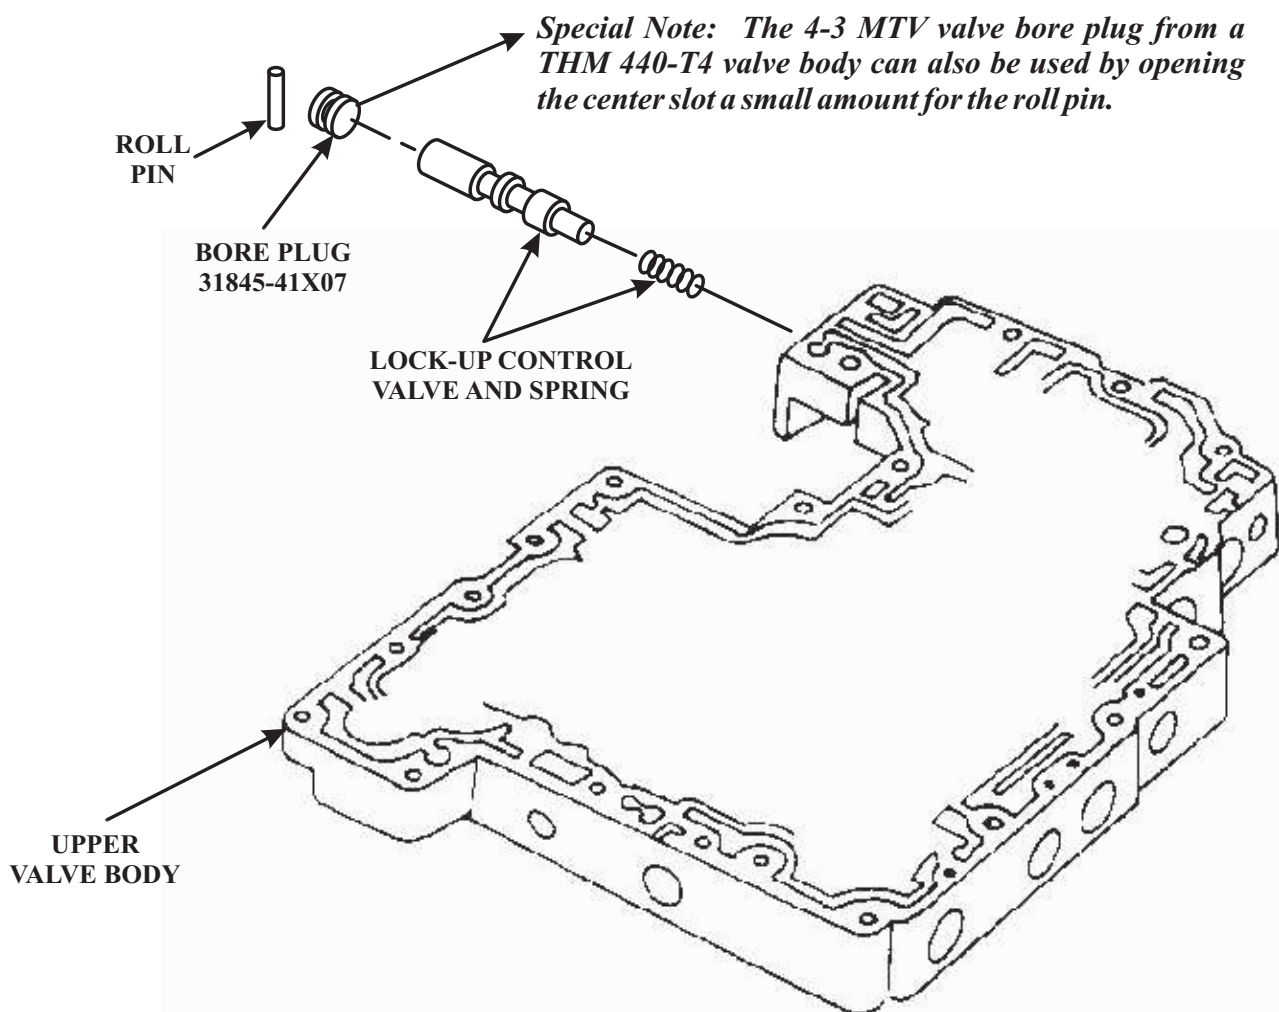
Figure 1

CAUSE: The cause may be, a "Broken" or "Cracked" valve body bore plug at the end of the "Lock-Up Control Valve Train", as shown in Figure 1. The reason is, when the vehicle speed and governor pressure is high enough (Approx. 44-49 MPH), governor pressure moves the 4th speed cut valve against spring pressure allowing 4th apply pressure to be fed to the lock-up control valve, at the bore plug end, which strokes the lock-up control valve and applies the converter clutch. When this action takes place, the broken bore plug can act as an exhaust for 4th apply oil, causing the loss of 4th gear.

LOCK-UP CONTROL VALVE LOCATION

CORRECTION: Replace the broken or cracked bore plug with OEM part number 31845-41X07, and ensure that it fits "snug" in the valve body bore. Refer to Figure 1.
