Technical Service Information

THM 4T60E CONVERTER DISCOLORED - NEW COOLER FITTINGS

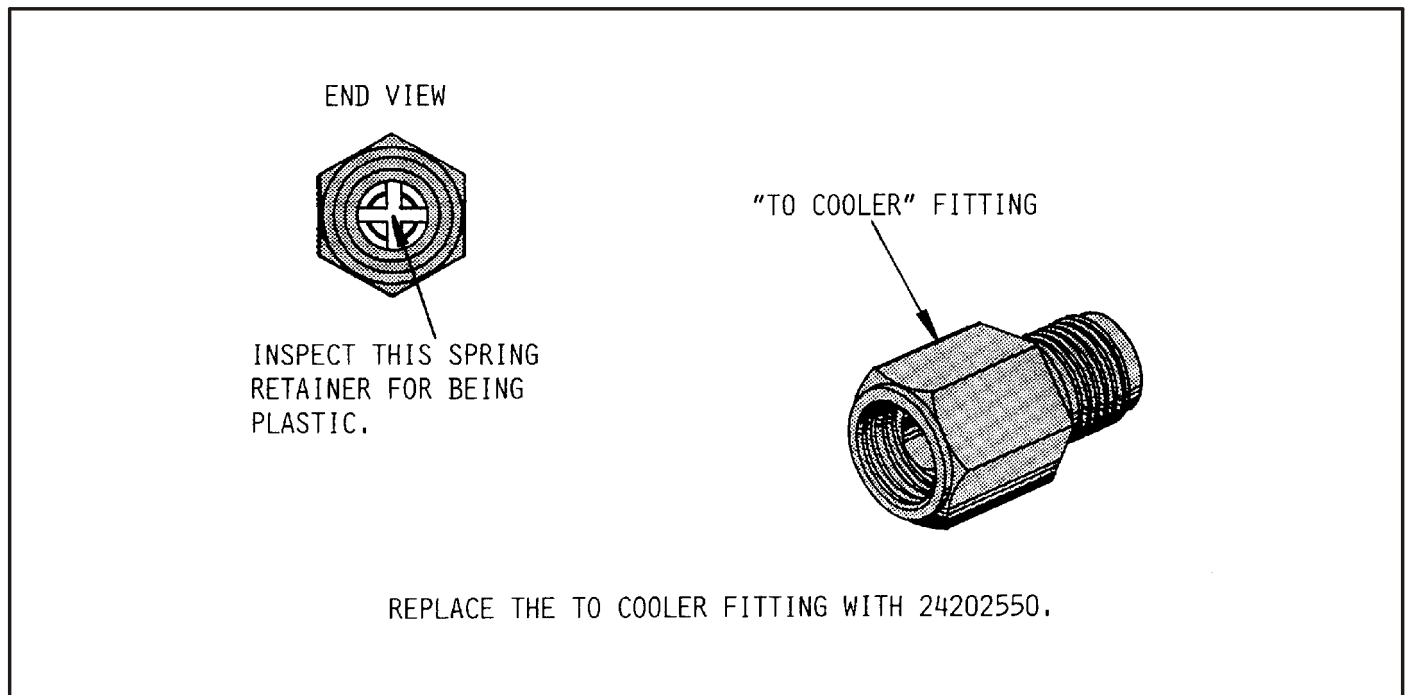
Figure 1

COMPLAINT: Some 1991-1994 vehicles equipped with the THM 4T60-E transaxle, may display a torque converter that is discolored, and turned Blue or Black.

CAUSE: The cause may be, the plastic spring retainer located inside of the "TO COOLER" (Large) fitting has melted, and is blocking and/or restricting cooler flow.

CORRECTION: Remove the "TO COOLER" (Large) fitting and inspect the spring retainer inside the fitting, as shown in Figure 1. If the spring retainer is plastic and/or melted, replace the fitting with OEM part number 24202550, which has a steel retainer. It is advisable to replace the "TO COOLER" fitting, even if the spring retainer is not melted, IF it has the plastic spring retainer. If the spring retainer is melted, the cooler in the radiator needs a thorough flushing, and possibly replacement.

Cooler Line Fitting (Steel Spring Retainer) 24202550
