Technical Service Information

AUDI AND VOLKSWAGEN 01M MULTIPLE SOLENOID CIRCUIT CODES

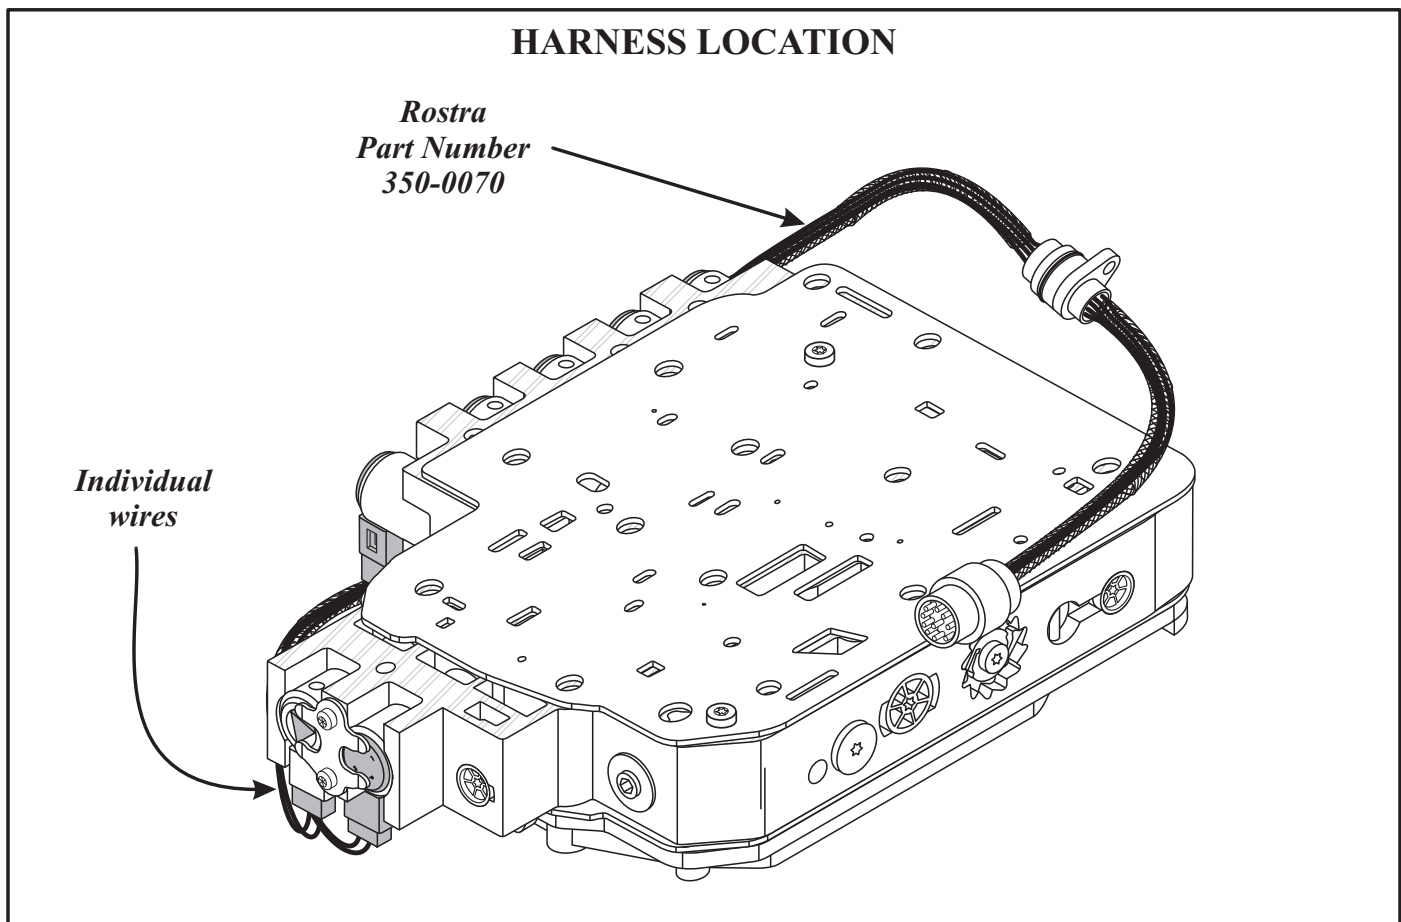
Figure 1

COMPLAINT: Audi and V.W. vehicles equipped with the 01M transaxle may exhibit multiple solenoid codes, before or after overhaul.

CAUSE: The cause may be, a faulty or broken "Ribbon strip." This ribbon strip connects all of the solenoids to the transaxle harness connector and is known to have brittle connectors.

CORRECTION: Refer to Figure 2 to check all of the ohm values to all of the solenoids. Replace the Ribbon strip as necessary. The Ribbon strip can be replaced with a new internal harness available from Rostra that has separate wires rather than a molded harness. See Figure 1.

INTERNAL WIRE HARNESS (*Rostra part number*).....350-0070
