# Technical Service Information

## FORD AODE/4R70W ENGAGEMENT CONCERNS AND OR EARLY OR LATE SHIFT PATTERNS

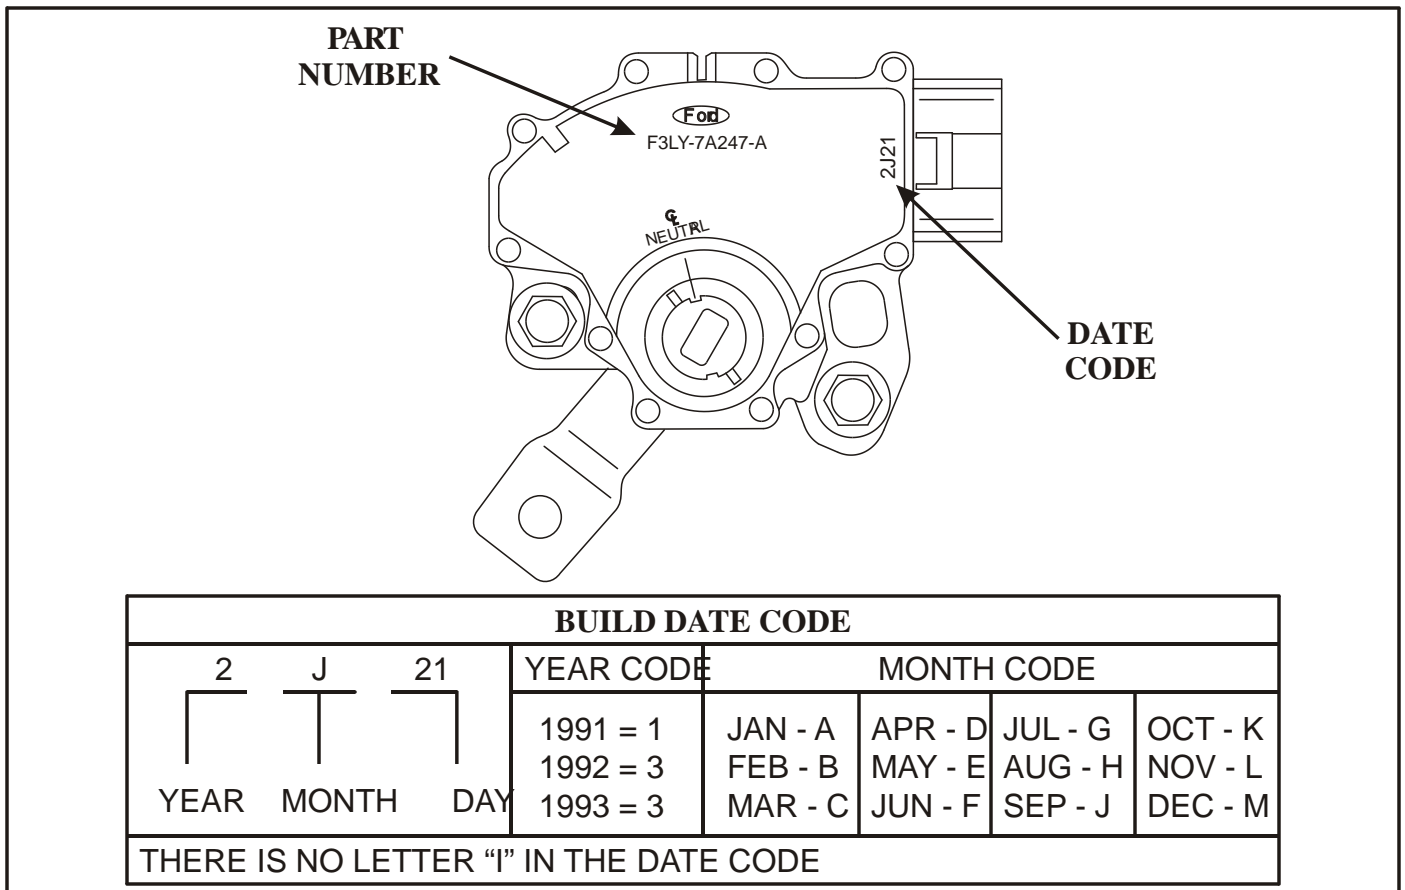
Figure 1

**COMPLAINT:** Some 1993 Crown Victoria, Grand Marquis, Mark VIII, and Town Cars may exhibit soft or harsh engagement and/or early or late shift pattern complaints.

**CAUSE:** The cause may be, internal contamination of the Manual Lever Position Sensor (MLPS).

**CORRECTION:** WITH DATE CODES OF 2521 TO 2L06. The date code is stamped on the outer cover of the MLPS, as shown in Figure 1. Use the service part numbers listed below.

Replace the MLPS with a revised service level sensor that is more resistant to internal contamination (See Figure 1). NOTE: WHEN REPLACING THE MLPS ON THE AODE/4R70W TRANSMISSION FOR ANY REASON, DO NOT USE MLP SENSORS
