Technical Service Information

DODGE/CHRYSLER/JEEP **45RFE TORQUE CONVERTER CLUTCH ENGAGEMENT ISSUES**

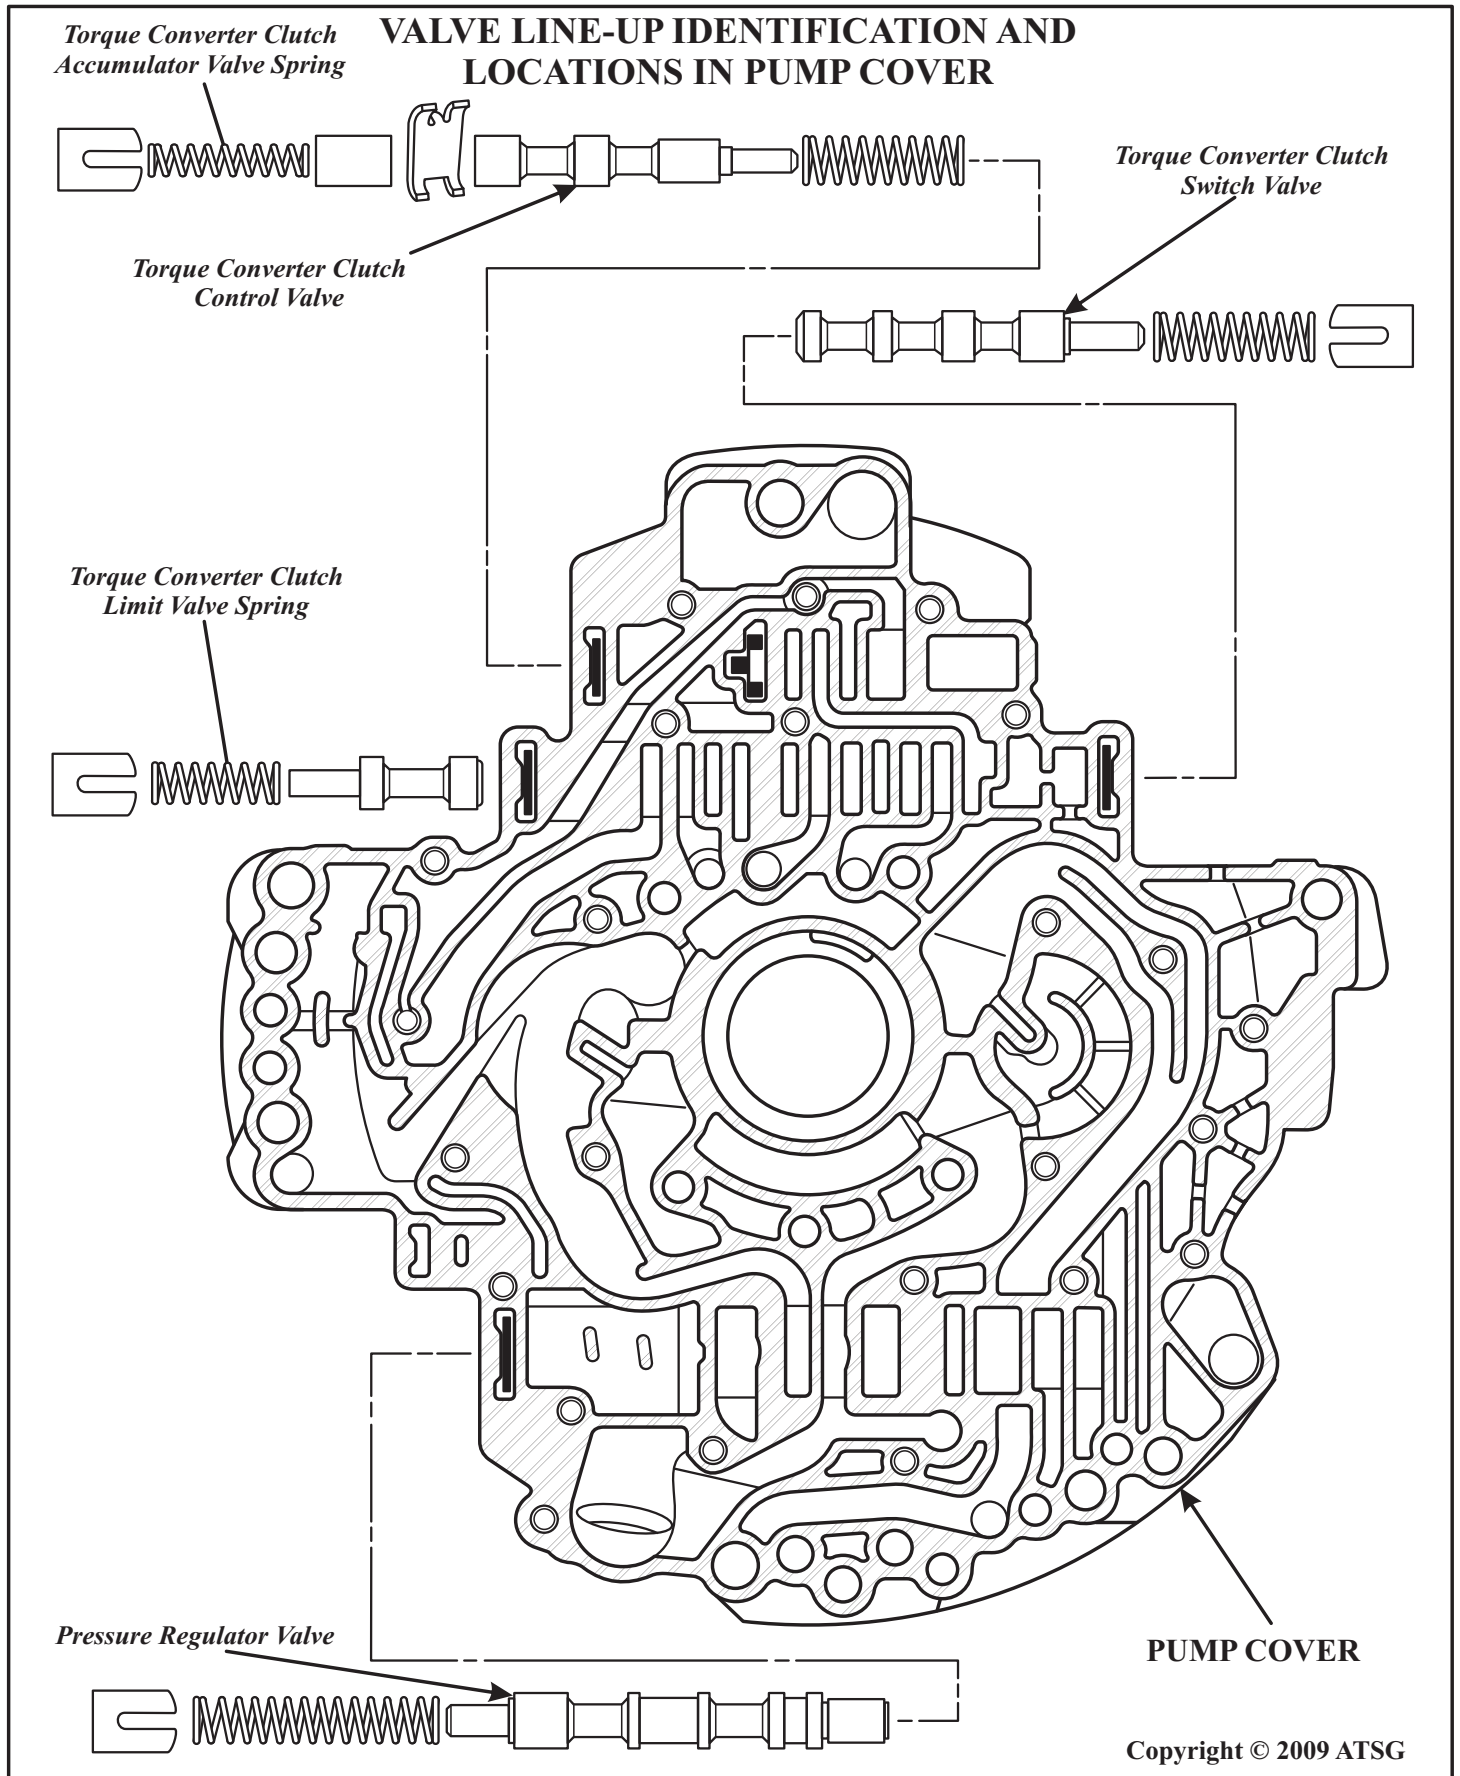
CAUSE: One cause may be broken springs in the Pump Assembly. A broken TCC Accumulator Valve Spring may cause a harsh engagement during TCC apply. A broken TCC Converter Limit Valve Spring may cause the engine to stall or stumble during a garage shift into Reverse or Drive.

Refer to Figure 1 for TCC Accumulator Valve and TCC Converter Limit Valve Spring location in the pump assembly.

CORRECTION: Replace the TCC Accumulator Valve Spring for harsh TCC apply. Replace the TCC Converter Limit Valve Spring for engine stall or stumble during garage shifts.
