# Technical Service Information

## ZF5HP24 (A5S 440Z)

### “E” CLUTCH PISTON FAILURE

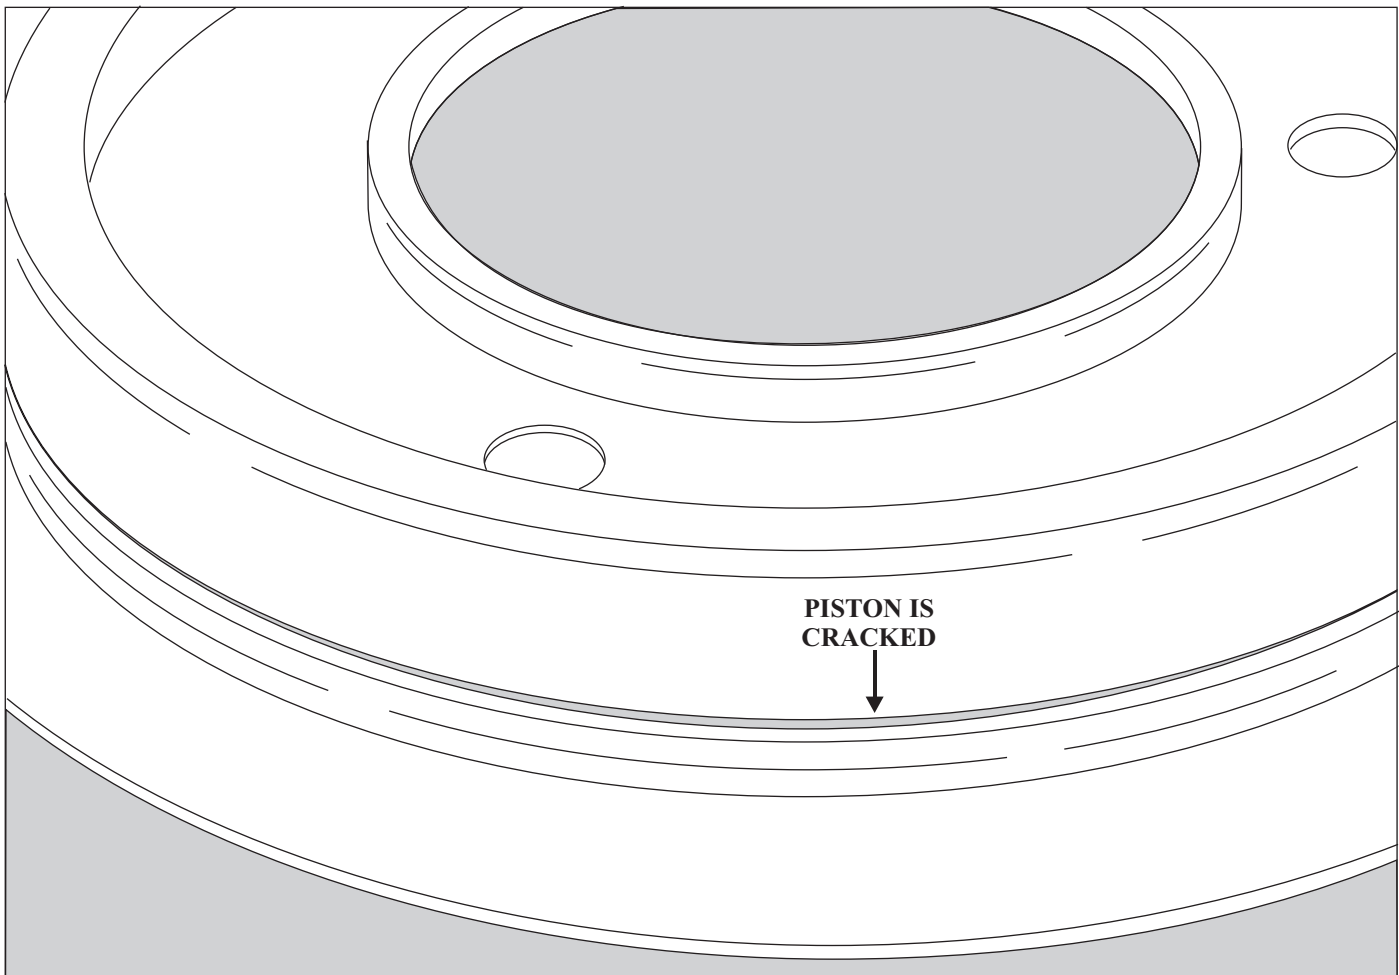
Figure 1

**COMPLAINT:** The transmission exhibits flared 1-2 and 2-3 shifts. P0732 and P0733 “Gear Control Malfunction 2nd and 3rd” codes are stored. Disassembly and inspection of the transmission reveals that the “E” clutch piston is badly cracked (Refer to Figure 1).

**CAUSE:** This condition is primarily seen in the Audi A8 and Jaguar XK8/XJ8 models. At this time the cause is unclear, however, it may be non-commanded line pressure spikes.

**CORRECTION:** Replace the “E” clutch piston.

*“E” Clutch Piston.....1058-375-020*
