## TOYOTA 140-E / 540-E HIGH AND/OR LOW LINE PRESSURE

**COMPLAINT:** Vehicles equipped with 140-E or 540-E transaxles may exhibit insufficient line pressure rise in the Drive ranges and higher than normal pressures in the Reverse range.

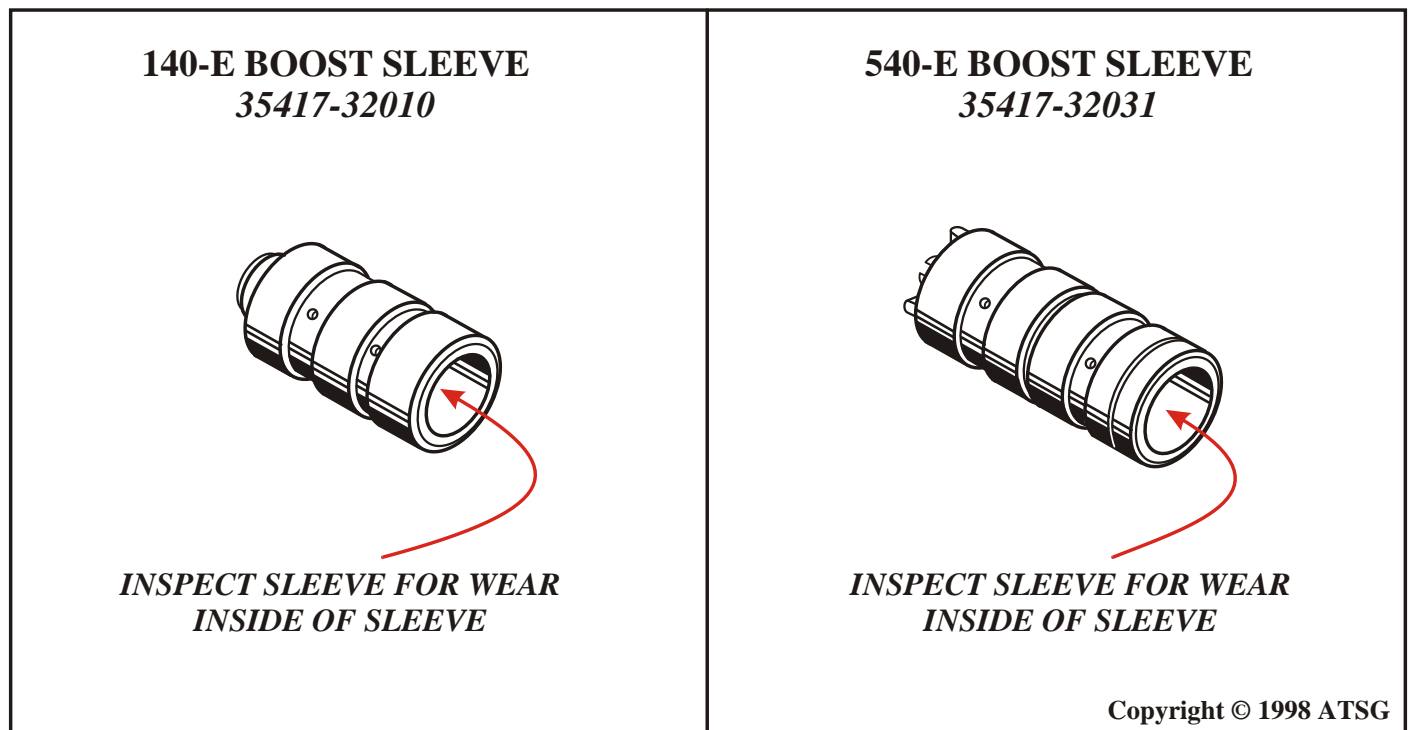
**CAUSE:** The cause may be, the Boost Sleeve in the Pressure Regulator line up severely worn, allowing T.V. pressure to leak into the reverse boost circuit which is open to exhaust at the manual valve, only when the manual valve is in the Drive ranges. When the selector is in the Reverse range, reverse boost oil can now enter the T.V. circuit forcing the Main Regulator valve to create higher than normal pressures.

**CORRECTION:** Refer to Figure 2 for the location of the boost sleeve in the valve body, and Figure 1 to check the Boost Sleeve for any wear. Replace as necessary with the OEM part numbers listed

140-E Boost Sleeve (Toyota NO.).....	35417-32010
540-E Boost Sleeve (Toyota NO.).....	35417-32031

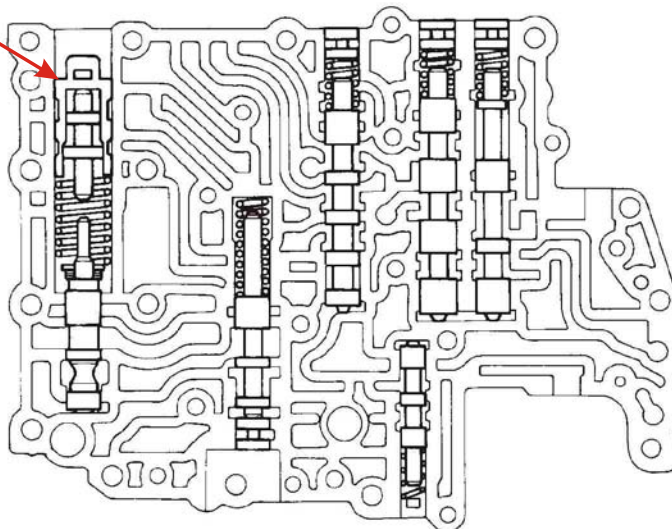
## 140-E LOWER VALVE BODY

BOOST SLEEVE  
LOCATION

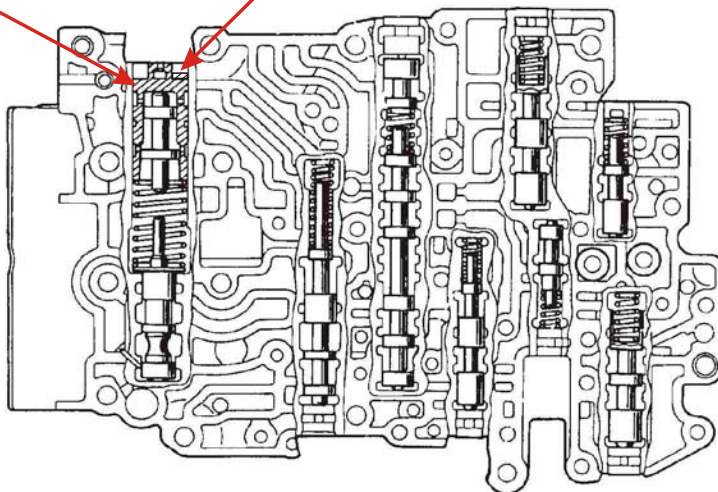
## 540-E LOWER VALVE BODY

BOOST SLEEVE  
LOCATION

ADJUSTABLE  
STEP

**NOTE: THE BOOST SLEEVE ON 540-E HAS AN ADJUSTABLE STEP. ENSURE THAT THE RETAINER IS IN THE SAME LOCATION AS BEFORE.**
