*1995 SEMINAR INFORMATION*  
**"HOW TO SURVIVE IN 95"**

# "HOW TO SURVIVE IN '95"

## INTRODUCTION

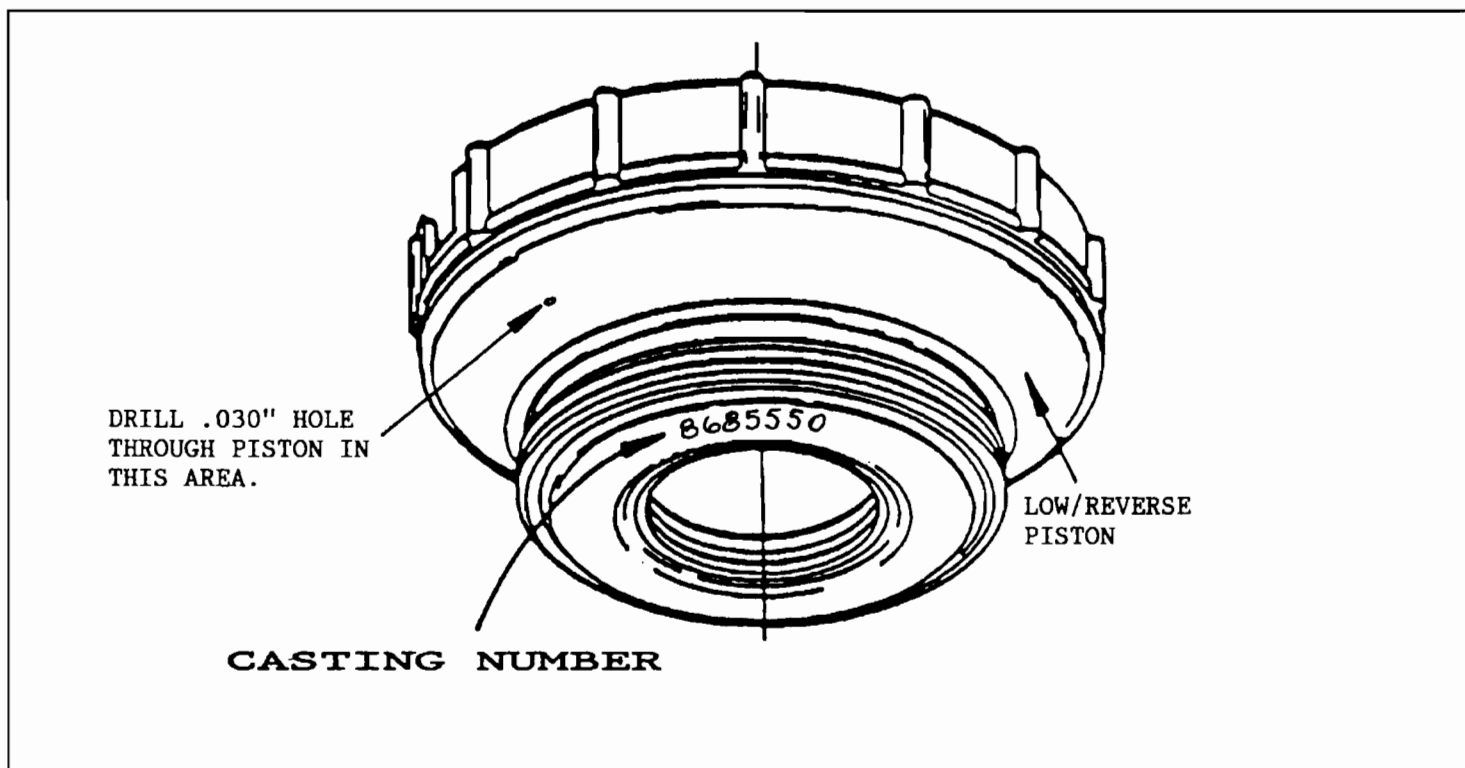
Figure 26

**COMPLAINT:** Premature and/or repeat failure of the Low/Reverse clutch pack, and may happen in as little as 5000 miles.

**CAUSE:** The cause may be, the Low/Reverse clutch not totally exhausting the apply oil when the shift lever is moved from Park to Drive position. The Low/Reverse clutch is applied in Park on this transmission.

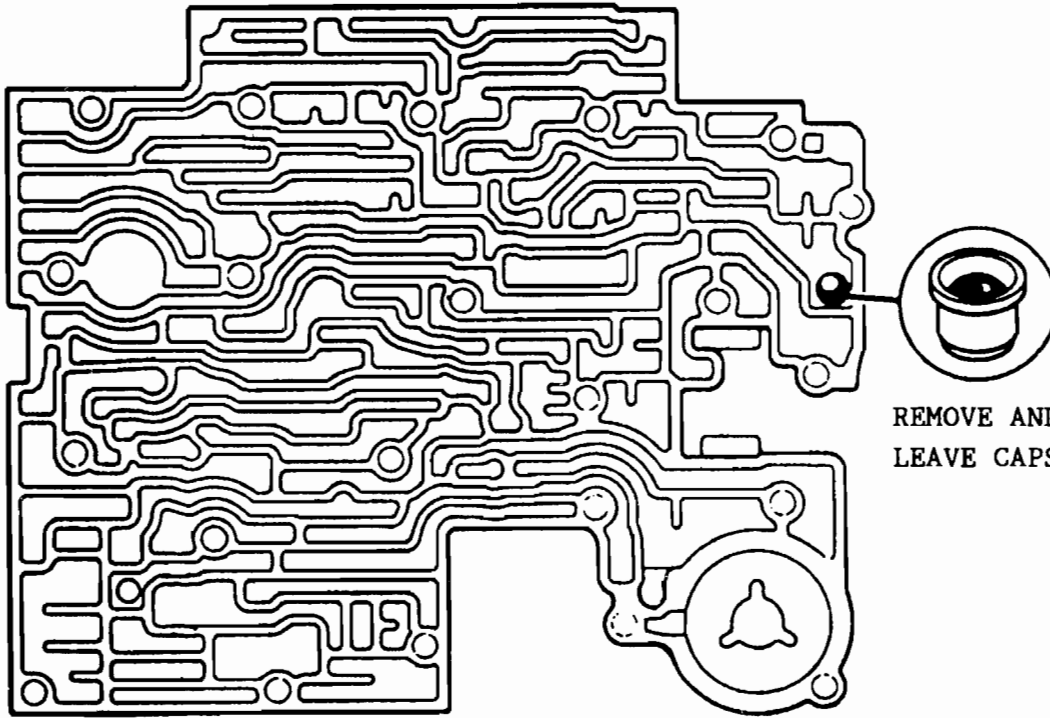
Figure 27

REMOVE AND DISCARD BALL ONLY.  
LEAVE CAPSULE IN THE CASE.

STEP 2: Remove the BALL ONLY from the capsule in the reverse passage at the rear of case worm track area, as shown in Figure 27. Leave the capsule in the case. This will allow larger volume of oil to the piston to overcome the leak we have created with the hole. We have now created a feed-bleed system.

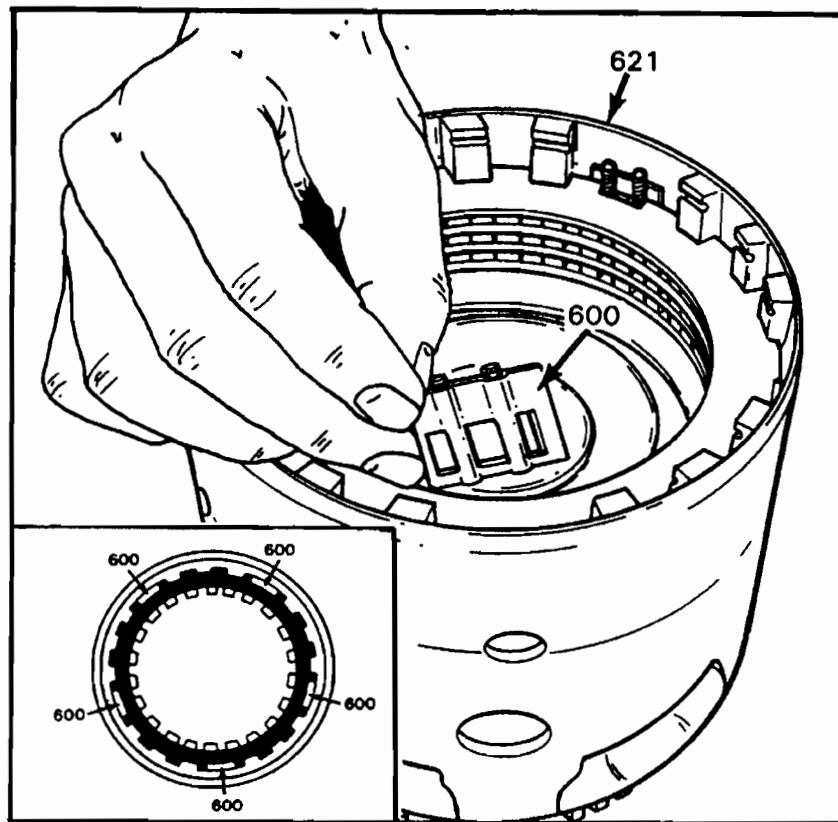
Figure 29

**COMPLAINT:** Premature failure of the 3-4 clutch pack and may happen in as little 5000 miles. The vehicle may also exhibit a very soft 2-3 shift.

**CAUSE:** The cause may be, not enough clamping force for the 3-4 clutch pack due to the 3-4 load release spring assemblies.

**CORRECTION:** **STEP 1:** Remove and discard the five 3-4 load release spring assemblies in the input housing and located between the steel plates and the input housing, as shown in Figure 29.

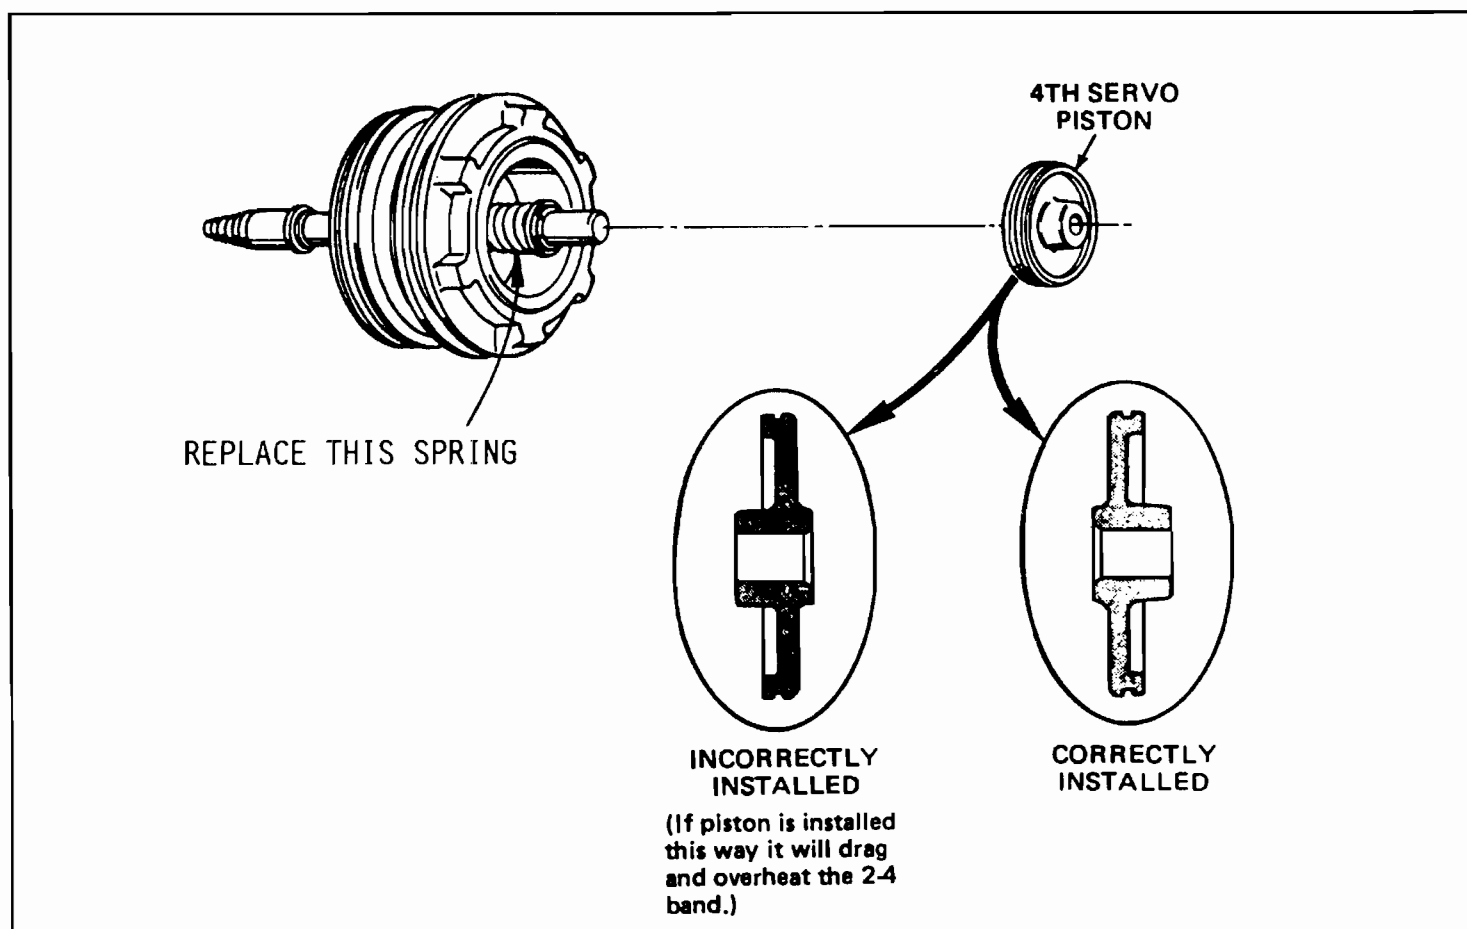
Figure 35

**COMPLAINT:** Repeated and/or premature burning of the 2-4 band assembly, with nothing else in the transmission showing any signs of burning.

**CAUSE:** The cause may be, a weak or collapsed 4th apply piston return spring, located on the servo apply pin, that will not allow the band to fully release on a 4-3 downshift. Compress the spring on the bench, while it is still installed on the servo pin, and hold compressed for about 30 seconds. Release the compression and check for servo pin movement, back and forth, in the piston assembly. If there is servo pin end play, the spring needs to be replaced.

**CORRECTION:** Remove and discard the OEM spring from the servo apply pin. Replace the 4th apply piston return spring with part number K004, available through Shift Technology Products. Reinstall washer and "E" clip, as shown in Figure 35.

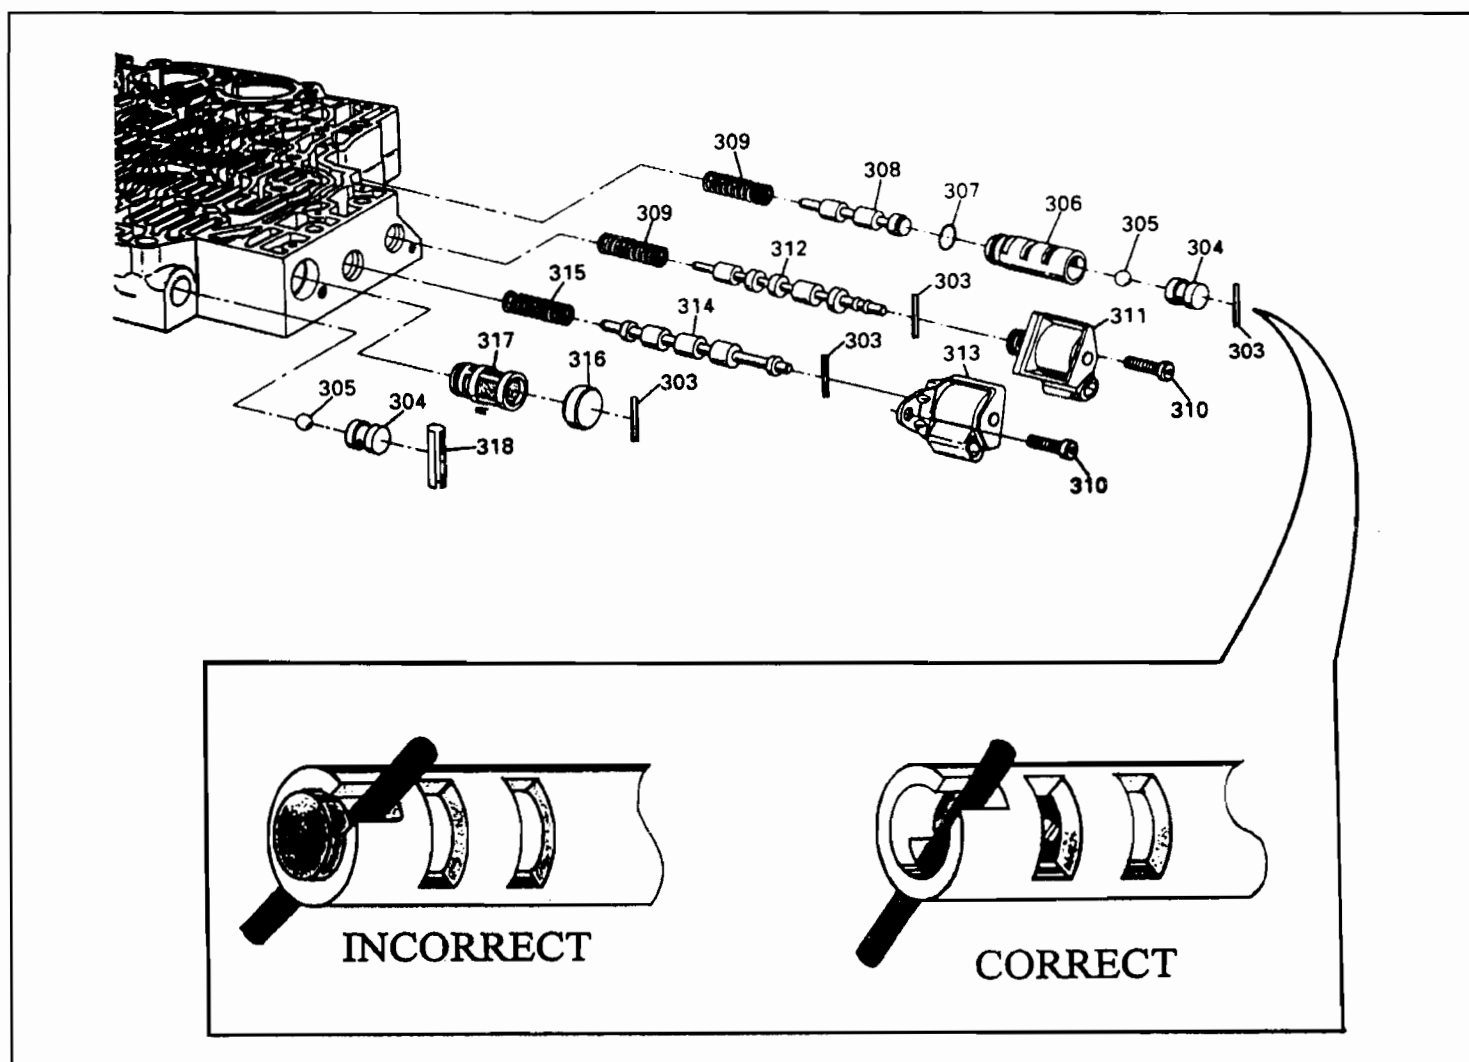
Figure 37

**CAUSE:** The cause may be, the roll pin that retains the 3rd/Reverse checkball bushing and bore plug in the valve body, has been mislocated through the hole in the bore plug, as shown in Figure 37.

**CORRECTION:** Position the roll pin in front of the bore plug, as shown Figure 37. The roll pin will be visible when looking at the end of the bore, after the valve train has been installed, if you have assembled it correctly (See Figure 37).

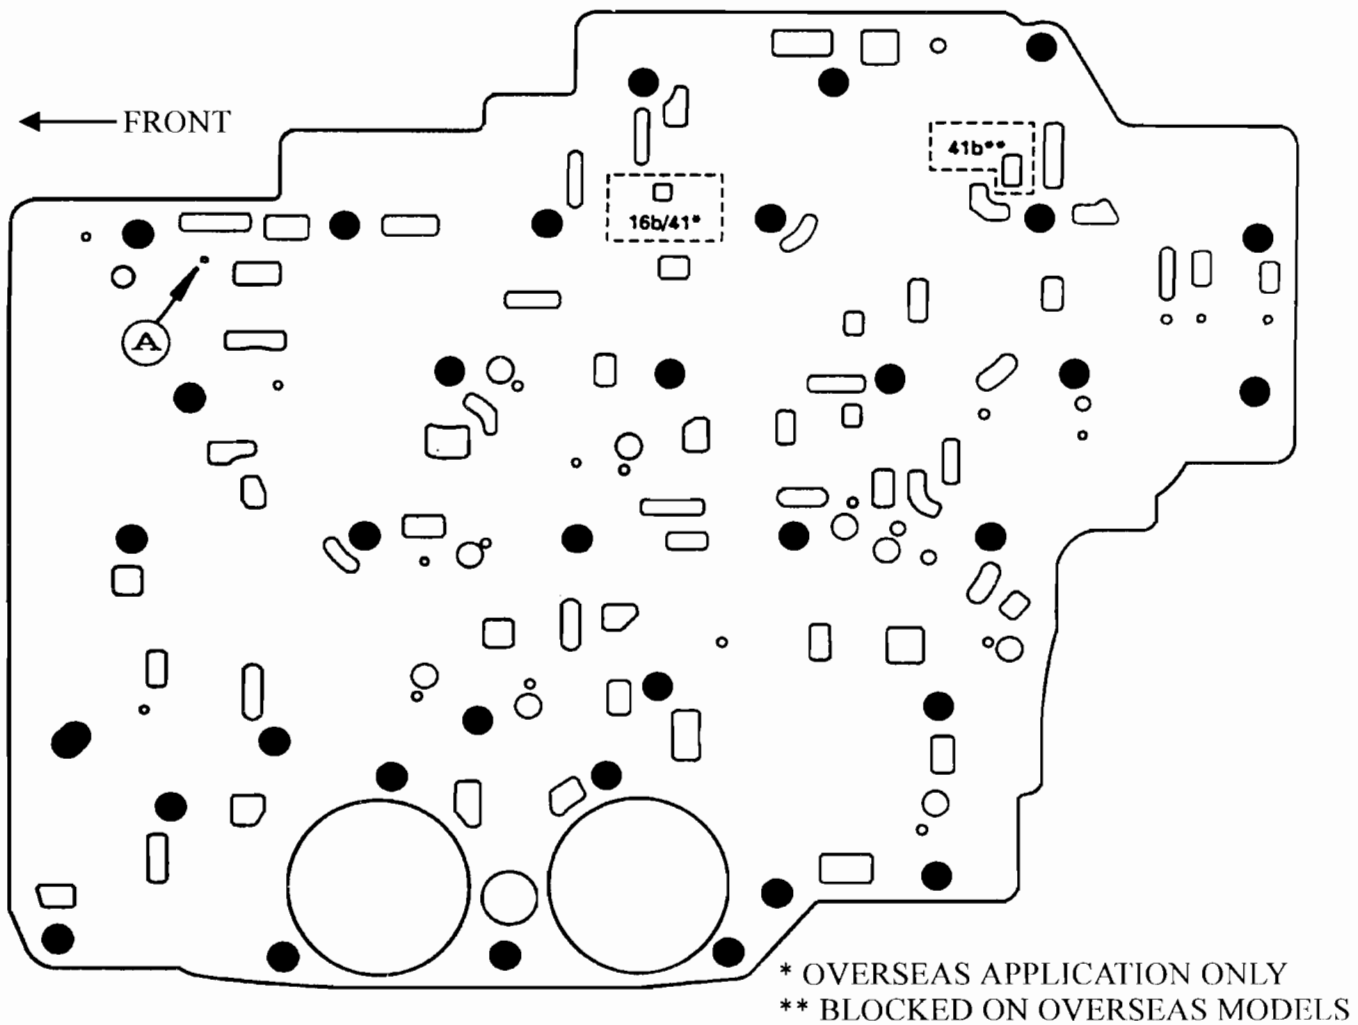
Figure 39

HOLE "A" ELIMINATED IN THE 1994 MODEL SPACER PLATE.

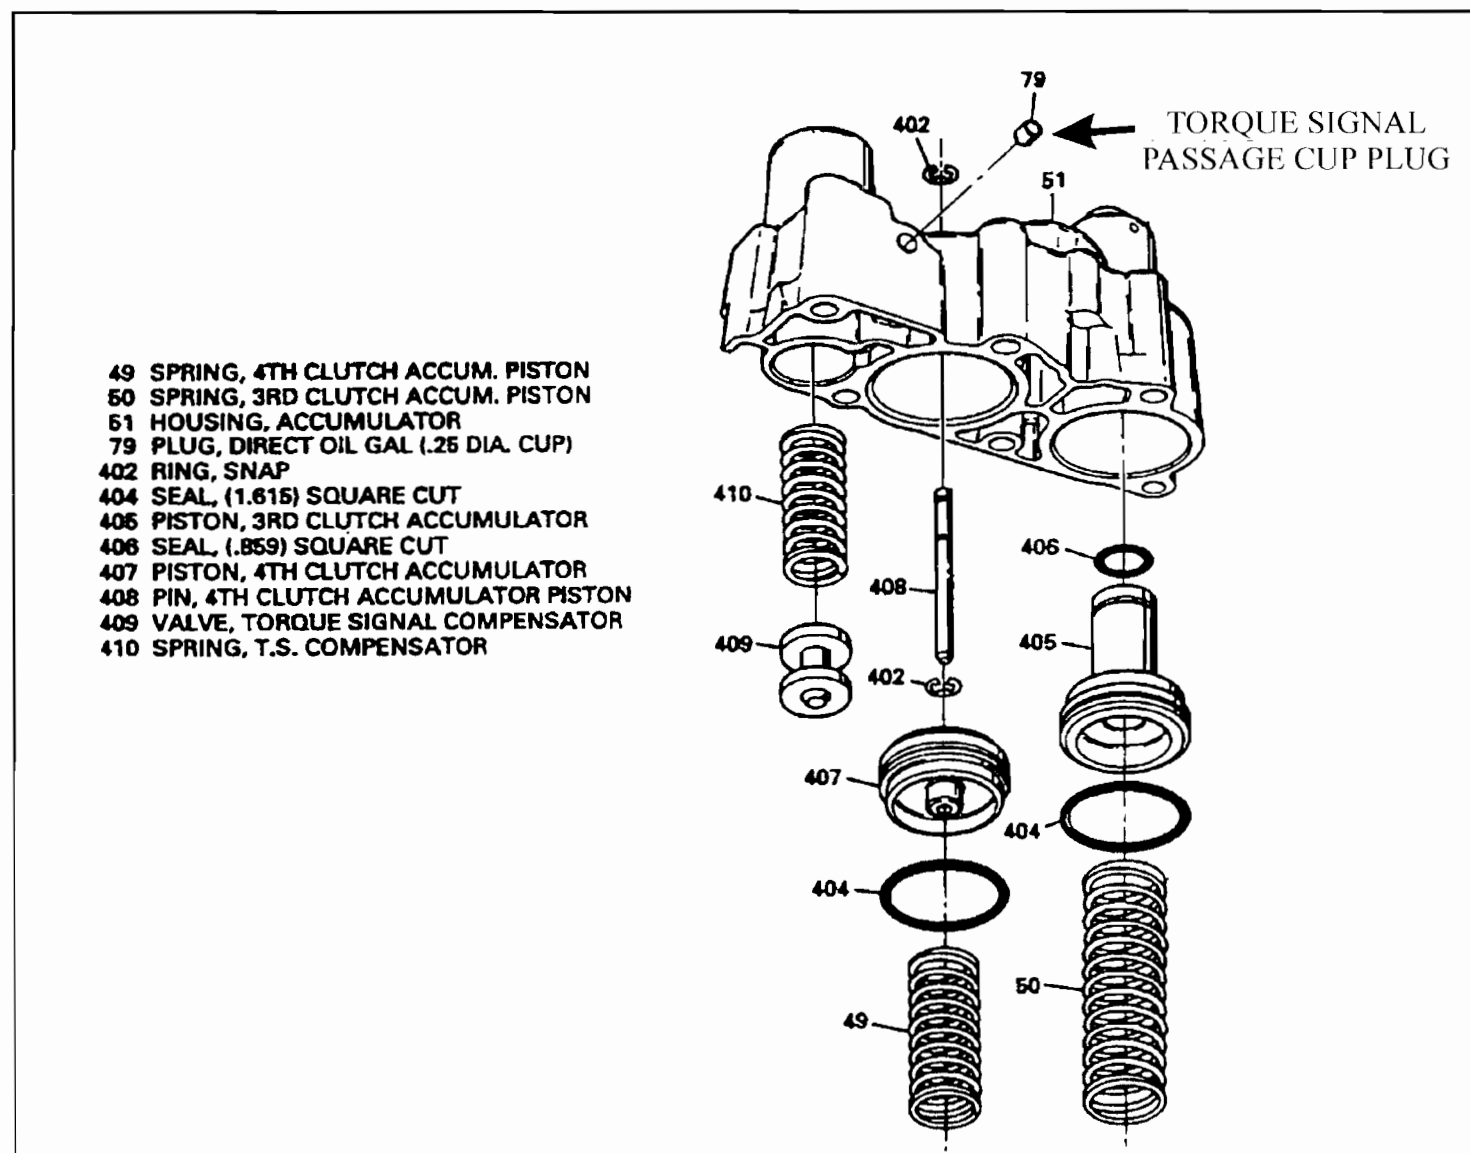
**CAUSE:** The cause may be that the cup plug has blown out of the torque signal passage in the accumulator body. See Figure 42 for the location of the cup plug.

**CORRECTION:** Replace the cup plug and stake it in place to prevent it from coming out again.

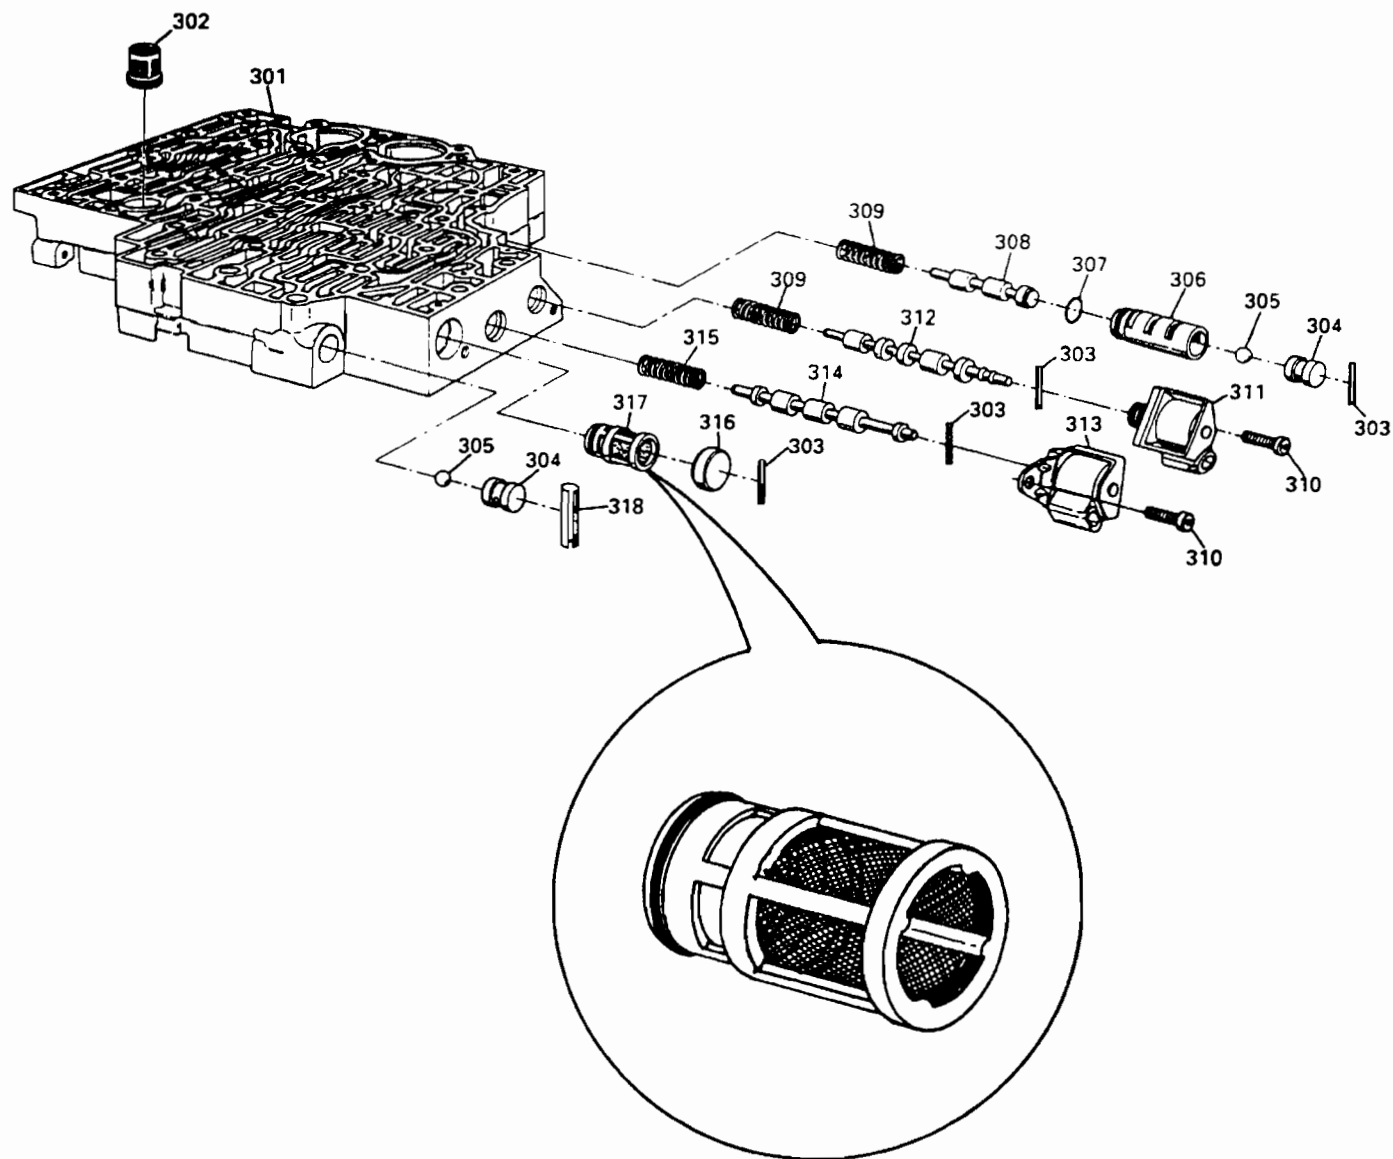
CAUSE: For ALL of the concerns listed above, the cause may be a broken Actuator Feed Screen located INSIDE of the valve body as shown in Figure 46.

CORRECTION: Replace the Actuator Feed Screen, located INSIDE the valve body with OEM part number 8661709. Refer to Figure 46 for location. We recommend that this screen be replaced on every rebuild and some kit suppliers are now putting this screen in the gasket set.

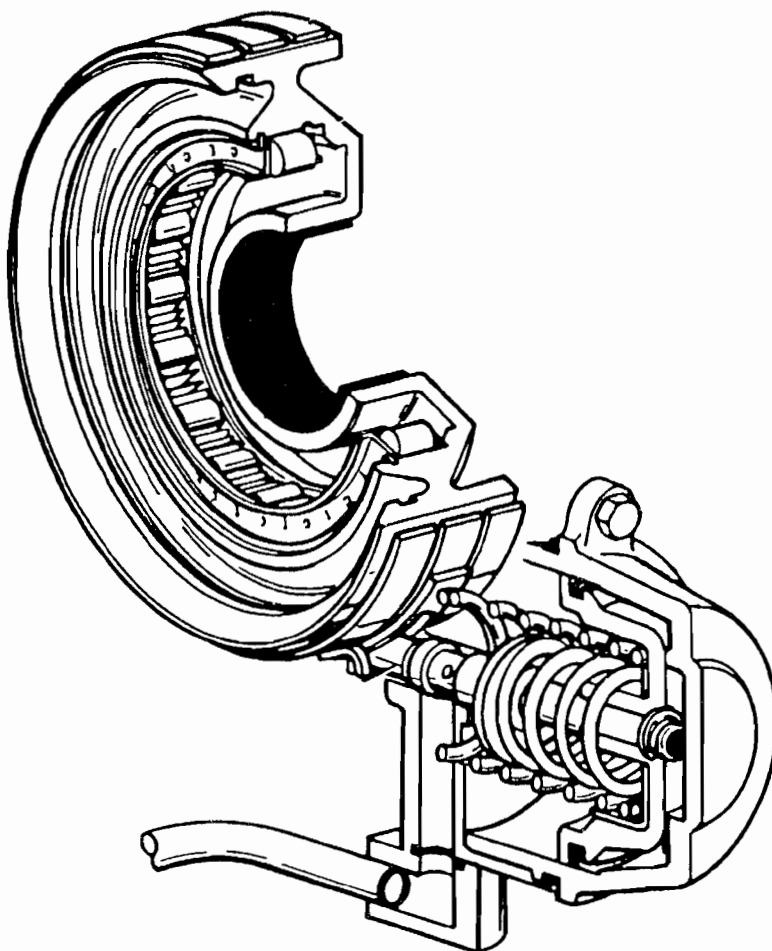
Figure 49

CAUSE: The cause for both complaints listed above is a 1-2 roller clutch failure. (See Figure 49)

CORRECTION: Replace the 1-2 Roller Clutch Assembly and any related parts that may be damaged or broken.

**WARNING: DO NOT EXCEED 3000 RPM WITH THE SELECTOR LEVER IN REVERSE AND THE WHEELS OFF THE GROUND.  
IF YOU DO THIS, YOU CAN FAIL THE 1-2 ROLLER CLUTCH BEFORE IT EVER LEAVES THE SHOP!**

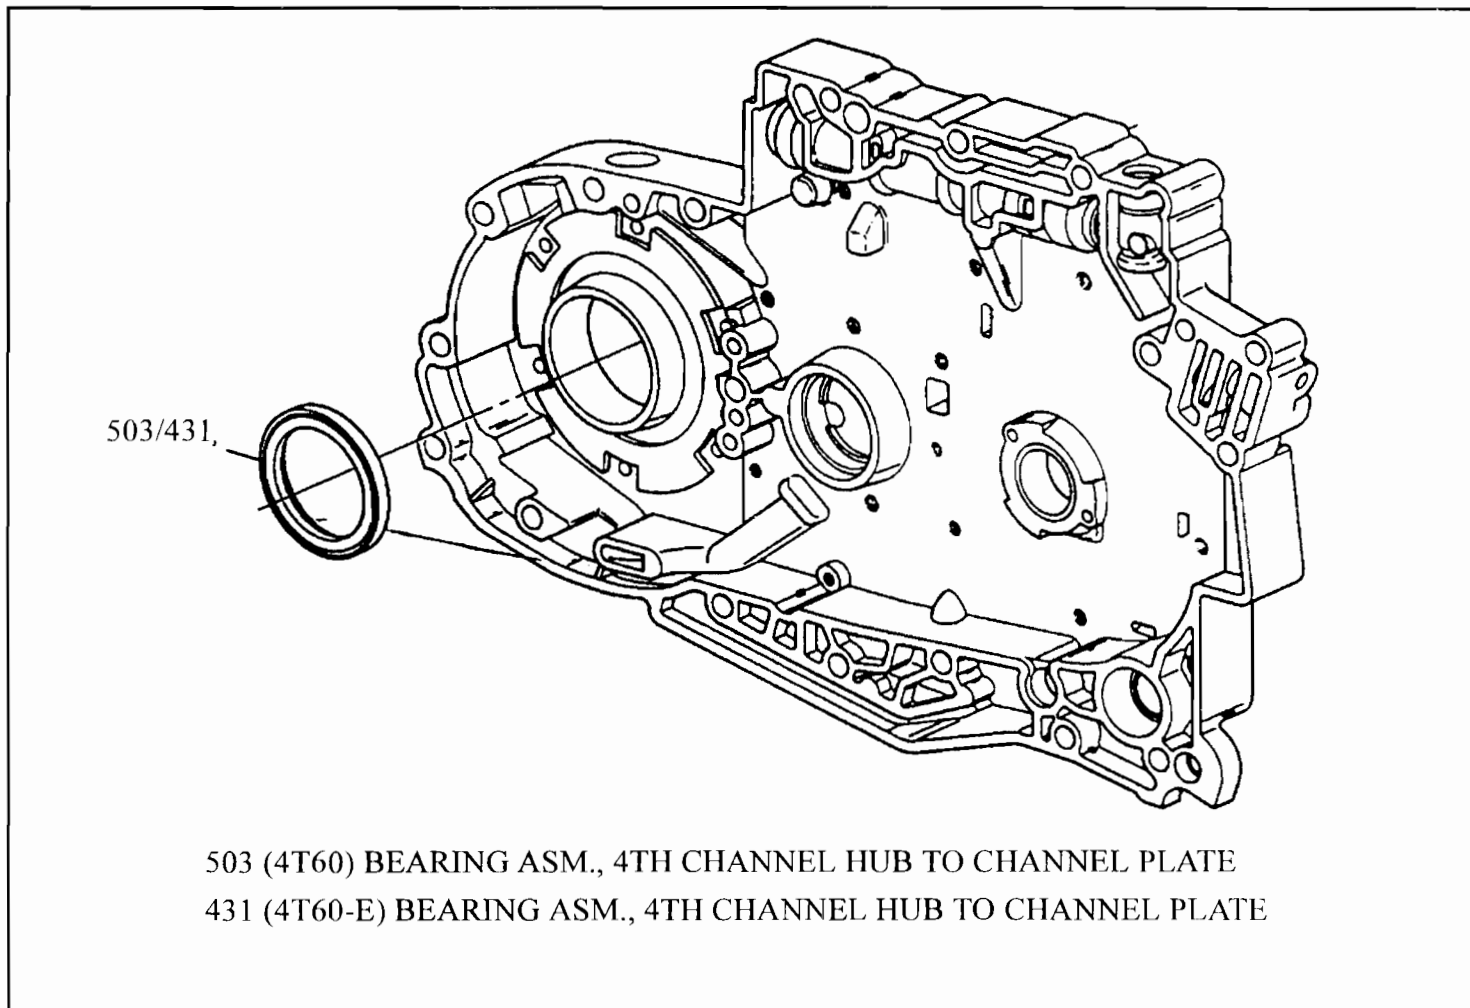
Figure 53

The cause may be, an improperly installed Channel Plate to 4th Clutch Hub Bearing assembly (Figure 53), causing the needle bearings to leave indentation marks on the bearing race.

Replace the Channel Plate to 4th Clutch Hub Bearing Assembly with OEM part number 8656393, and use "Hand Pressure Only" to install the bearing assembly into the channel plate (See Figure 53). The part number is the same for both the THM 4T60 and the 4T60-E transaxles.

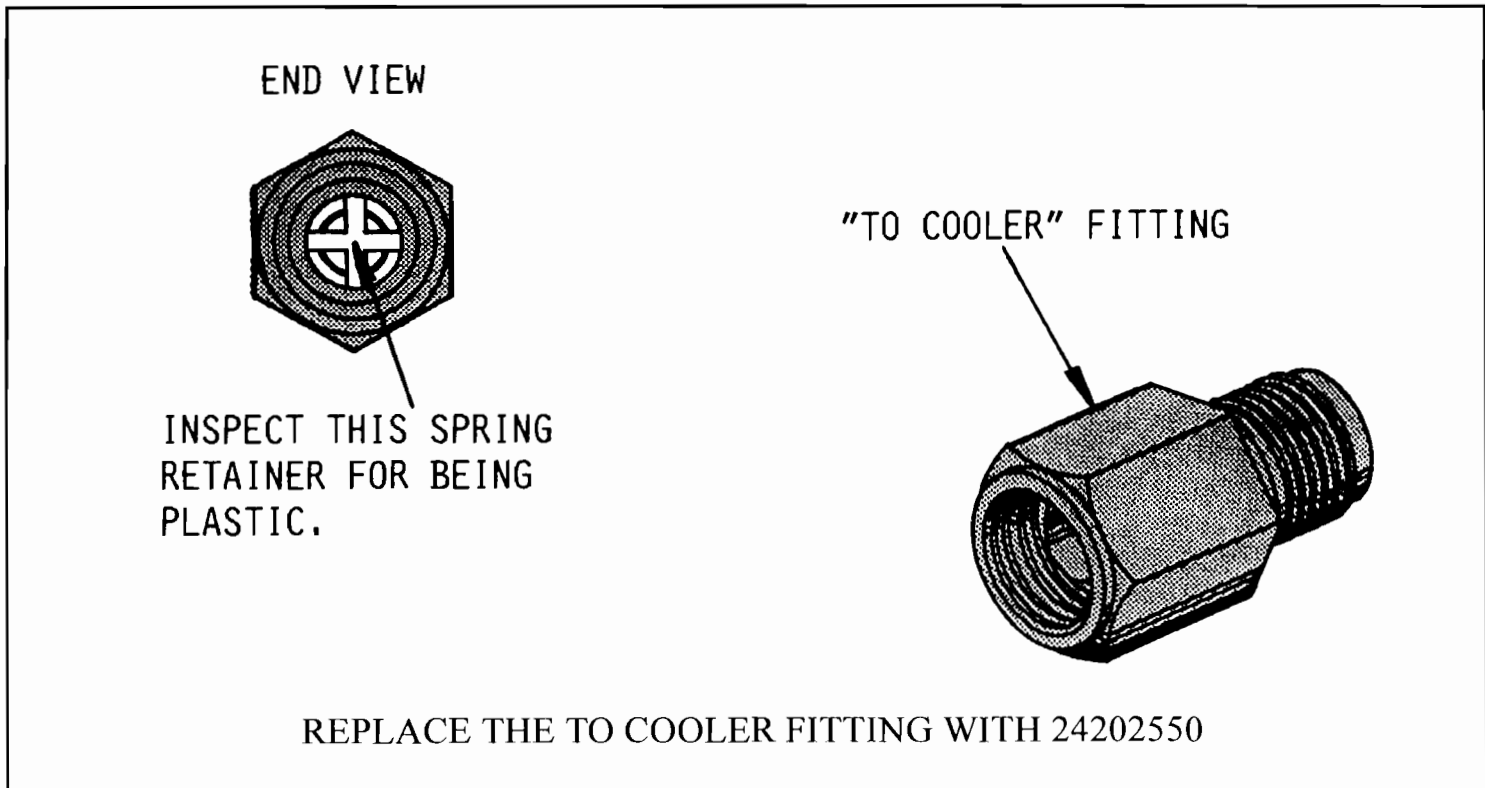
Figure 74

**CAUSE:** The cause may be, the plastic spring retainer located inside of the "TO COOLER" (Large) fitting has melted, and is blocking and/or restricting cooler flow.

**CORRECTION:** Remove the "TO COOLER" (Large) fitting and inspect the spring retainer inside the fitting, as shown in Figure 74. If the spring retainer is plastic and/or melted, replace the fitting with OEM part number 24202550, which has a steel retainer. It is advisable to replace the "TO COOLER" fitting, even if the spring retainer is not melted, IF it has the plastic spring retainer. If the spring retainer IS melted, the cooler in the radiator needs a thorough flushing, and possibly replacement.
