Technical Service Information

NISSAN MAXIMA RE4FO2A REPEATED FRONT SEAL LEAK

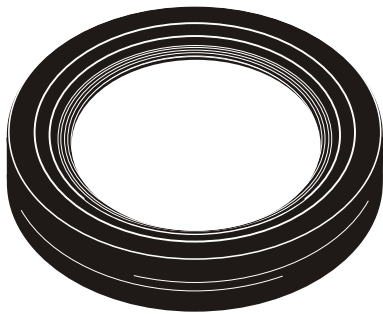
**SEAL WITHOUT
ROUND NOTCH**

- CAUSE:** One cause may be that during the rebuild procedure the front pump seal was installed too deeply into the converter housing. When this happens, the seal will block off approximately half of the drain back hole in the pump causing an increase of oil pressure behind the seal. Due to the increased pressure, the front seal may either pop out of the converter housing, or oil may blow past the seal between the seal lip and the converter hub.

INSTALLING A NEW SEAL TOO DEEPLY INTO THE CONVERTER HOUSING WILL BLOCK ABOUT HALF OF THE DRAIN BACK HOLE IN THE SEAL AREA, WHICH COULD CREATE EXCESS PRESSURE BEHIND THE SEAL CAUSING THE SEAL TO WALK OUT OF THE PUMP.

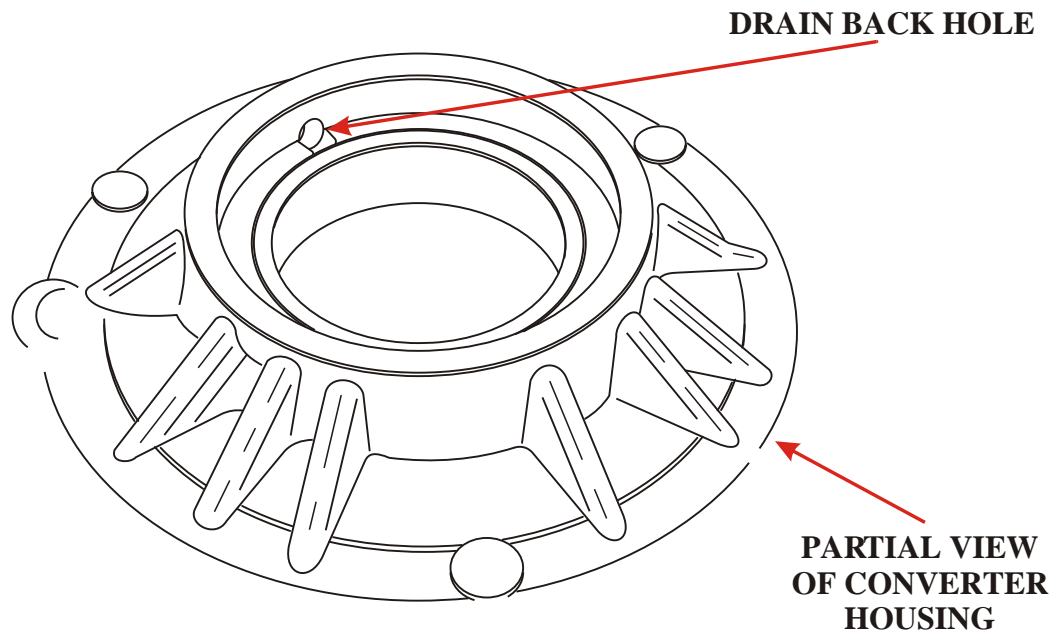
- COMPLAINT:** Before and/or after rebuild, vehicle exhibits a condition of a repeated front seal leak. The front seal may appear to have popped out of the converter housing.

- CORRECTION:** To correct the problem use a die grinder and cut a round notch into the seal approximately the same size as the drain back hole, then index the seal into the converter housing lining up the notch that you just cut, with the drain back hole. Refer to Figure 1 for location of the drain back hole in the converter housing and location of round notch in seal. It has been ATSG's experience that OEM seals have a better retention rate than some of the aftermarket seals.
