FORD A4LD, 4R55E, 5R55E, 5R55N, 5R55W PUMP TO CONVERTER HOUSING THREAD REPAIR OR PUMP BODY TO PUMP COVER

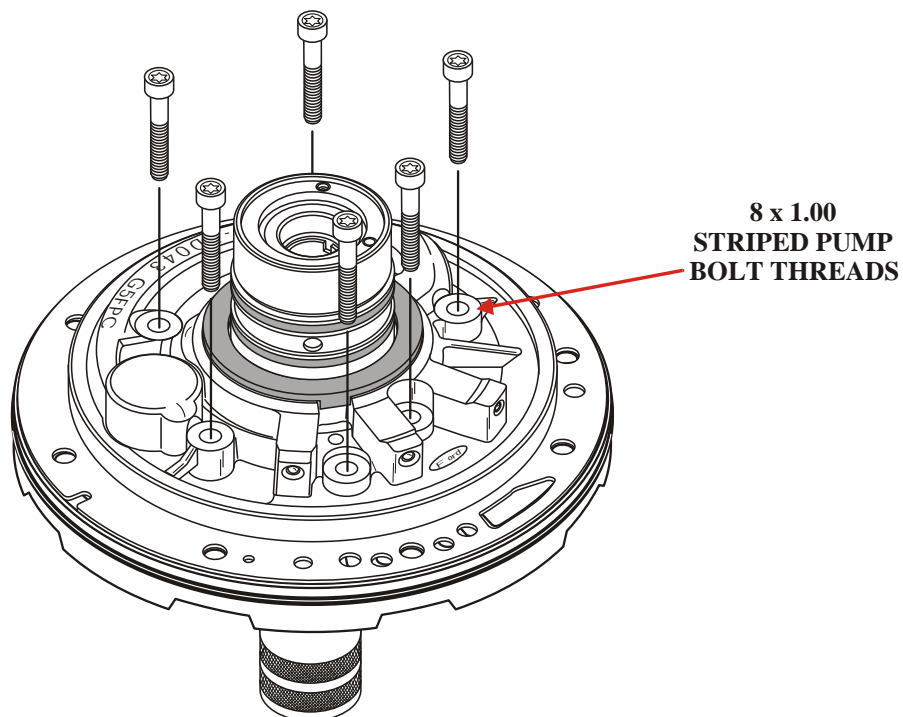
Figure 1

COMPLAINT: When tightening the pump to converter housing bolts, one or more of the bolt hole threads strips out, which will now require repair using the Heli-Coil® method. After an attempt to locate a Heli-Coil® kit for 8mm x 1.00 thread, it is discovered that a repair kit does not exist for this size thread.

CAUSE: The causes of this complaint can be metal fatigue or over tightening.

CORRECTION: The original bolt size, seen in Figure 1, is 8 x 1.00 x 35mm. Since a thread repair kit does not exist for this size, use an 8 x 1.25mm tap to repair the damaged threads, because a thread repair kit does exist for this size thread.
