TRANSMISSION SEMINAR 1991

NEW DESIGNATION SYSTEM FOR HYDRA-MATIC PRODUCTS

THM 4L60 (700-R4) SOFT UPSHIFTS AND OTHER THINGS

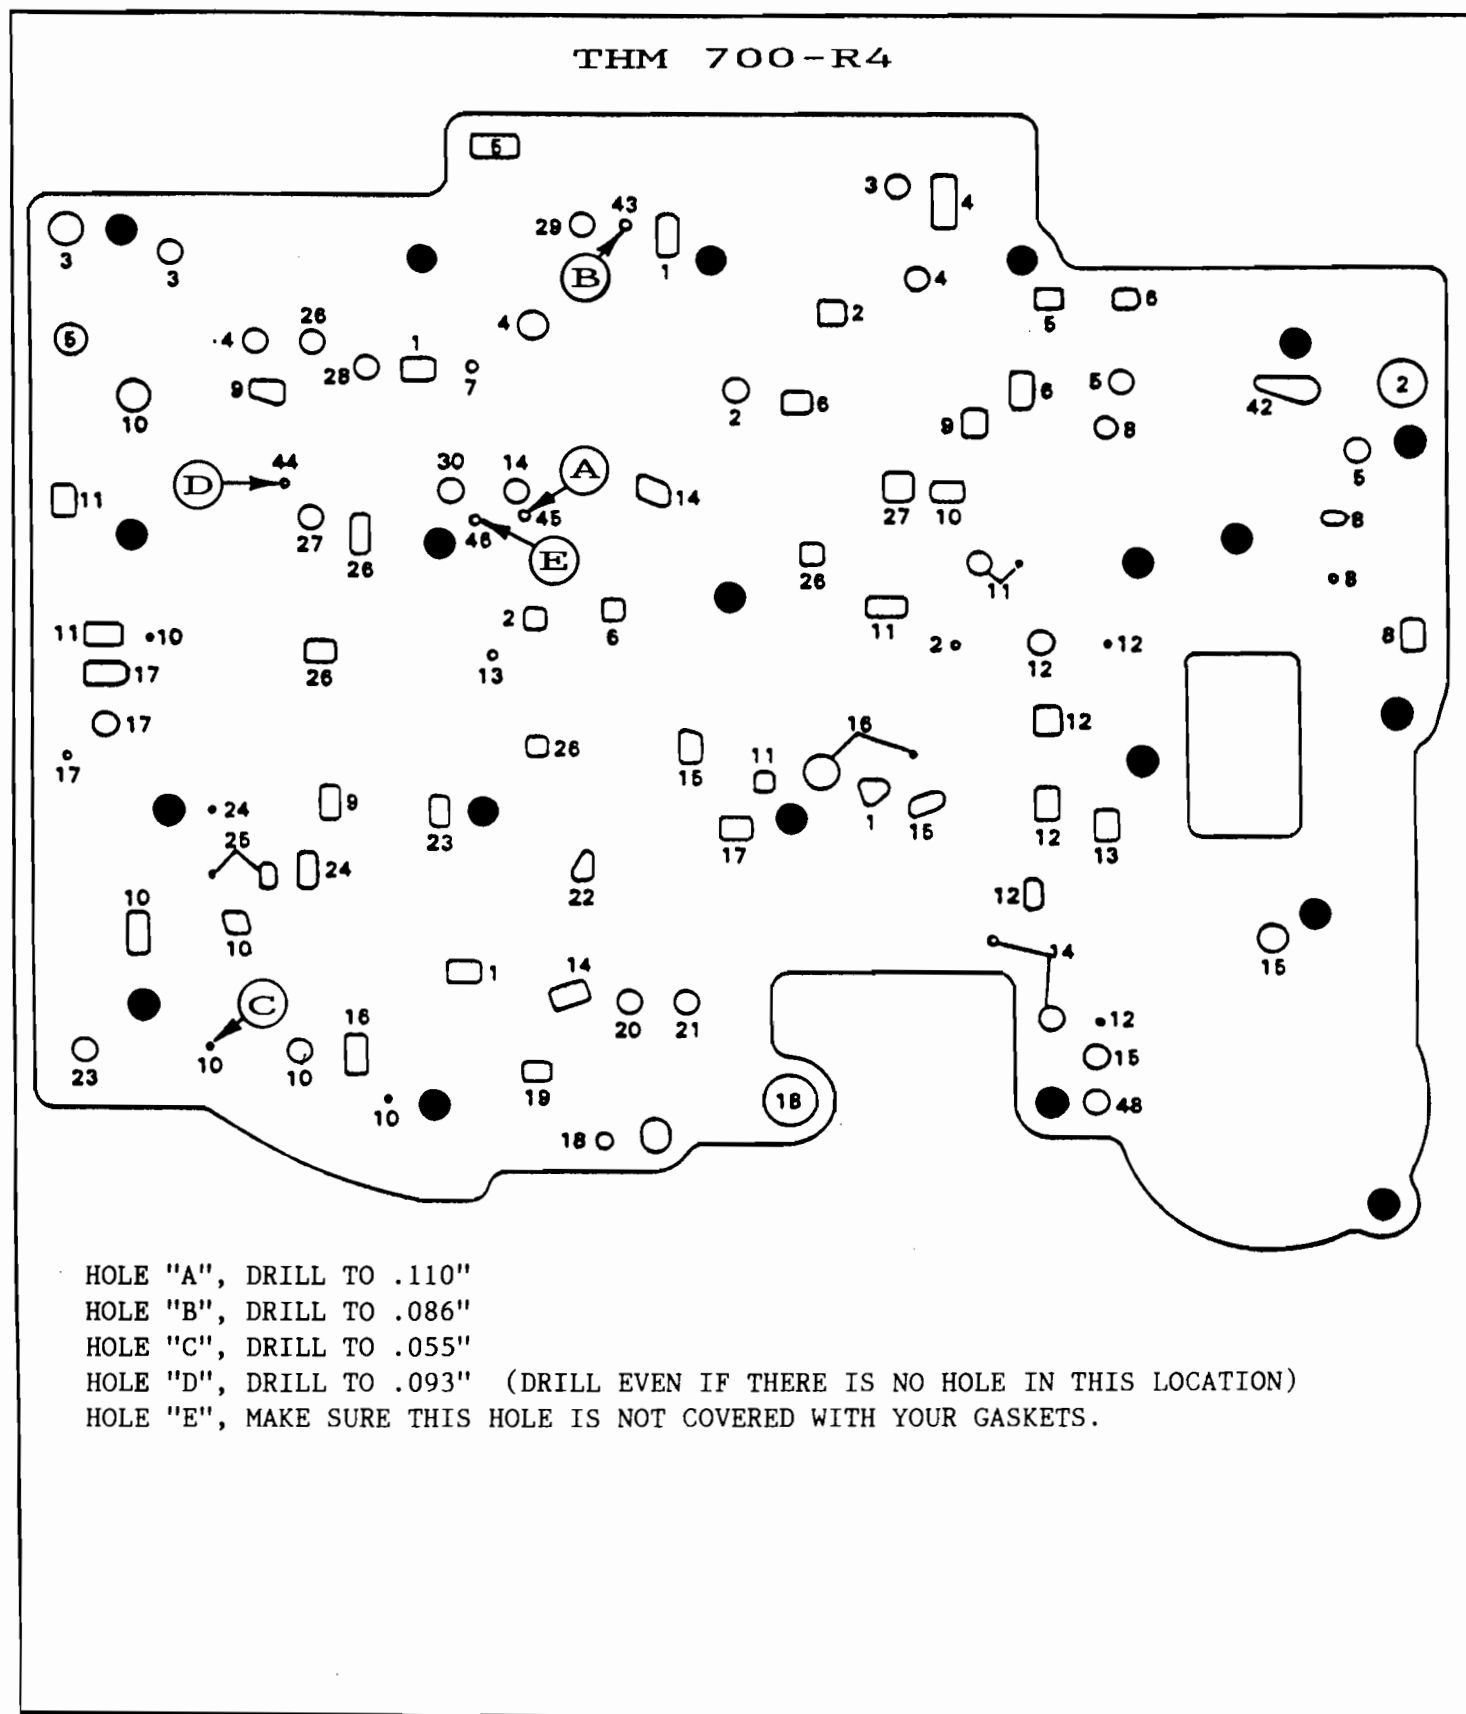
Figure 1

COMPLAINT: Soft and/or mushy upshifts regardless of throttle position.

CAUSE: Not enough feed oil to the 2-4 band, and the 3-4 clutch pack.

CORRECTION: Drill the holes in the spacer plate, as shown in Figure 1, as follows:

HOLE "A", DRILL TO .110".

This will improve the 1-2 shift.

HOLE "B", DRILL TO .086".

This will improve the 2-3 shift. DO NOT drill any larger than .086" as a larger hole will create a flare on the 2-3 shift on some models.

HOLE "C", DRILL TO .055".

This will prevent the T.V. valve from hydraulically locking.

HOLE "D", DRILL TO .093".

This will help prevent the 3-4 clutches from burning. This hole was eliminated on the 1988 and later 5.7L models. If your spacer plate does not have this hole, use the gasket as a template and drill it to .093".

HOLE "E", MAKE SURE THIS HOLE IS NOT COVERED WITH YOUR GASKETS.

If this hole is covered by the gaskets, it will create the following:

- (1) Shifts 1-3 in drive, after initial upshift pattern. First set of upshifts are normal, and will be again, after setting awhile.
- (2) Delayed (5 Seconds) 4-2, or 3-2 kickdown.
- (3) Delayed (5 Seconds) manual downshift from D3 to D2. (Stays in 3rd)
- (4) Binds in reverse, after upshifting to 3rd gear. Normal operation after setting for a while.
- (5) Binds in manual Lo, after upshifting to 3rd gear. Normal operation after setting for a while.
- (6) Results in burnt 3-4 clutch plates. They are usually wiped out on the road test, as this is the exhaust hole for the 3-4 clutch.

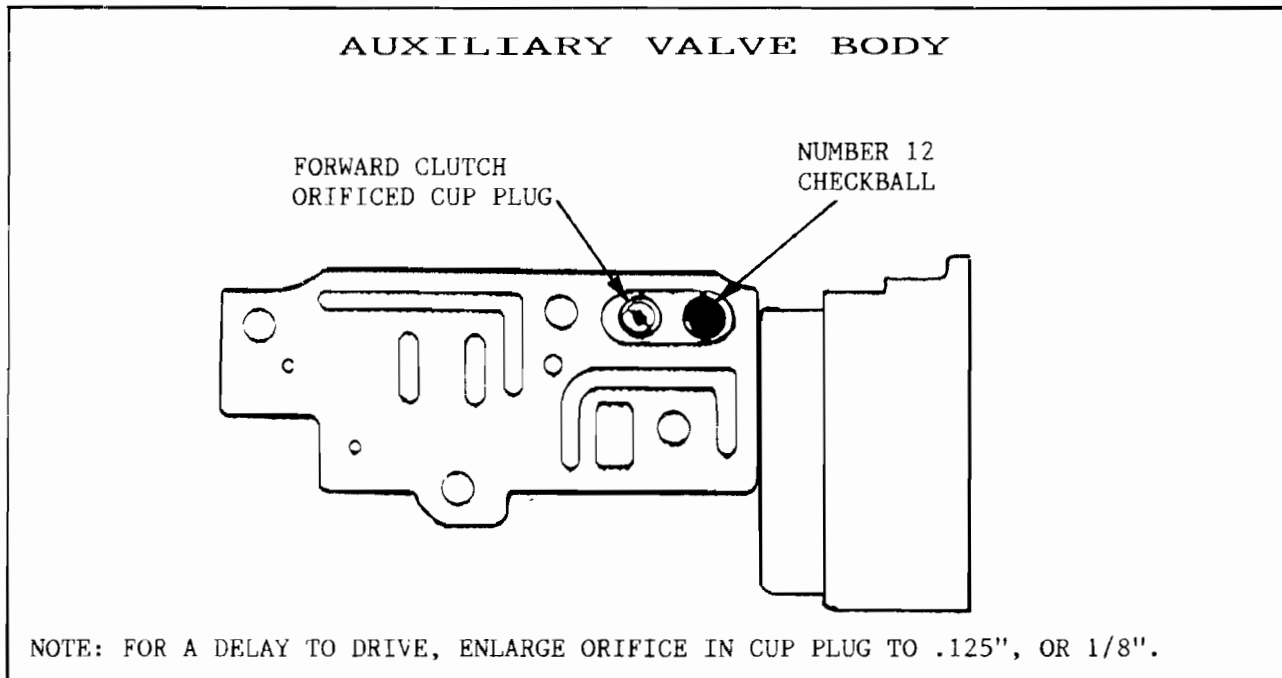
Figure 2

Do not install the number 12 checkball on top of the orifice cup plug in the auxiliary valve body. It goes next to the orifice cup plug as shown in Figure 2. If you install it improperly, the checkball falls through the spacer plate into the D4 passage, and is forced into the governor screen blocking all of governor feed oil, and creates "No Upshift". It may also be an intermittent problem, as the checkball sometimes falls away from the screen allowing D4 oil to the governor (See Figure 3).

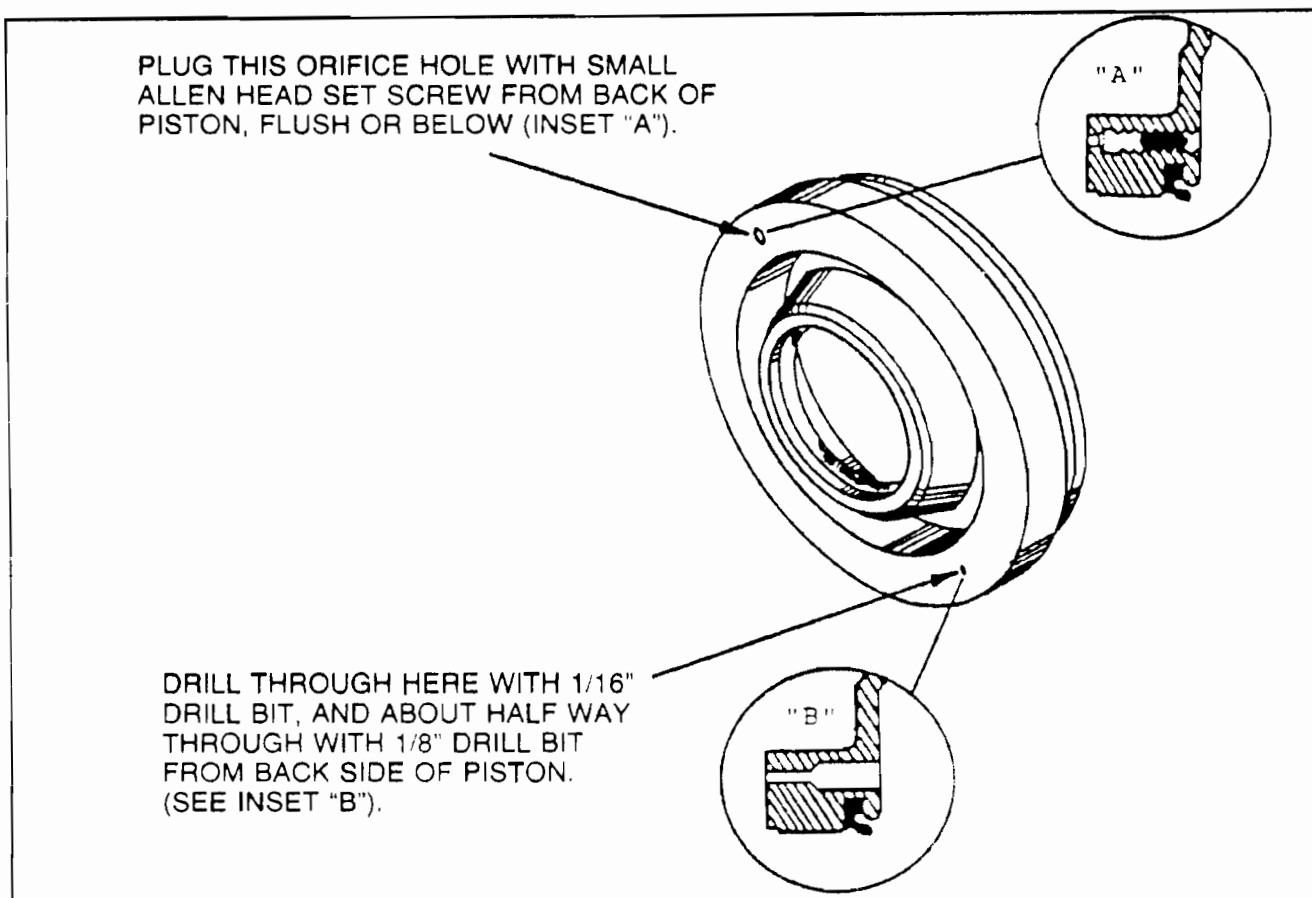
Figure 12

- COMPLAINT:** Premature failure of the reverse input clutches, on 1987 or later models only. These models have the new aluminum piston.
- CAUSE:** The cause may be the orifice hole in the new aluminum piston being larger than the feed hole in the reverse input housing. The original orifice hole was .116".

- CORRECTION:** This should be modified on ALL aluminum pistons to eliminate any repeat failures, and there are two methods.
- METHOD NO. 1.**
Plug the original hole from the back side of piston with an allen head set screw, flush or below. Retain the set screw with Loc-tite, (See Figure 12, Inset "A").
180 degrees from original hole you will find a hole started but not drilled through. Drill through here with a 1/16" drill bit, from the front side of piston. Turn the piston over and from the back side of piston, drill about half way through with a 1/8" drill bit (See Figure 12, Inset "B"). Please use a drill press for this operation to keep the holes straight.

- METHOD NO. 2.**
Install an orifice cup plug, OEM part number 8631146, into original hole from the back side of piston, and enlarge orifice to 1/16".

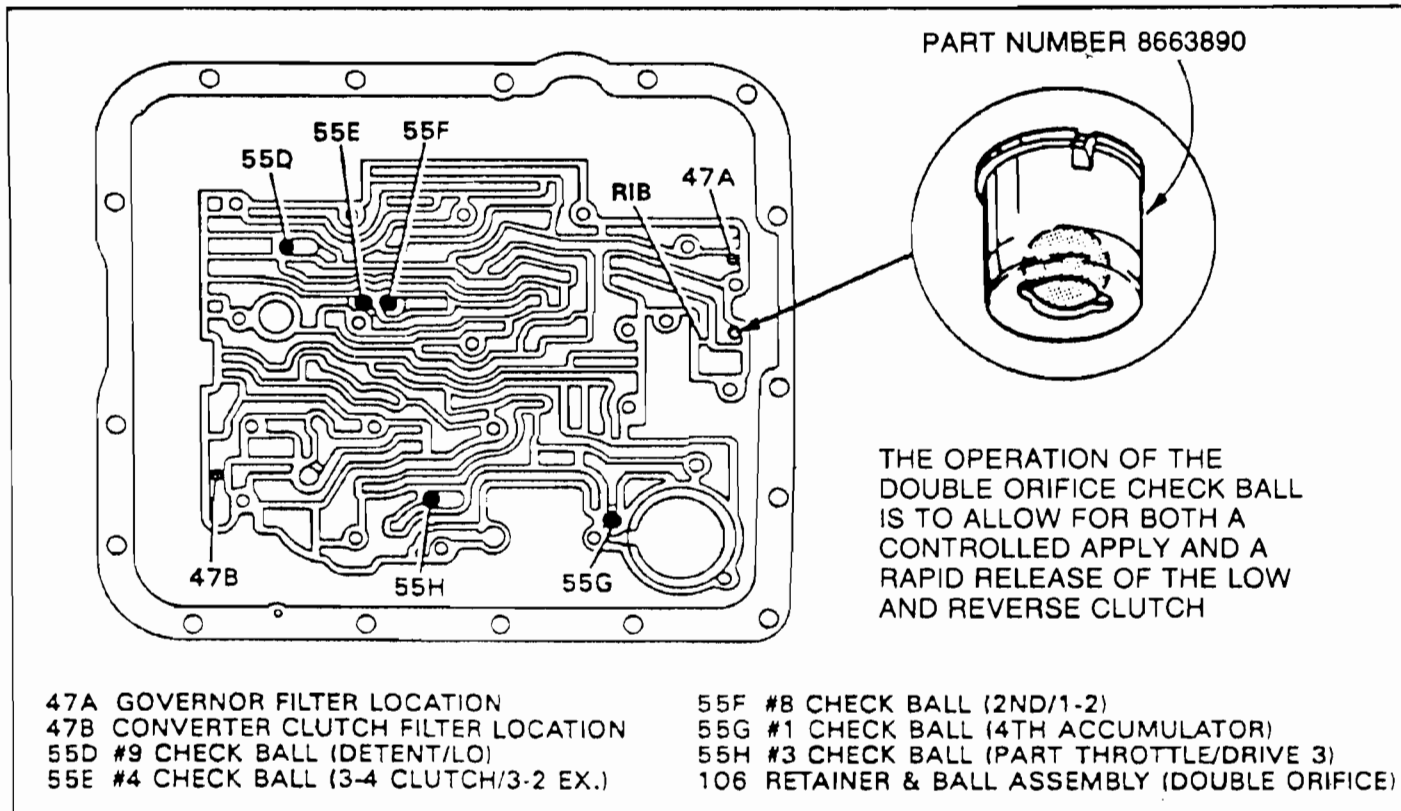
Figure 13

CAUSE: The cause may be, lack of feed oil to the Lo/Reverse clutch pack.

CORRECTION: Remove the BALL ONLY from the capsule at the rear of the case in the Lo/Reverse feed passage (See Figure 13). Leave the capsule in place in the case. Remove the ball only.

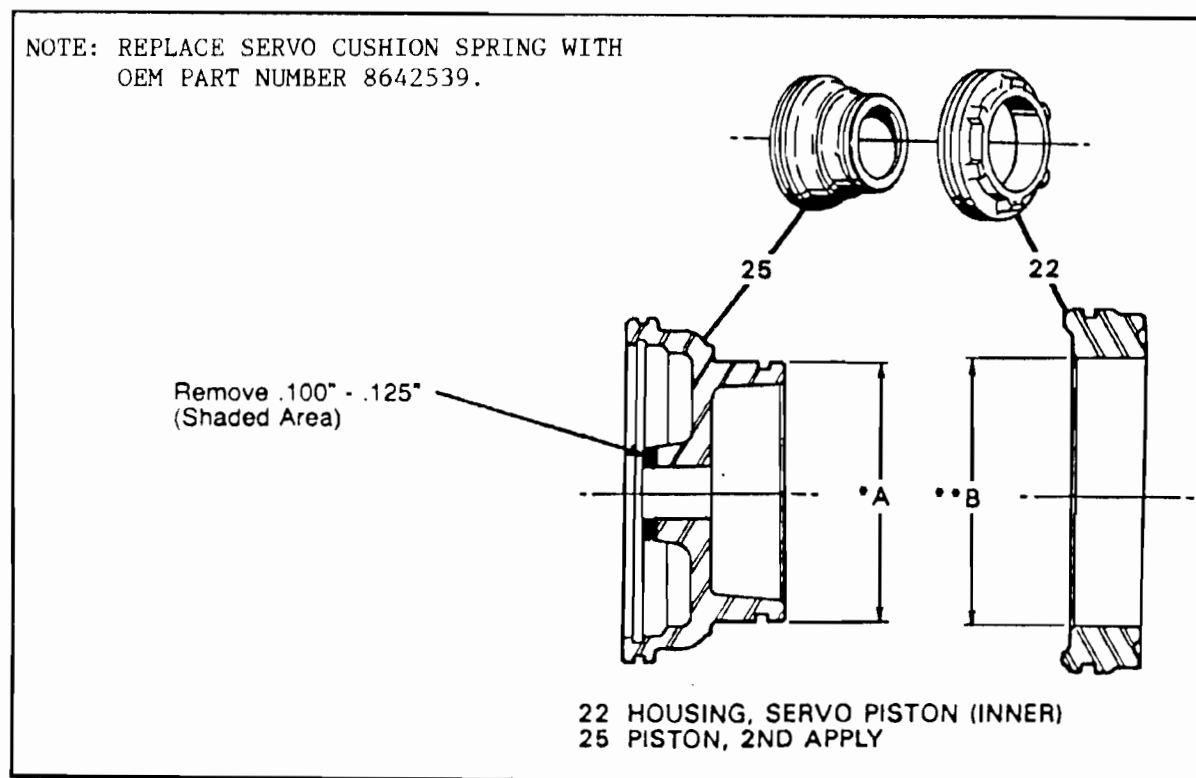
Figure 14

CAUSE: Not enough travel for the 2/4 servo cushion spring.

CORRECTION: Remove .100" to .125" from the inner hub of the 2nd apply servo piston as shown in Figure 14, and replace the servo cushion spring with OEM Part Number 8642539.

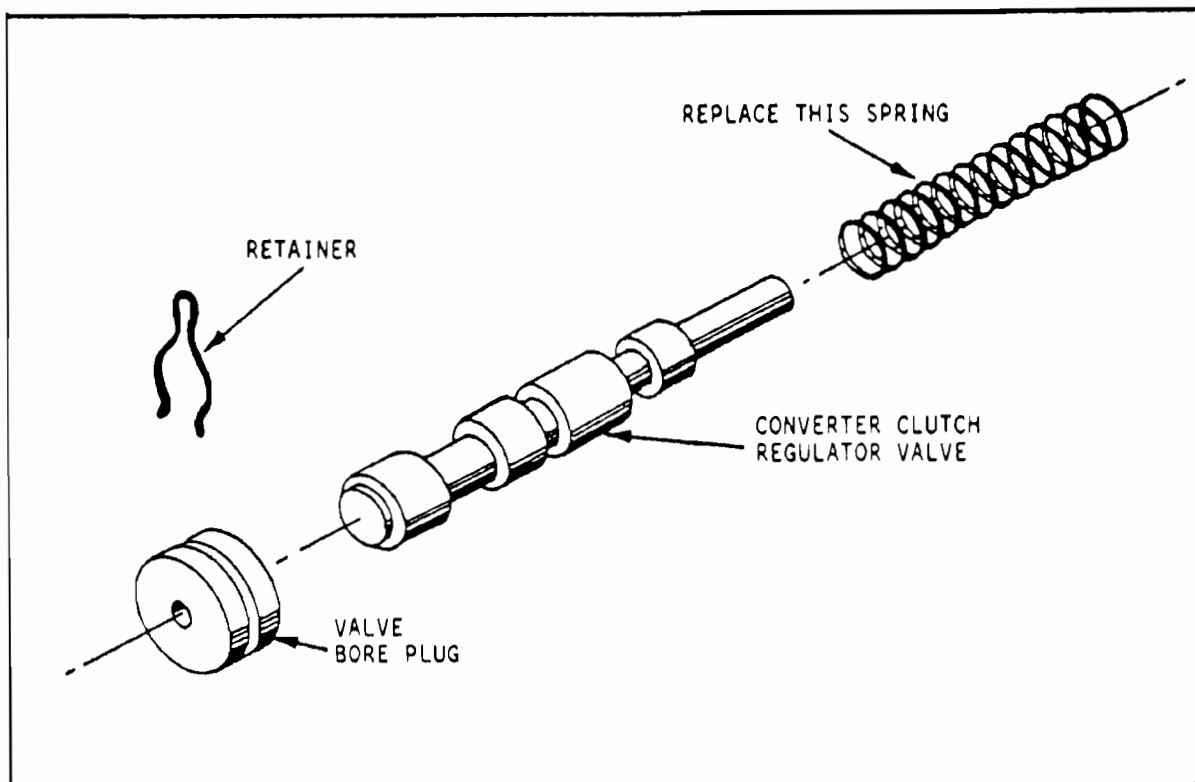
Figure 15

CAUSE: The cause may be, not enough converter apply pressure, as the factory has it calibrated at 45 PSI.

CORRECTION: There is now available from the aftermarket suppliers a spring for the converter clutch regulator valve that will raise the apply pressure from 45 PSI to 61 PSI, and will eliminate converter clutch shudder (See Figure 15).

The new spring is available under part number SGSF-440.

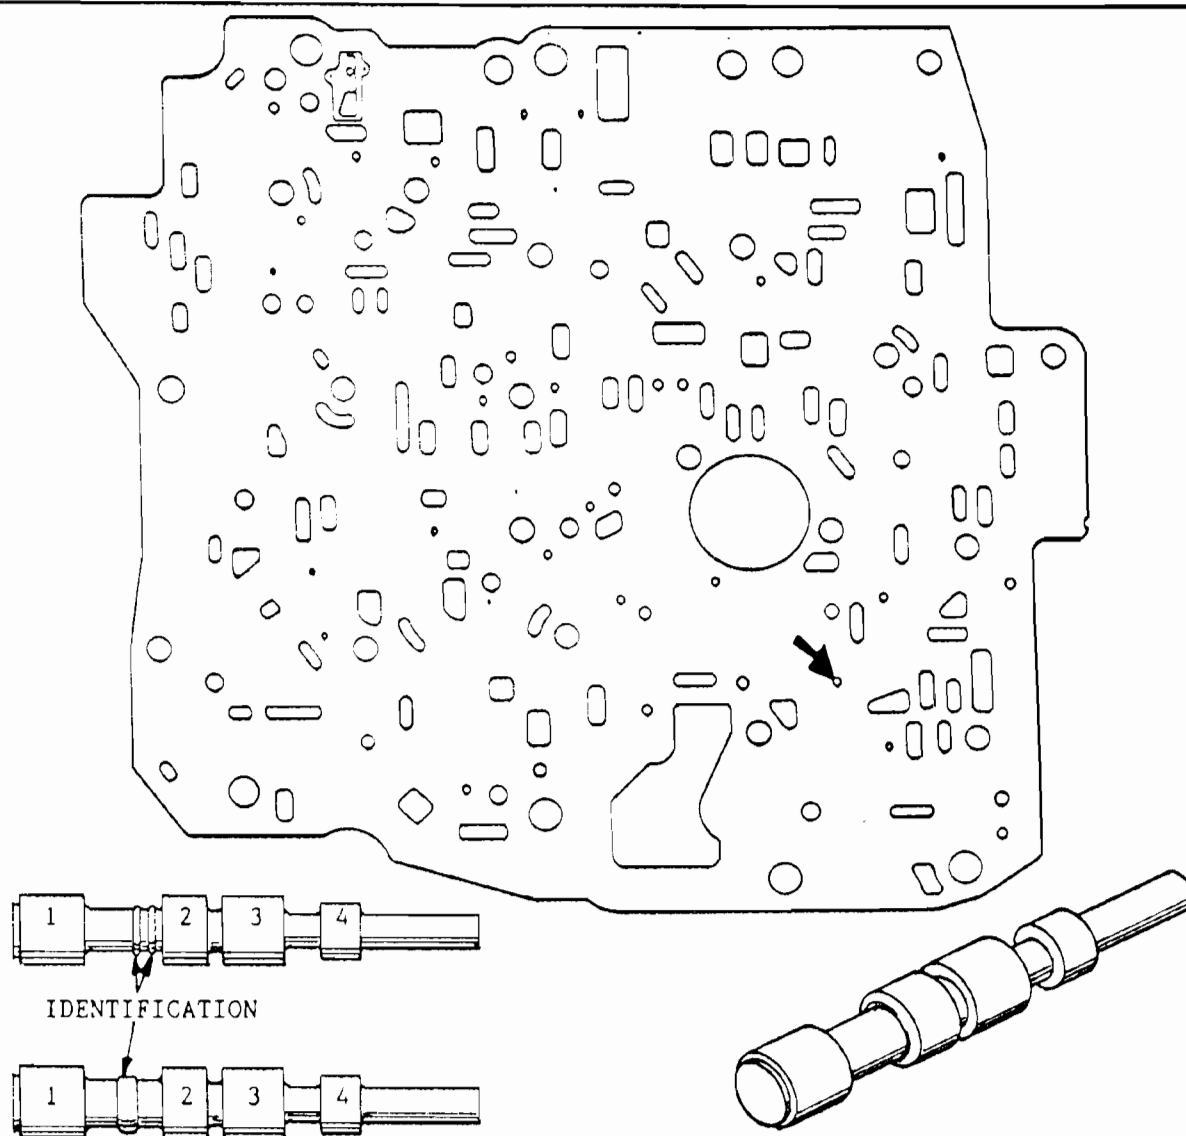
Figure 16

CAUSE: The cause may be, a loss of T.V. pressure due to a mis-matched spacer plate and T.C.C. Regulator Valve.

THIS TYPE OF CONVERTER CLUTCH REGULATOR VALVE REQUIRES
SPACER PLATE WITH HOLE SHOWN BY ARROW ABOVE.

CORRECTION: Install spacer plate and T.C.C. regulator valve that are compatible with one another. Refer to Figures 16 and 17.

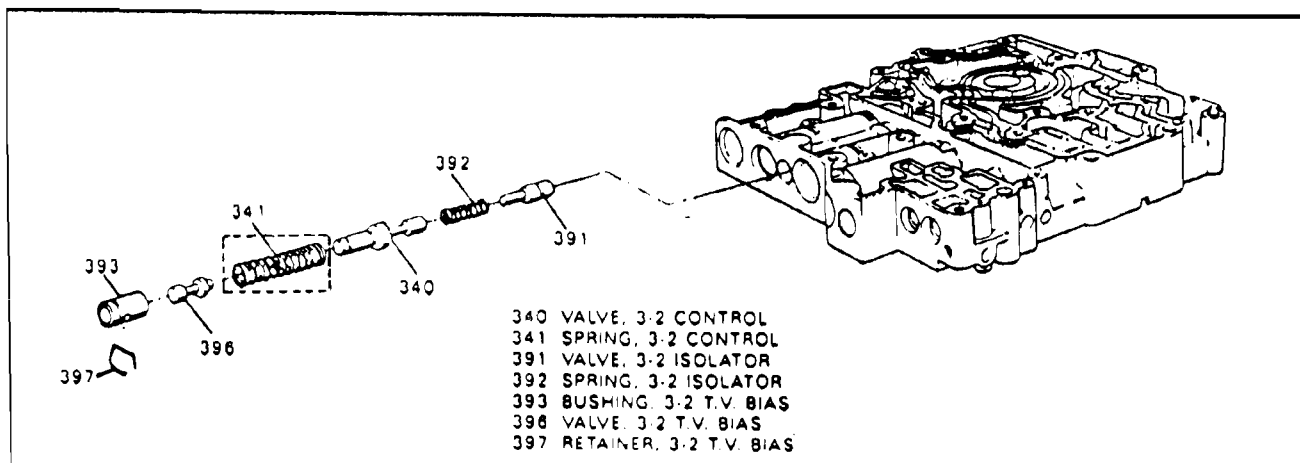
CAUSE: Improper timing for release of the third clutch and re-application of the 1-2 band.

CORRECTION: Install a new 3-2 Control Valve Spring, now available in a service package from OEM. See "Service Information" on pages 28 and 29 for proper OEM part numbers. Refer to Figure 19 for proper installation.

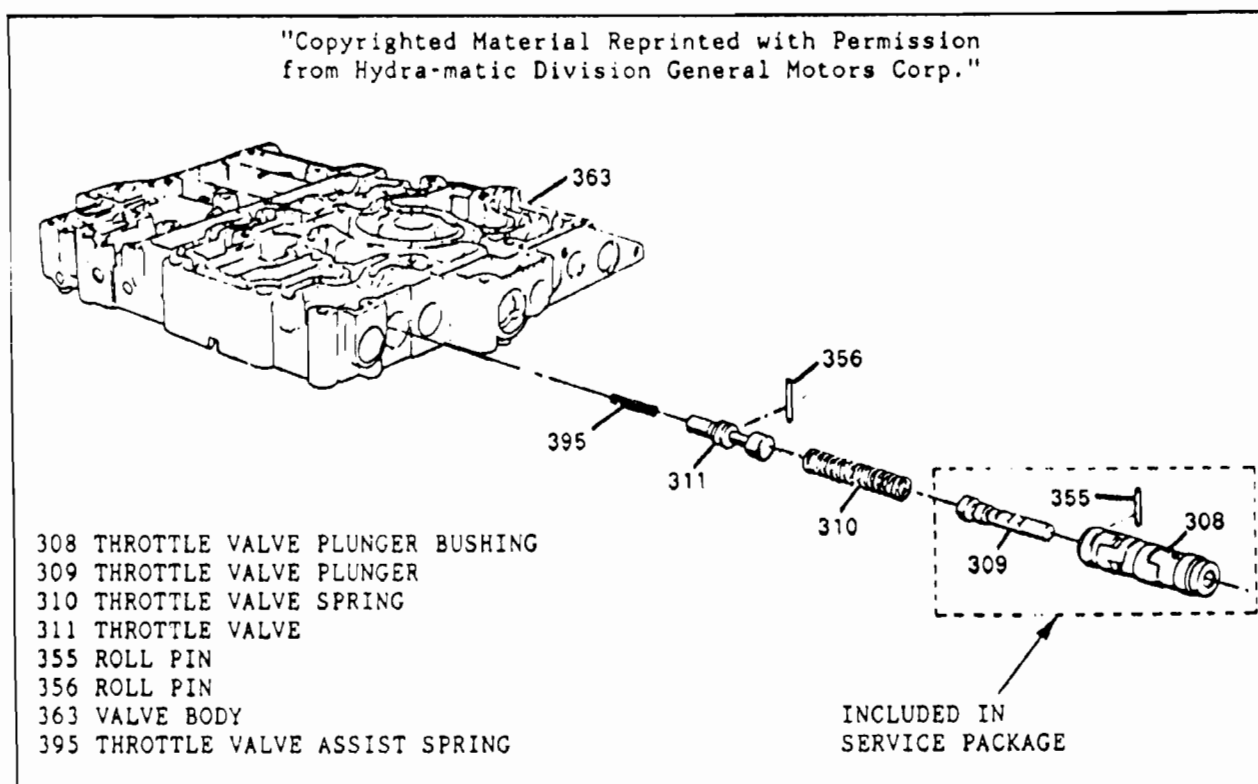
Figure 20

BROKEN T.V. PLUNGER

The T.V. Plunger and Bushing Assembly are now available from OEM in a service package, so that buying a valve body is no longer necessary when the TV plunger is broken or cracked (See Figure 20). Refer to the following OEM part numbers as it IS a model sensitive part.

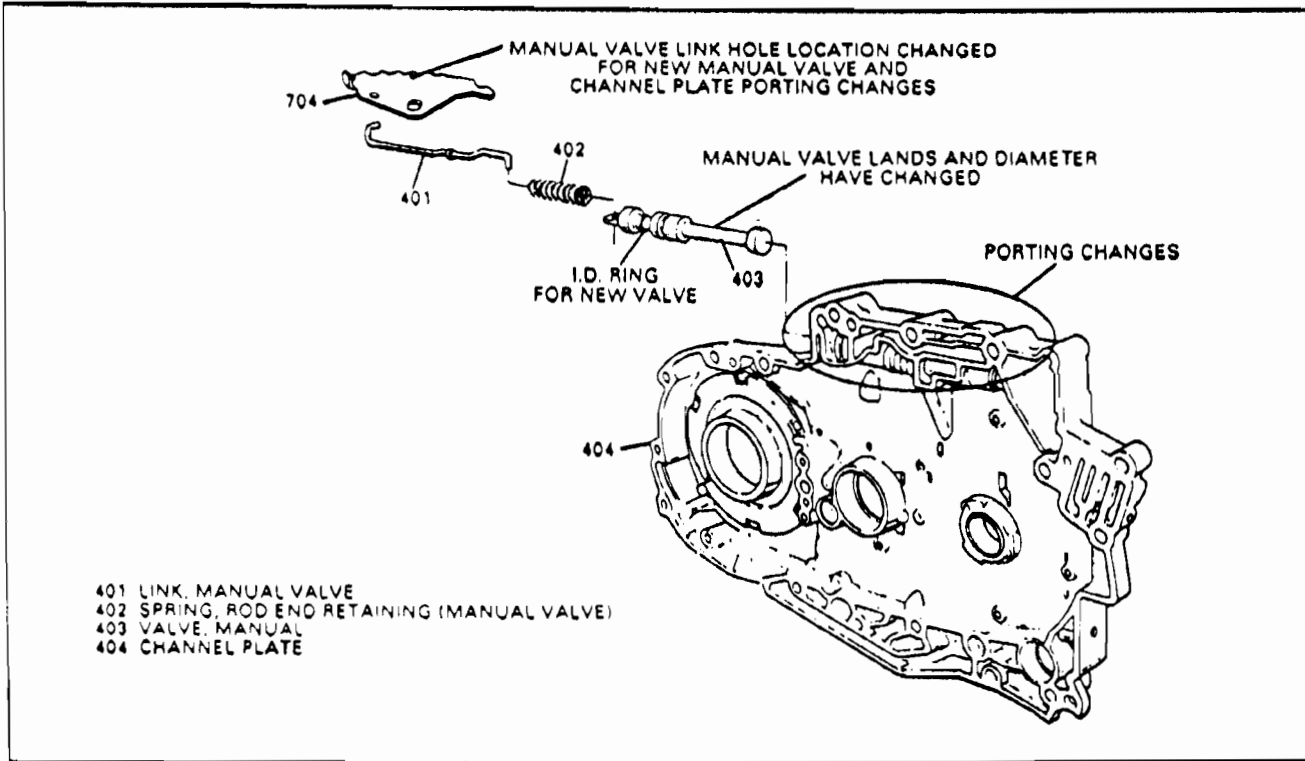
Figure 22

COMPLAINT: On 1989 and 1990 models only, the fourth clutch lined and steel plates burnt to the point that it has melted the channel plate in the fourth clutch area.

CAUSE: The cause may be the manual valve being positioned between the neutral and D4 position, which would allow the input clutch to be applied in 4th gear.

- (1) **NEW CHANNEL PLATE** - Will have porting changes for the new manual valve and new inside detent lever. The porting changes will help ensure that the 2 ports will never be opened at once to cause burnt 4th clutch assembly. The bore for the new manual valve will be reduced by .010" to accommodate the new manual valve. This will make the previous and new parts non-interchangeable (See Figures 22 and 23).

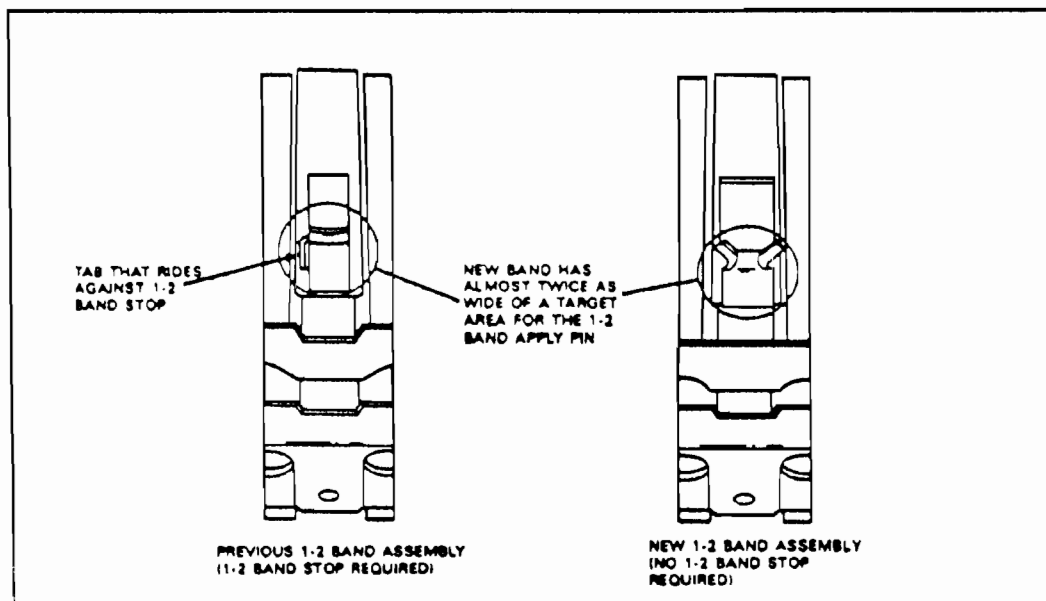
Figure 42

REASON: To eliminate the possibility of a intermittent "No Drive" condition.

- (1) 1-2 BAND ASSEMBLY - The target area on the new 1-2 band, where the band apply pin engages, has been made wider and has "Wings" added to prevent the pin from ever missing the "Target" area (See Figure 42).
- (2) 1-2 BAND STOP ASSEMBLY - The 1-2 Band Stop has been eliminated as it is no longer needed (See Figure 43).

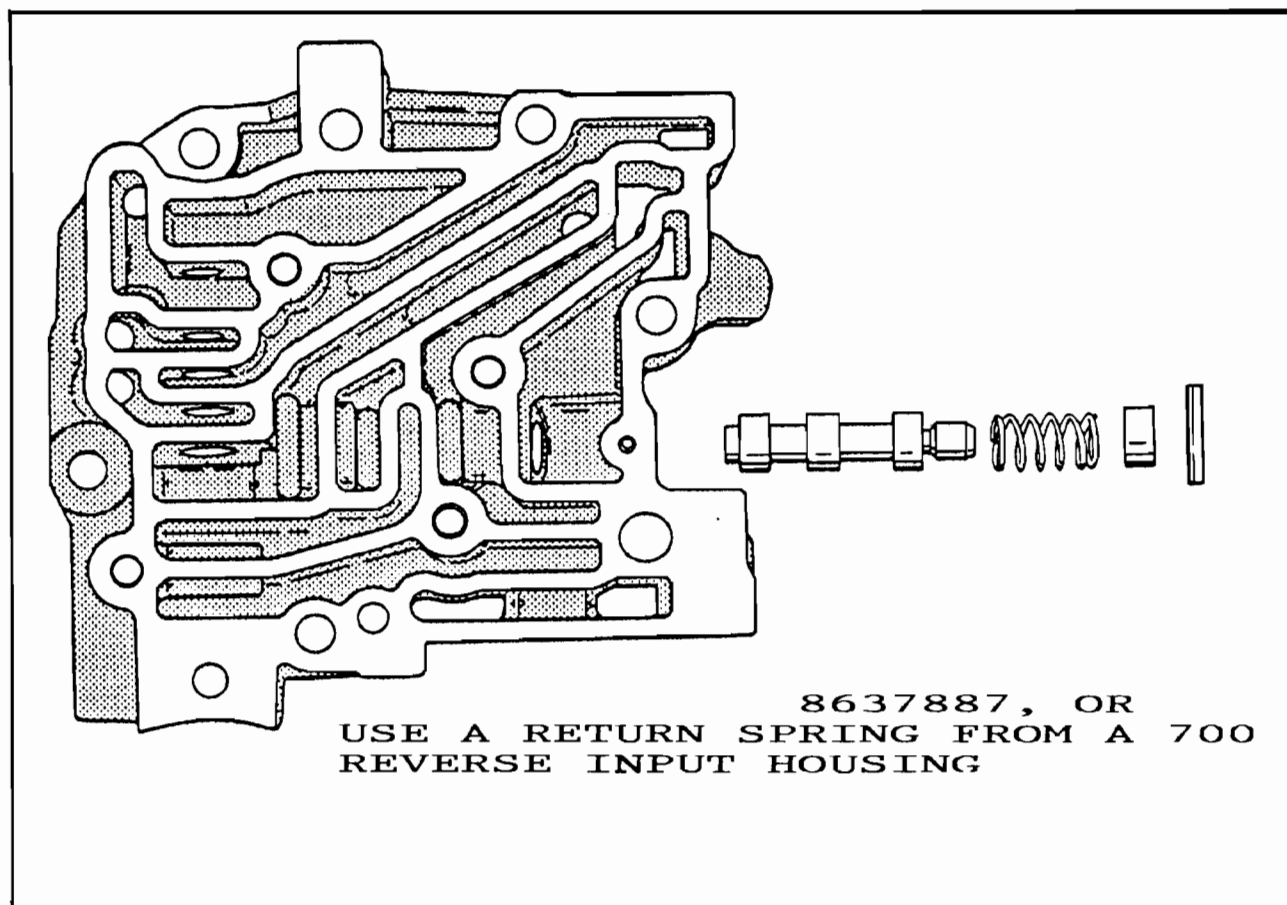
Figure 65

CAUSE: One cause may be low converter charge pressure. Another cause may be slow drain of converter release oil from the front side of the converter clutch piston.

CORRECTION: Install a stronger converter clutch regulator valve spring, OEM part number 8637887, or use a return spring from a 700 reverse input housing return spring assembly. Also drill the converter clutch exhaust hole in the spacer plate to .080". Refer to Figures 65 and 66.

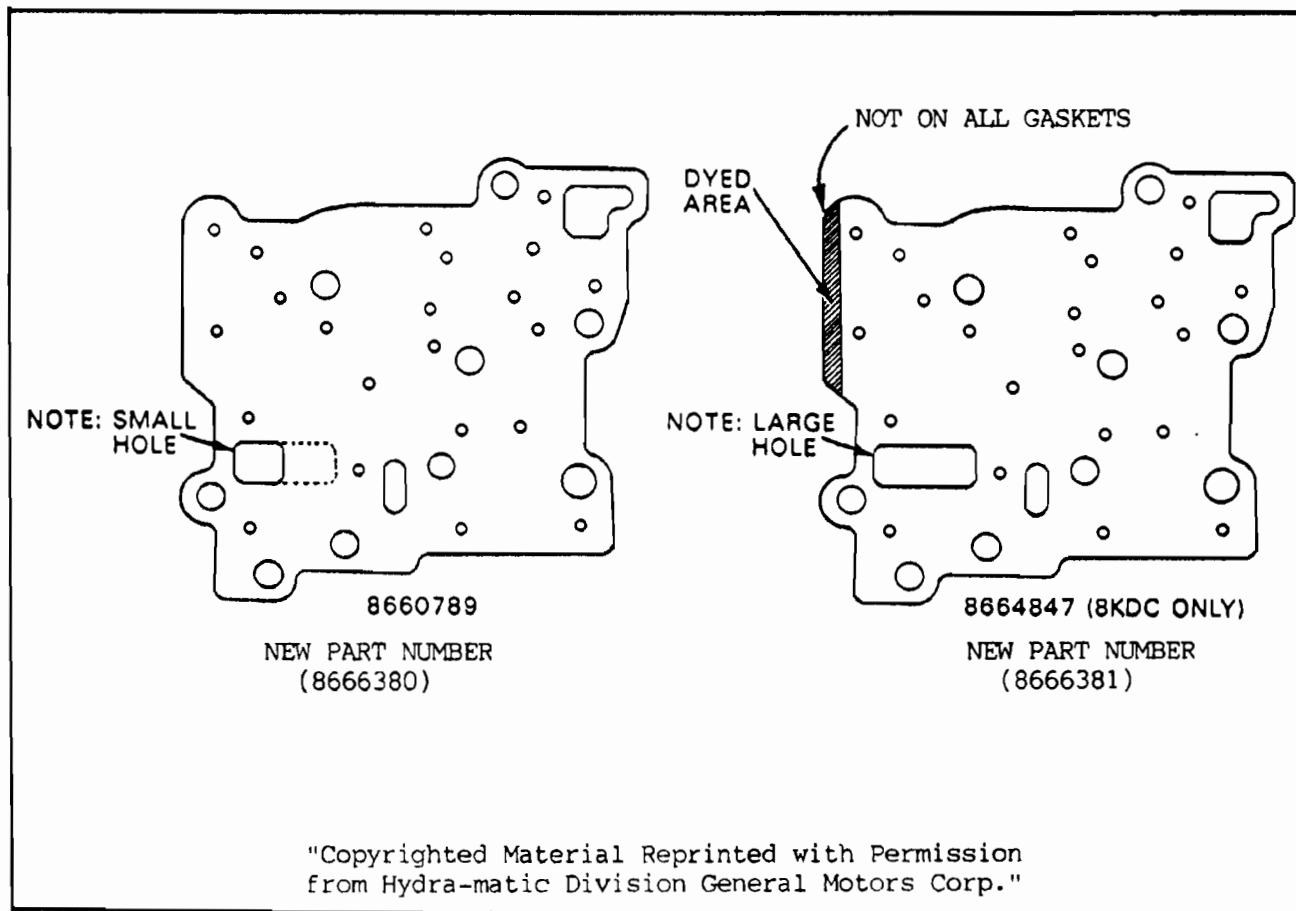
Figure 67

CAUSE: Not enough converter clutch apply oil.

CORRECTION: Install the 1988 (KDC) auxilliary valve body gasket with the
large hole (See Figure 67, or modify the 1987 gasket with the
small hole, by cutting on the dotted line (See Figure 67).

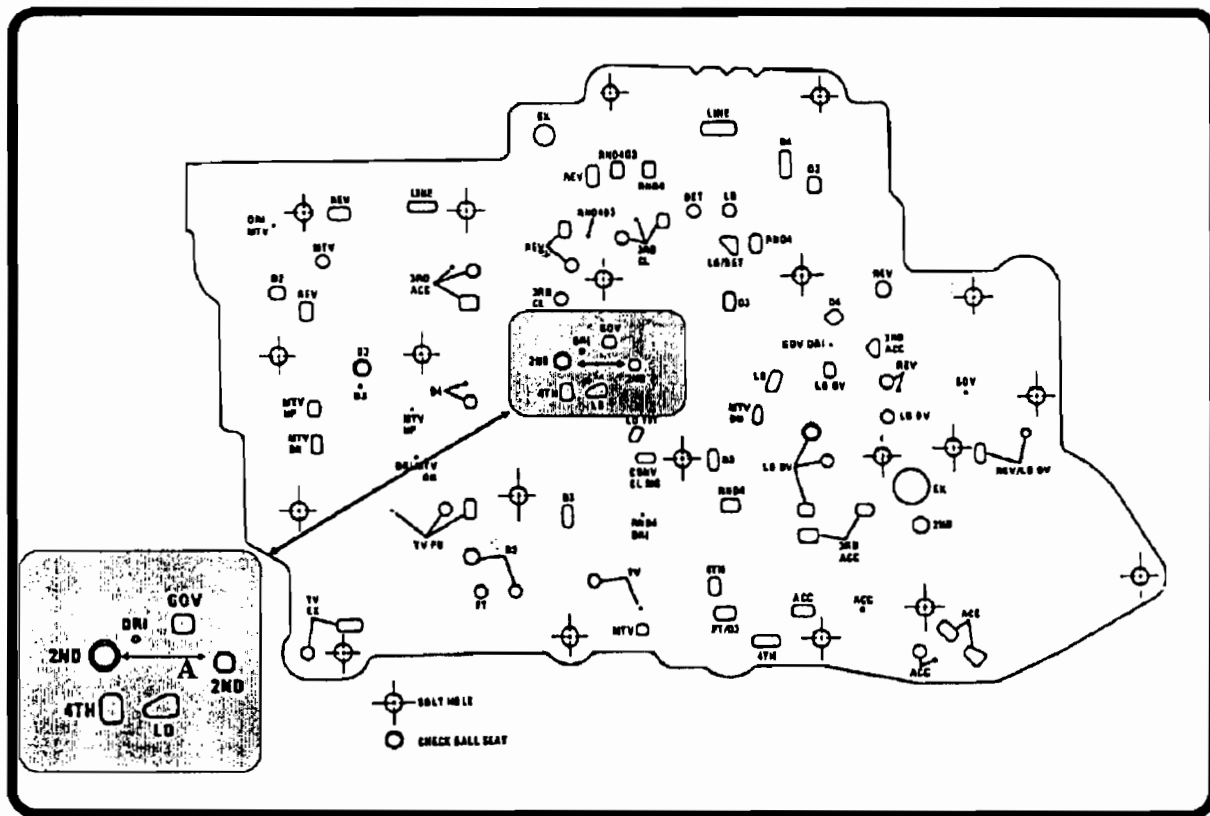
FIGURE 69

A condition of no converter clutch apply, or no second gear, may result from mismatch of valve bodies & separator plates. An early plate installed on a late valve body may result in no converter clutch apply. A late plate installed on a early valve body may result in no second gear condition. Refer to figure 69 to identify the the separator plates.

Measure Dimension "A", As Shown By Arrows.
 IF DIMENSION "A" IS : APPROXIMATELY 3/4" = EARLY PLATE
 IF DIMENSION "A" IS : APPROXIMATELY 1-1/8" = LATE PLATE
