Technical Service Information

SUBARU 3 SPEED BINDS UP IN REVERSE AFTER REBUILD

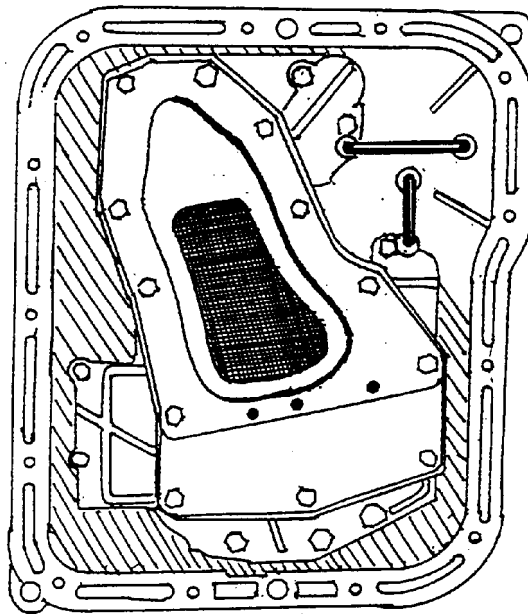
Figure 1

COMPLAINT: Transmission binds up in reverse after rebuild. Also transmission shifts 1-3 with no possibility of obtaining 2nd gear.

CAUSE: Valve body to servo tubes incorrectly installed. Direct clutch oil can be fed to the apply side of the servo causing the band to come on in reverse.

CORRECTION: Install tubes to look like the letter T as shown in figure below.
