Technical Service Information

FORD 5R55N, 5R55W, 5R55S DELAYED OR NO ENGAGEMENT

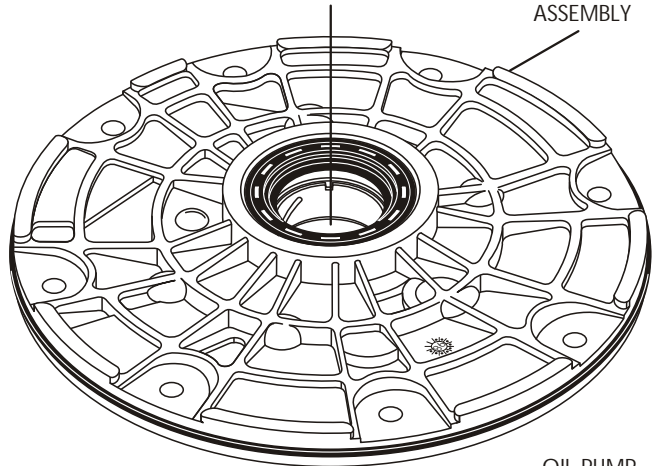
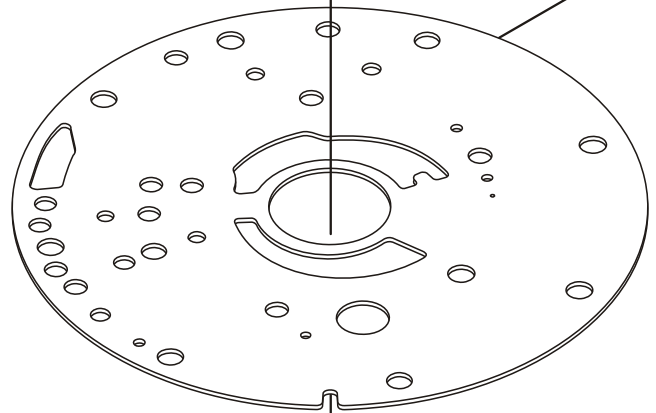
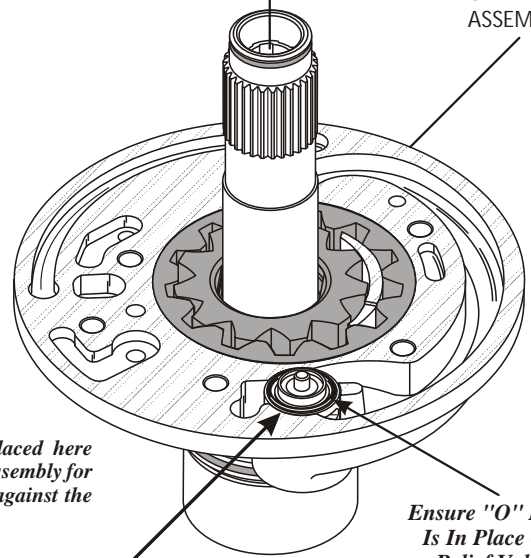
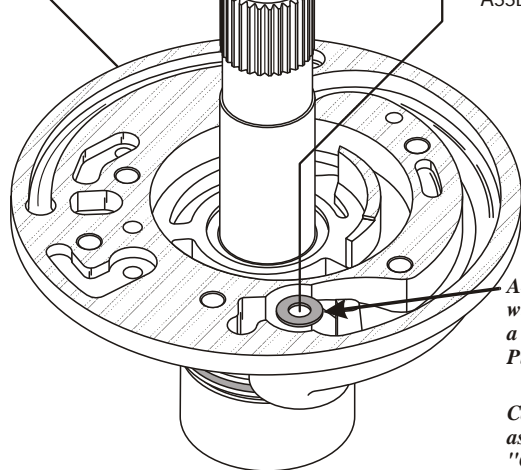
Figure 1

CAUSE NO. 1: The above concern could be oil leaking past the o-ring that belongs on the relief valve sleeve between the pump plate and sleeve, as shown in Figure 1, or the "O" ring totally missing. This "O"-ring is very thin with minimal compression against the pump plate.

CAUTION: The Pump Relief Valve Assembly "Must" Have The "O" Ring In Place As Shown Below

"O" RING IN PLACE ON RELIEF VALVE

Ensure "O" Ring Is In Place On Relief Valve

RELIEF VALVE "O" RING

Adding an A4LD pump bolt washer in the pocket of the pump under the sleeve would help raise the sleeve up to compress the o-ring tighter creating a better seal (See Figure 1).

Caution: Be careful not to raise the sleeve above the pump surface, "**Only**" the o-ring.

A4LD pump washer placed here will raise Relief Valve Assembly for a better "O" ring seal against the Pump Spacer Plate.

Caution: Do not raise the sleeve assembly above the pump surface, "Only" the "O" ring.

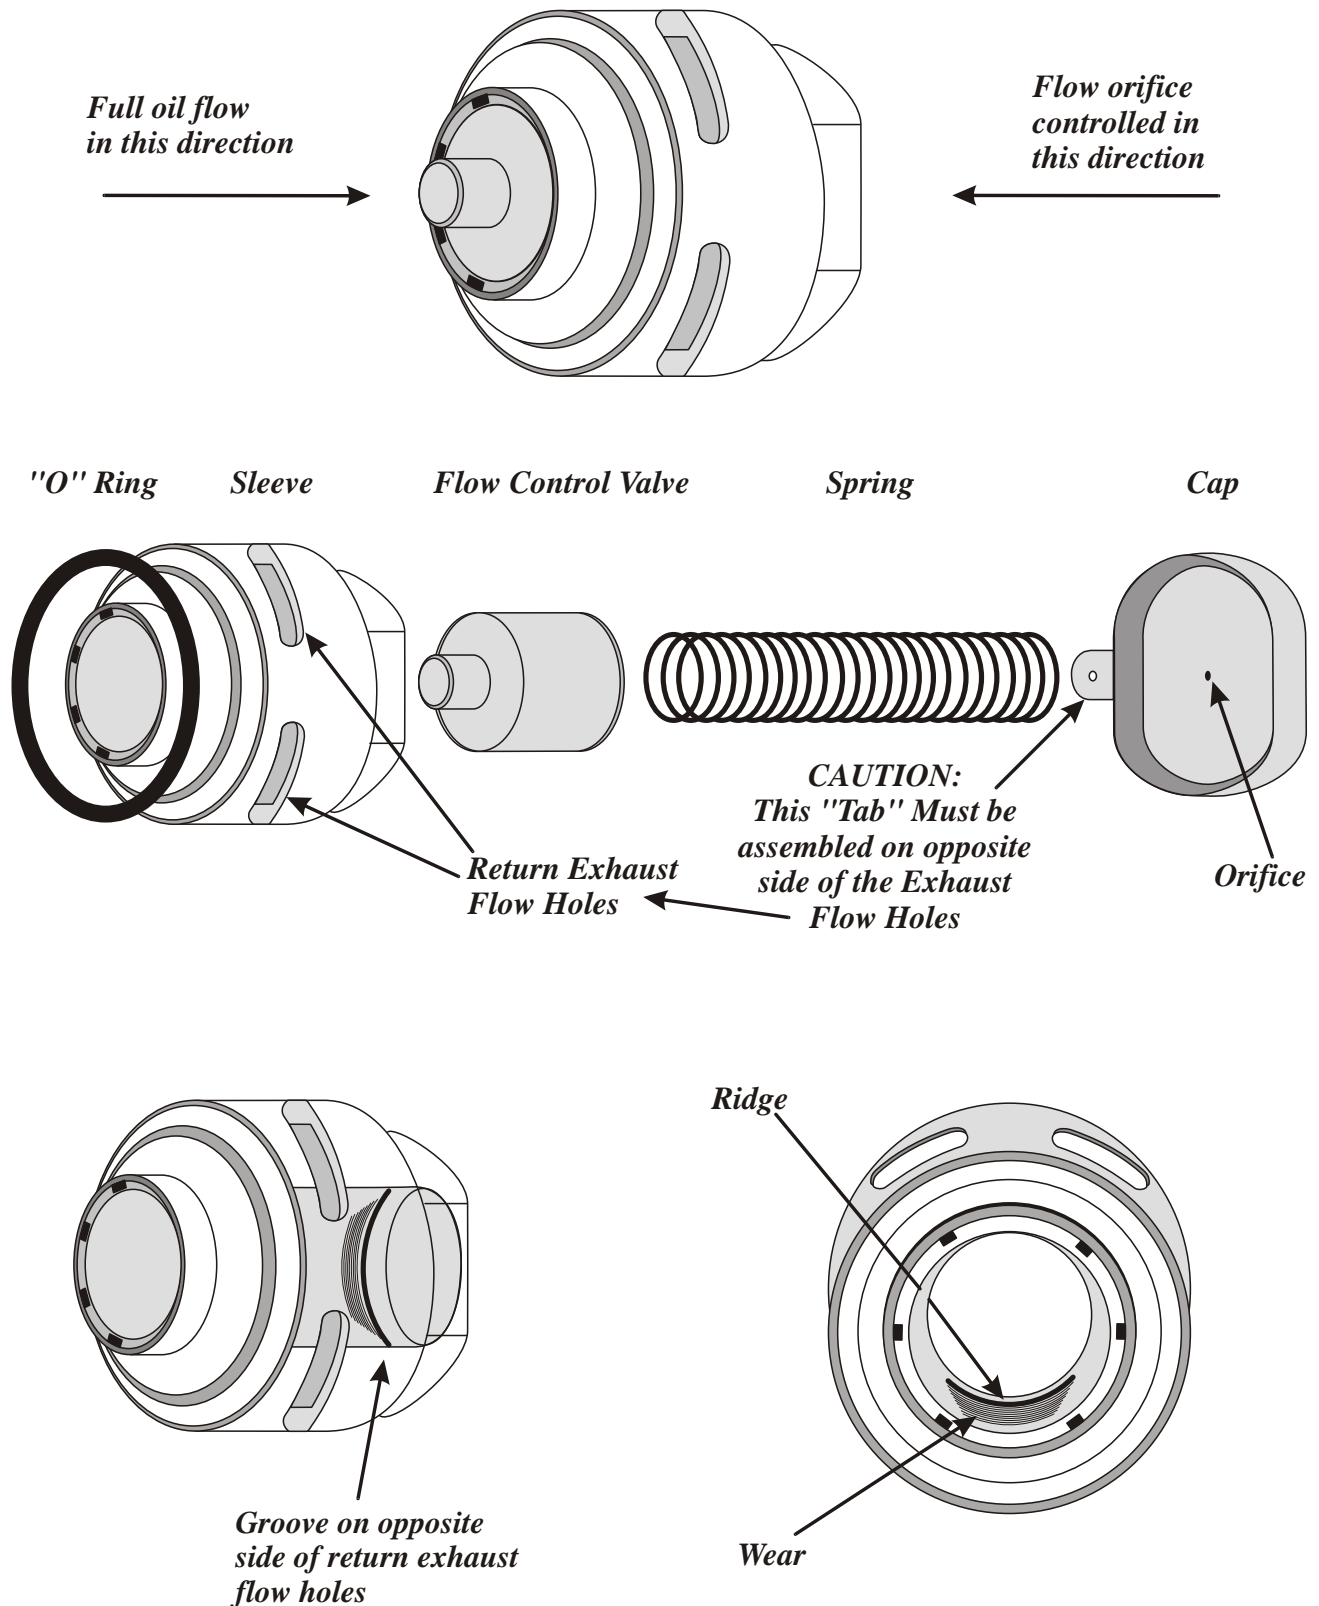
CAUSE NO. 2: The cause may be, the Line Pressure Relief Valve Assembly (Flow Control Valve) located in the pump stator, as shown in Figure 1, stuck in the open position due to extreme bore wear in the relief valve sleeve. Figure 2 shows the area prone to wear causing the valve to stick in the open position, and lodged onto the ridge at the end of the worn area. The partial hydraulic schematic in Figure 3, will show that if the valve were to stick in the open position, the oil from the pressure side of the pump would follow the path of least restriction and return to the suction side of the pump. The oil pressure would then be severely compromised through out the rest of the unit.

CAUTION:
This "Tab" Must be
assembled on opposite
side of the Exhaust
Flow Holes

Caution: *If this valve assembly is disassembled for inspection, it "Must" be re-assembled with the tab on cap opposite the exhaust holes, as shown in Figure 2.*

At the time of this printing, a complete pump assembly will be necessary, as Ford does not service the relief valve assembly separately. These are available from OEM or from many aftermarket Hard Parts Suppliers, or you could rob one from another pump if you happen to have one. Keep in mind though, it may be in the same shape.

Superior now has a replacement flow control valve assembly available for this unit under Superior part number K060. (07/23/04)

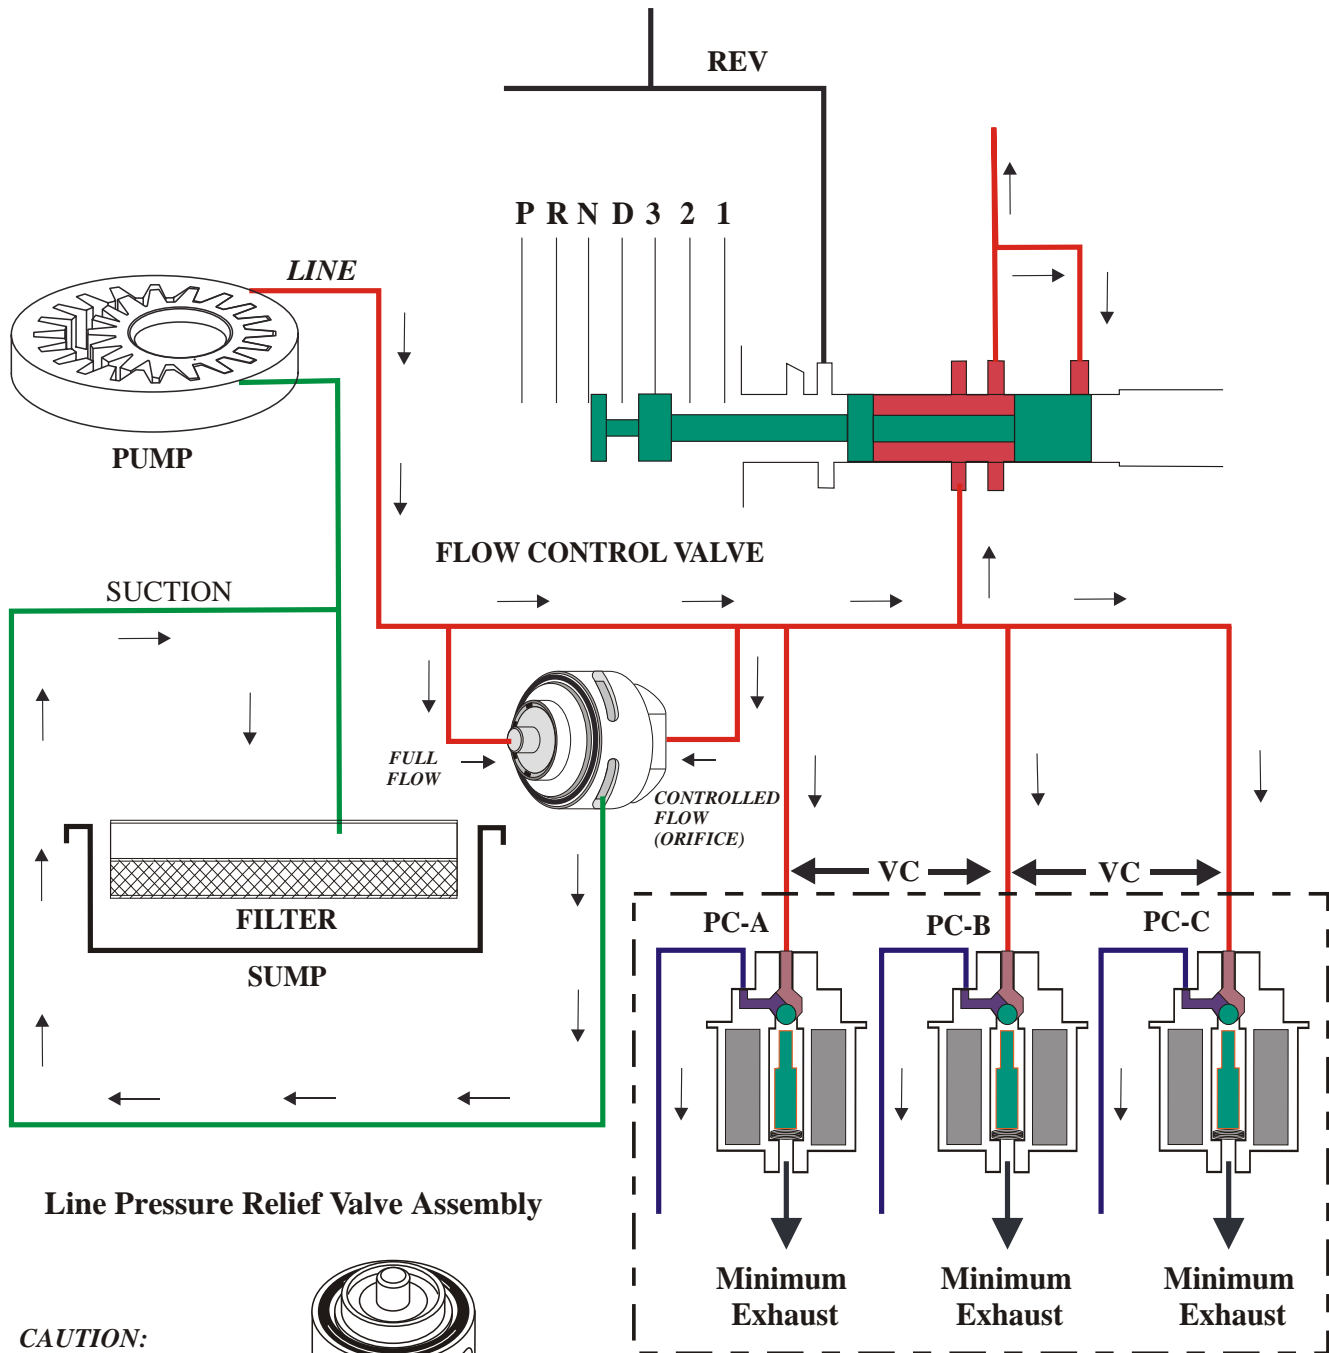
Figure 3

Line Pressure Relief Valve Assembly Oil Flow

PWM SOLENOID BLOCK
SHOWN IN "D" 1st GEAR

Add A4LD
Pump Bolt Washer
Here As Needed
