Technical Service Information

THM 4T40-E TROUBLE CODE P1887 OR P0742

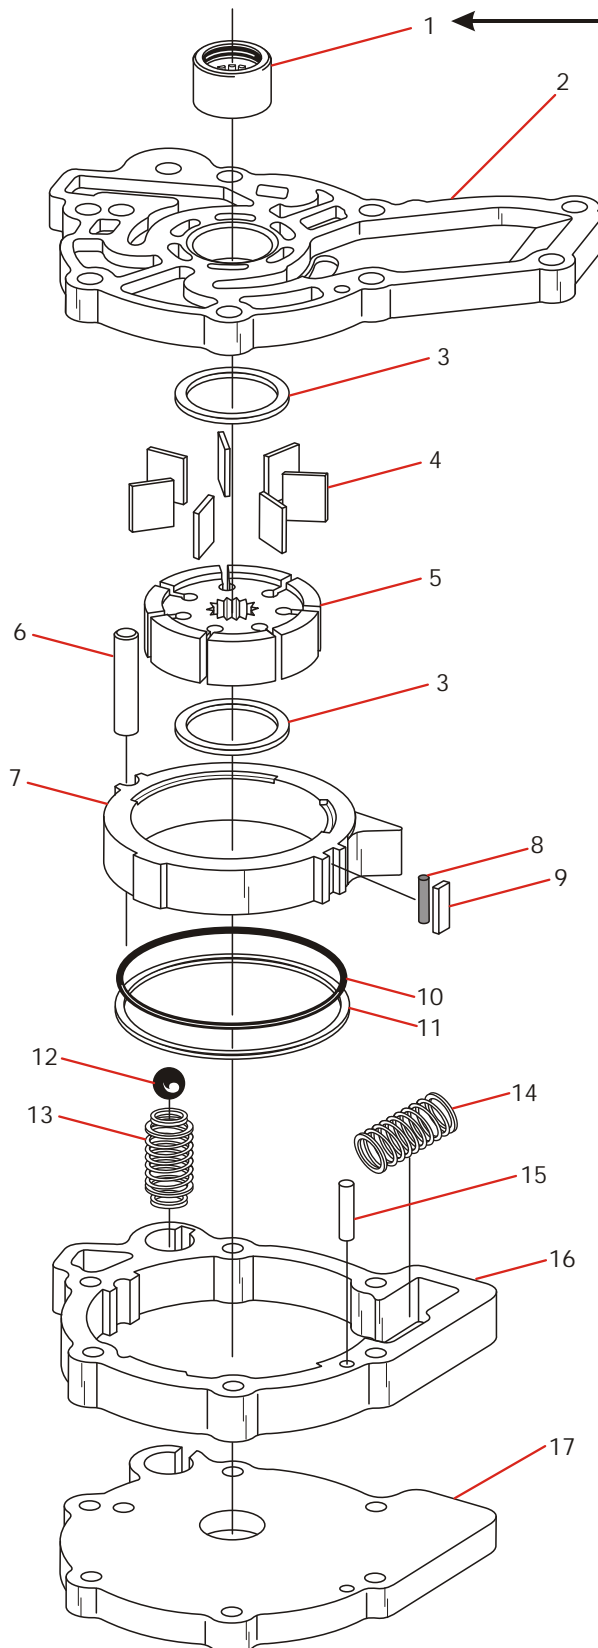
THM 4T40-E OIL PUMP ASSEMBLY

CAUSE: This is usually created by a leak of TCC release oil through the needle bearing and seal assembly located in the oil pump, as shown in Figure 1.

*This Needle Bearing and Seal Assembly
Is Now Available Under TRANSTAR
Part No. 67922B*

CORRECTION: This needle bearing and seal assembly is now available under TranStar part number 67922B. In some instances, because of the bearing failure, the entire pump assembly will have to be replaced and is available under OEM part number 24208987.

This Needle Bearing and Seal Assembly has been such a high failure item that ATSG recommends the needle bearing and seal assembly be replaced on every rebuild.
