# Technical Service Information

## ISUZU 4L30-E

### SYSTEM VOLTAGE CONCERNS ON TROOPER/RODEO

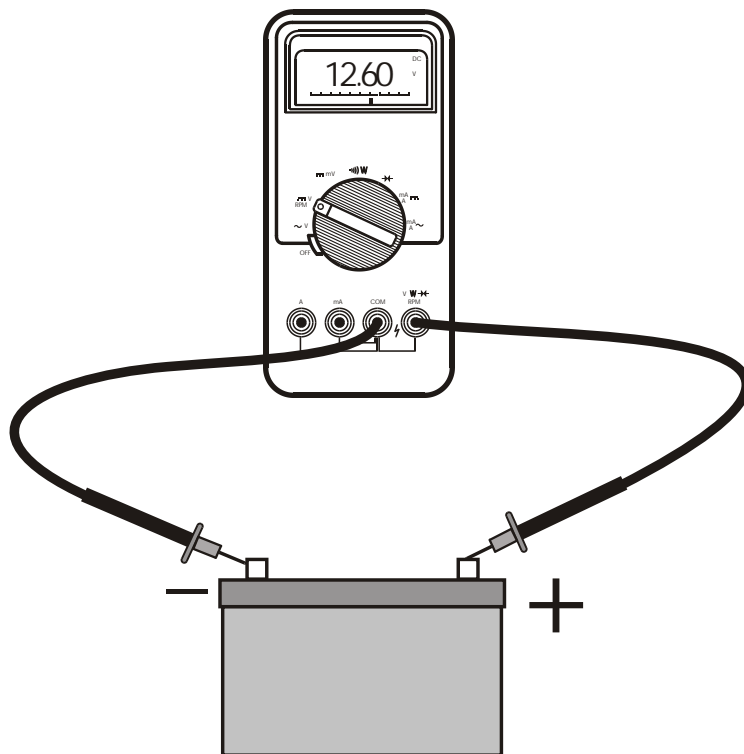
Figure 1

This begins with checking open post battery voltage, which should be approximately 12.6 volts, preferably after a load has been induced on the battery, as shown in Figure 1.

Make certain the battery is in good condition. If alternator replacement becomes necessary, make certain that the replacement alternator indicates, somewhere on the alternator or its package, "**MADE FOR AMERICAN ISUZU MOTORS**", as shown in Figure 2, in order to avoid an over voltage problem for the TCM.

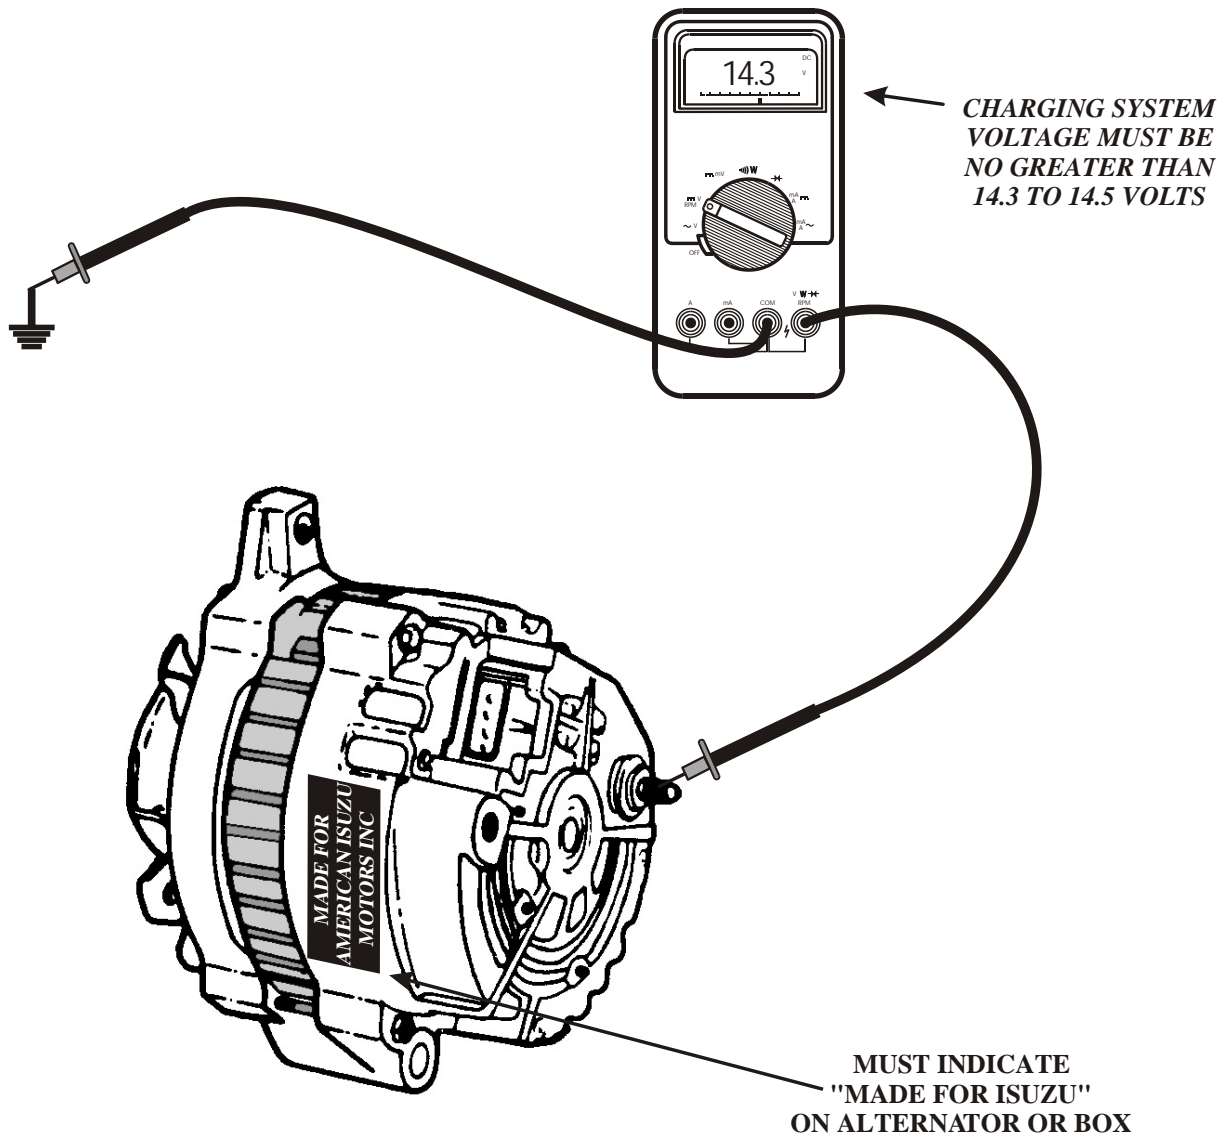
Figure 2

Next check the charging system voltage, on these vehicles it should not exceed 14.3 to 14.5 volts, as shown in Figure 2.

This can be caused by an overcharging alternator or, the incorrect alternator has been installed. Due to the heavy GM influence in Isuzu vehicles, an alternator made for a GM vehicle resembles the alternator found in Isuzu vehicles.

There is however, a major difference being, the average GM alternator usually puts out a charging system voltage of approximately 14.9 to 15.3 volts. This is too much voltage output for an Isuzu system, which is designed to operate within the 14.3 to 14.5 volt range. If the above checks are good, the shift and band apply solenoid circuits will have to be checked for resistance to insure circuit integrity.

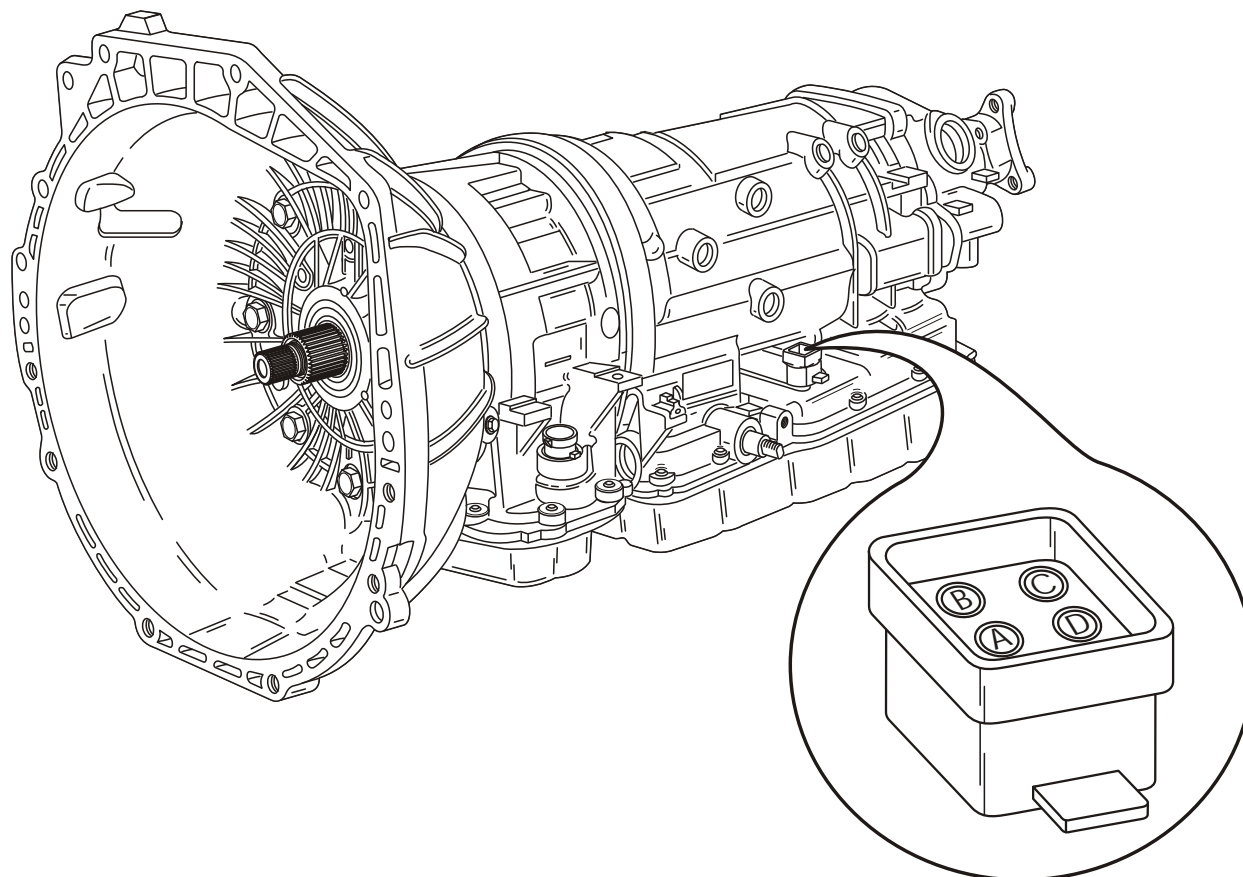
In some cases the main case connector is at fault and can be replaced using the 4T60 square case connector.

Utilizing the chart shown in Figure 3, ensure shift and band apply circuit integrity by checking solenoid resistance which will also check the integrity of the case connector.

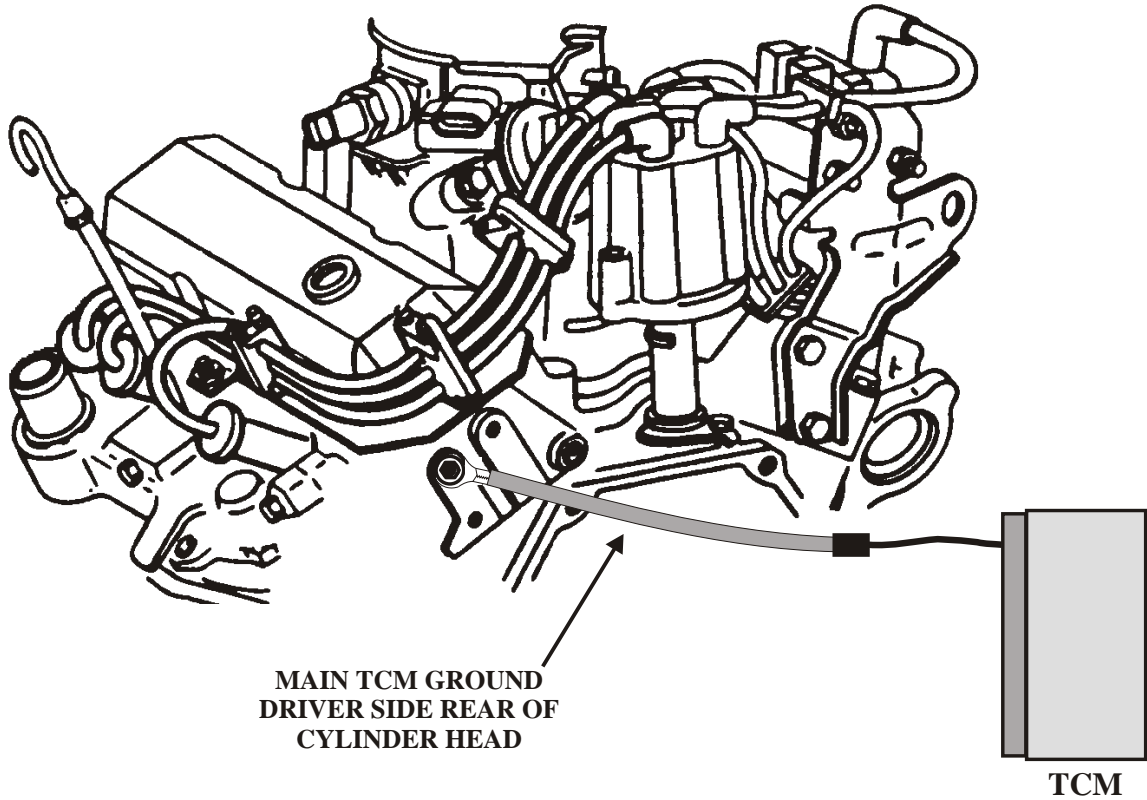
Figure 4

**CAUSE: (2) *A Loss of Ground:*** The second cause indicates, that somewhere in the vehicle the TCM main ground has been lost. This can also be caused by a faulty negative battery cable.

The main TCM grounds in these vehicles are usually located in the most obscure places which is what makes them so easy to overlook.

Check the main TCM ground circuits, that are in different locations, depending on model year and vehicle. For Trooper vehicles, refer to Figures 4 and 5. For Rodeo vehicles, refer to Figures 6 and 7. Check the negative battery cable condition at both ends. Use the voltage drop method on all ground checks, and repair *any* ground circuit that contains 300 millivolts or higher, as shown in Figure 8.
