1999 SEMINAR INFORMATION

"TECH ON TIME FOR '99"

INDEX

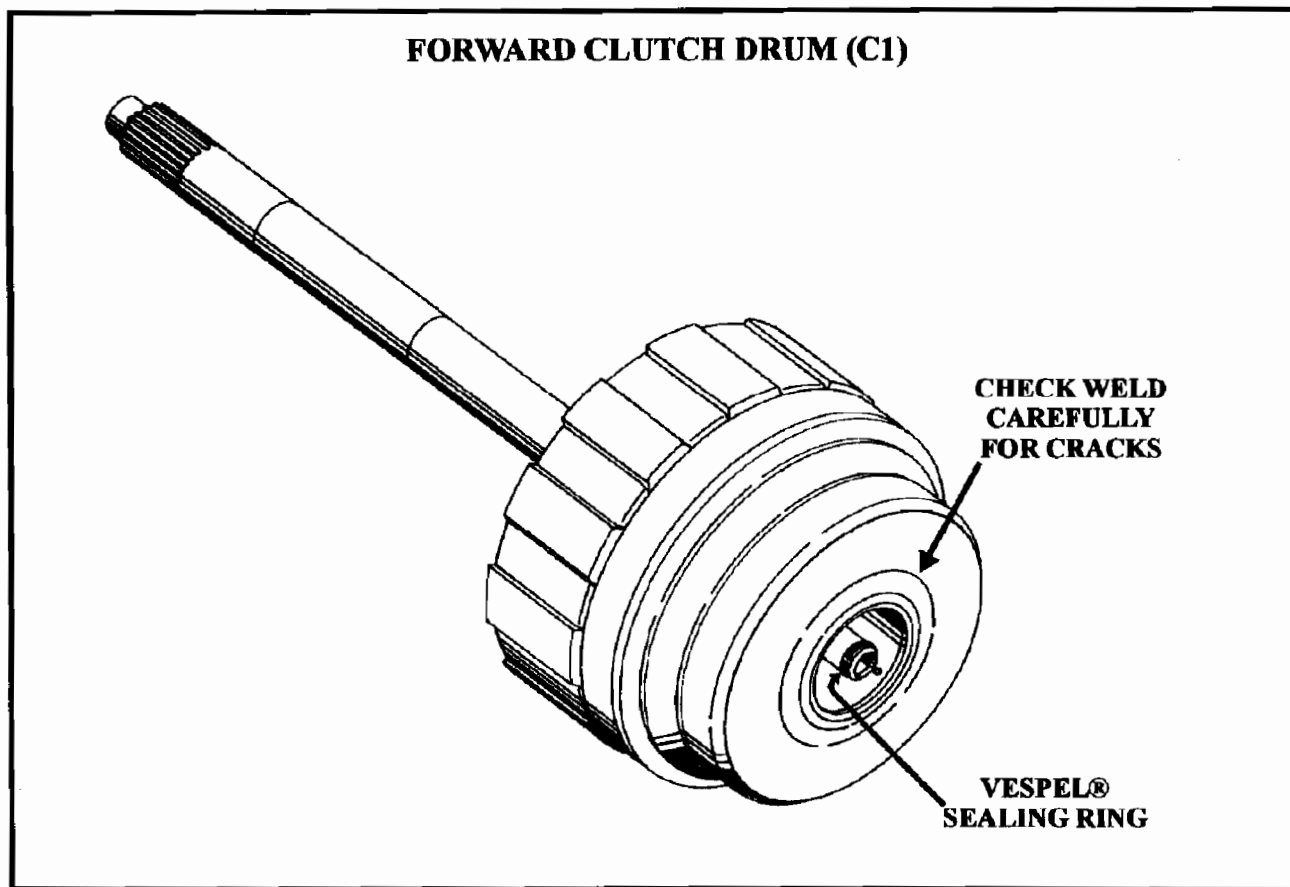
Figure 6

Forward clutch (C1) failure is common in this unit, in figure 6, one cause is illustrated. Inspect the forward drum carefully for a fine crack in the weld area as shown in figure 6.

CAUTION: Be sure the Vespel® ring shown in figure 6 is present and in good condition. failure to do so will result in forward drum pilot shaft bearing due to a lack of lube oil.

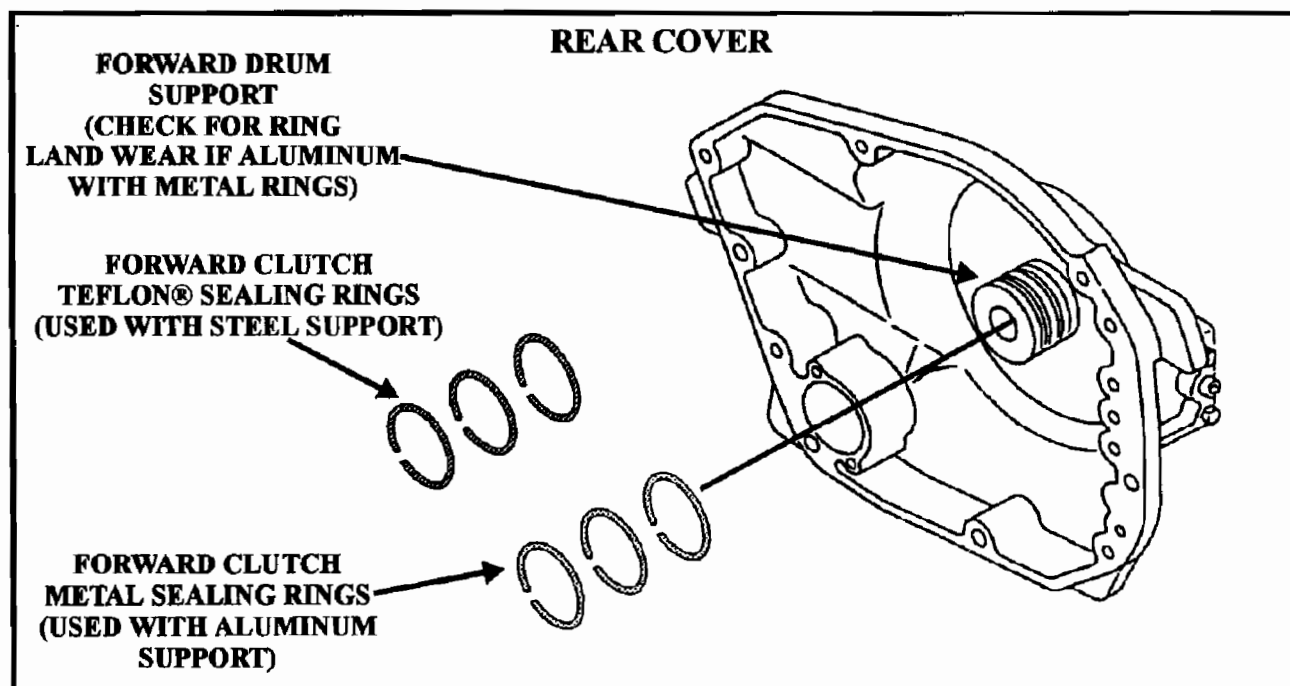
Figure 7

Another cause of forward clutch failure is shown in figure 7. The early rear cover has an aluminum forward drum support which utilized metal rings. The metal rings would wear the ring lands of the aluminum support resulting in forward clutch failure.

The late cover has a steel support and utilizes Teflon® rings which eliminates the ring land wear problem and the subsequent forward clutch failure.

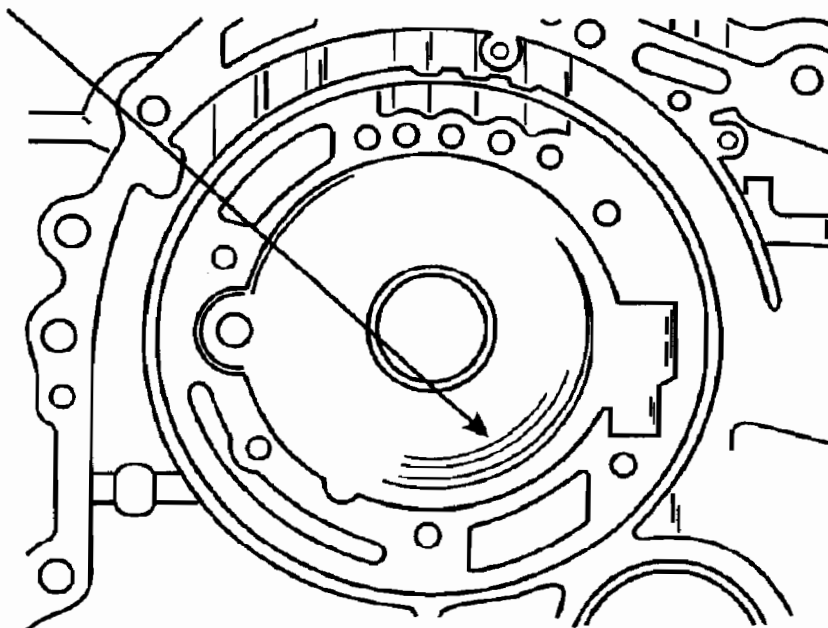
BELLHOUSING CHECK

NOTE: WEAR IN THIS AREA MAY CAUSE A LOSS OF PUMP PRESSURE OR MAY CAUSE THE SLIDE TO BIND

CHECK THE BELLHOUSING FOR SLIDE WEAR AND REPLACE AS NECESSARY

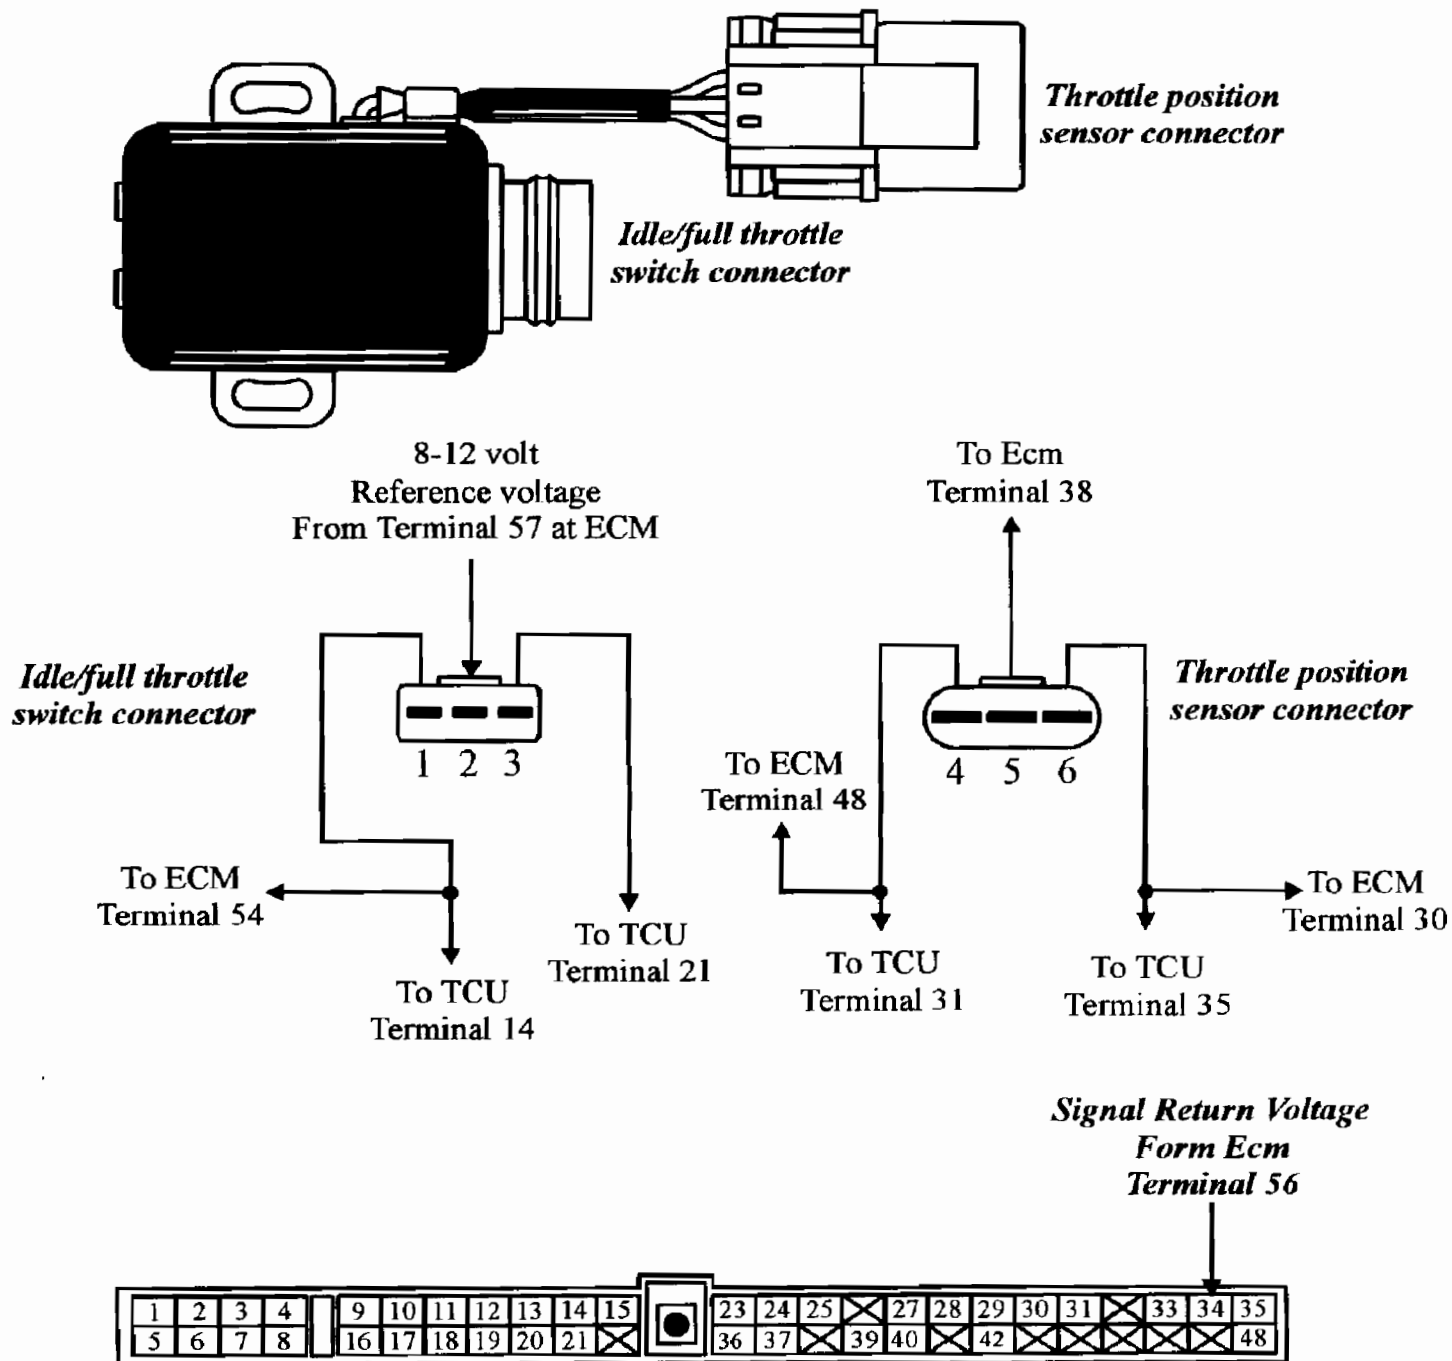
THROTTLE POSITION SENSOR CIRCUIT DIAGRAM

NOTE: THE TPS SIGNAL RETURN VOLTAGE IS FED FROM ECM TERMINAL 56 TO TCU TERMINAL 34. THEREFORE A BROKEN WIRE MAY CAUSE NO SIGNAL RETURN VOLTAGE AT THE TCU.

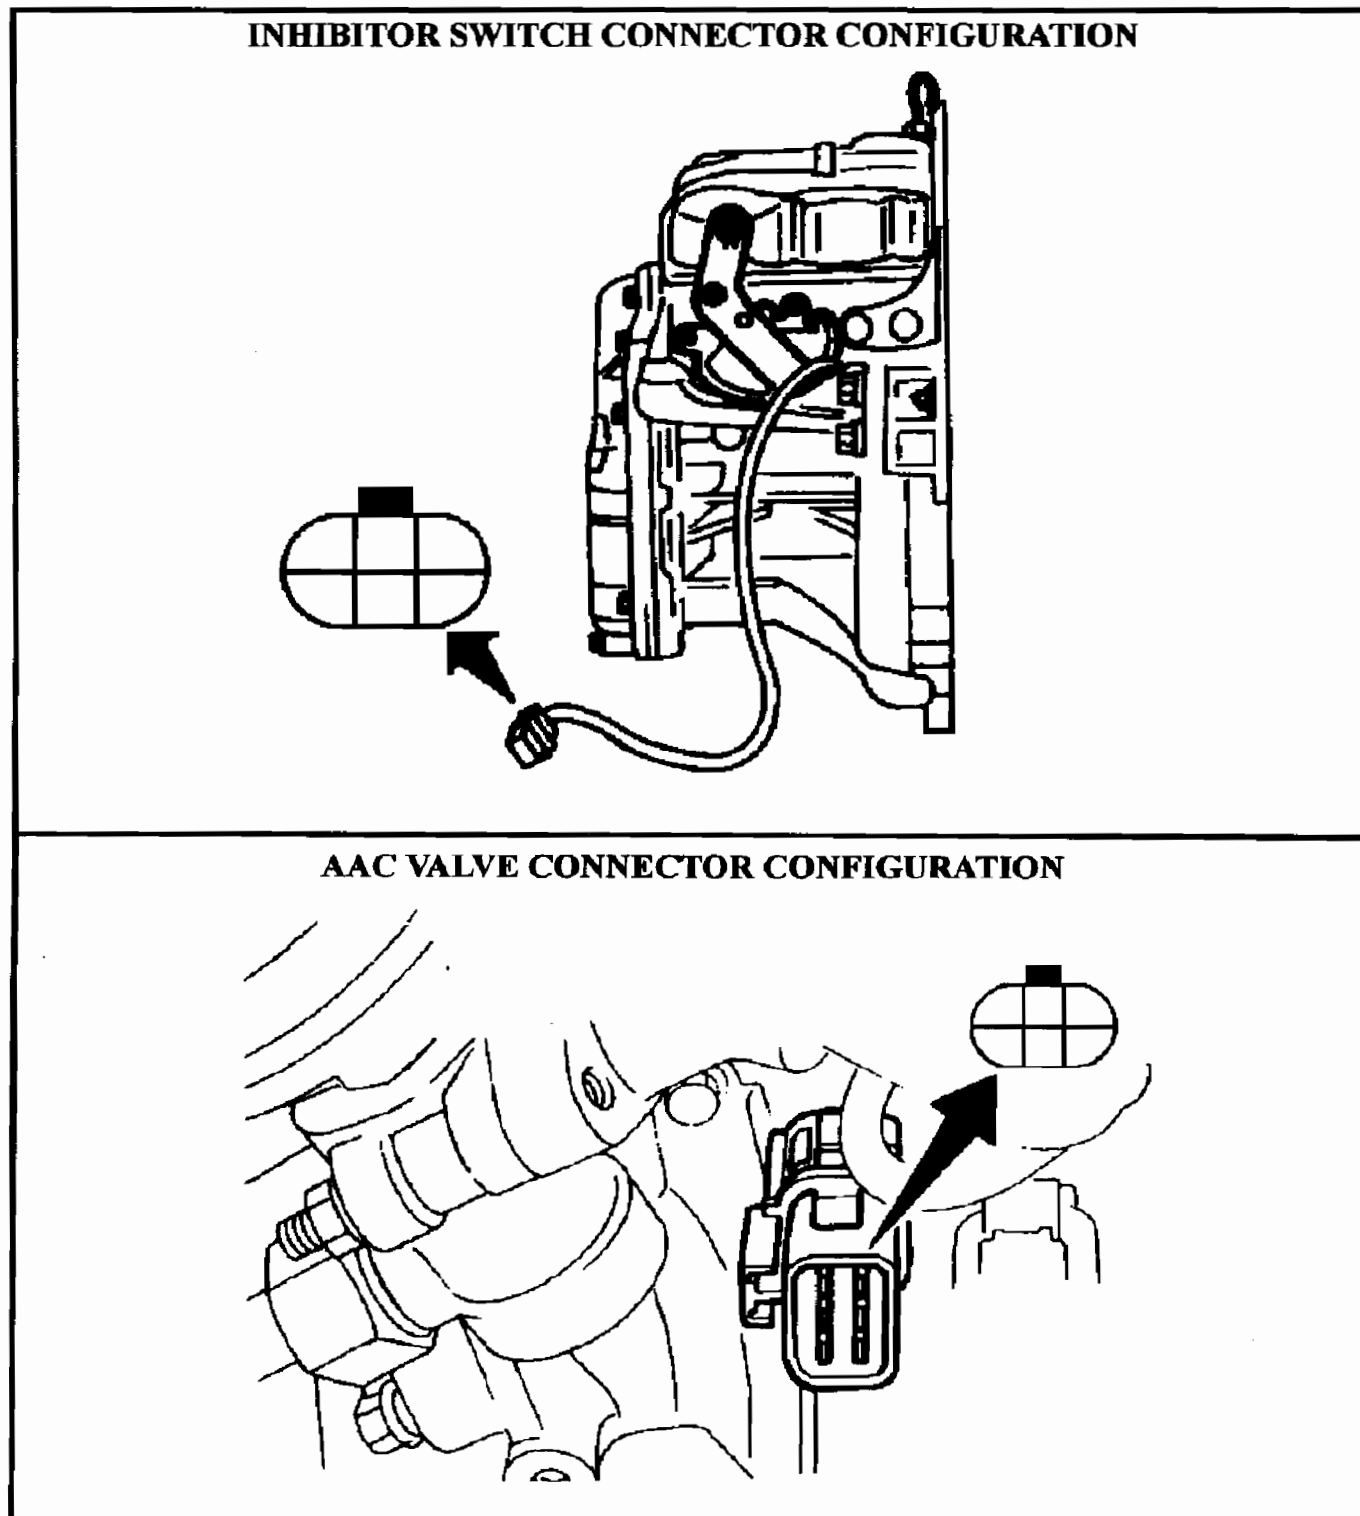
Figure 1

CAUSE: The Auxiliary Air Control Valve (AAC) connector was switched with the Inhibitor Switch connector.

**ACC VALVE CONNECTOR SWITCHED WITH INHIBITOR SWITCH CONNECTOR
(RE4FO2A EQUIPPED VEHICLES ONLY)**

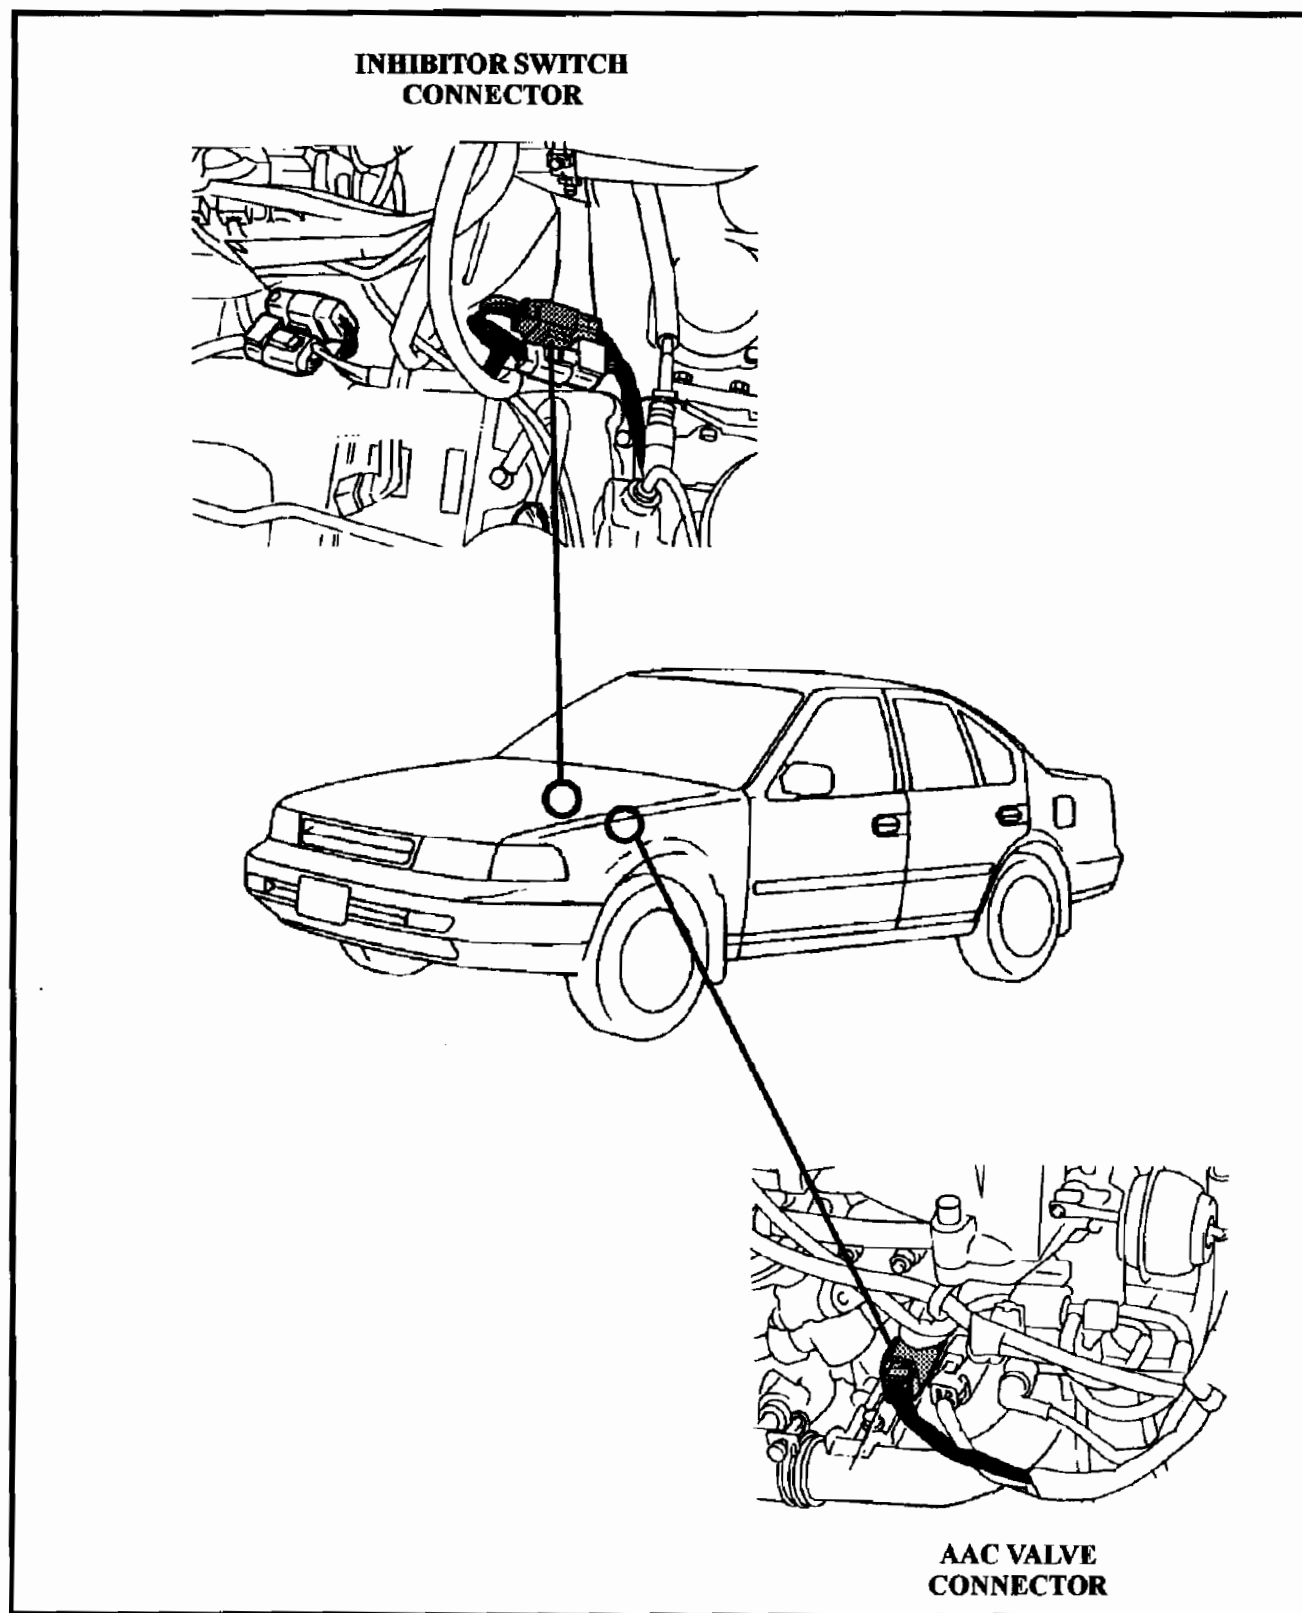
Figure 2

**ACC VALVE CONNECTOR SWITCHED WITH INHIBITOR SWITCH CONNECTOR
(RE4FO2A EQUIPPED VEHICLES ONLY)**

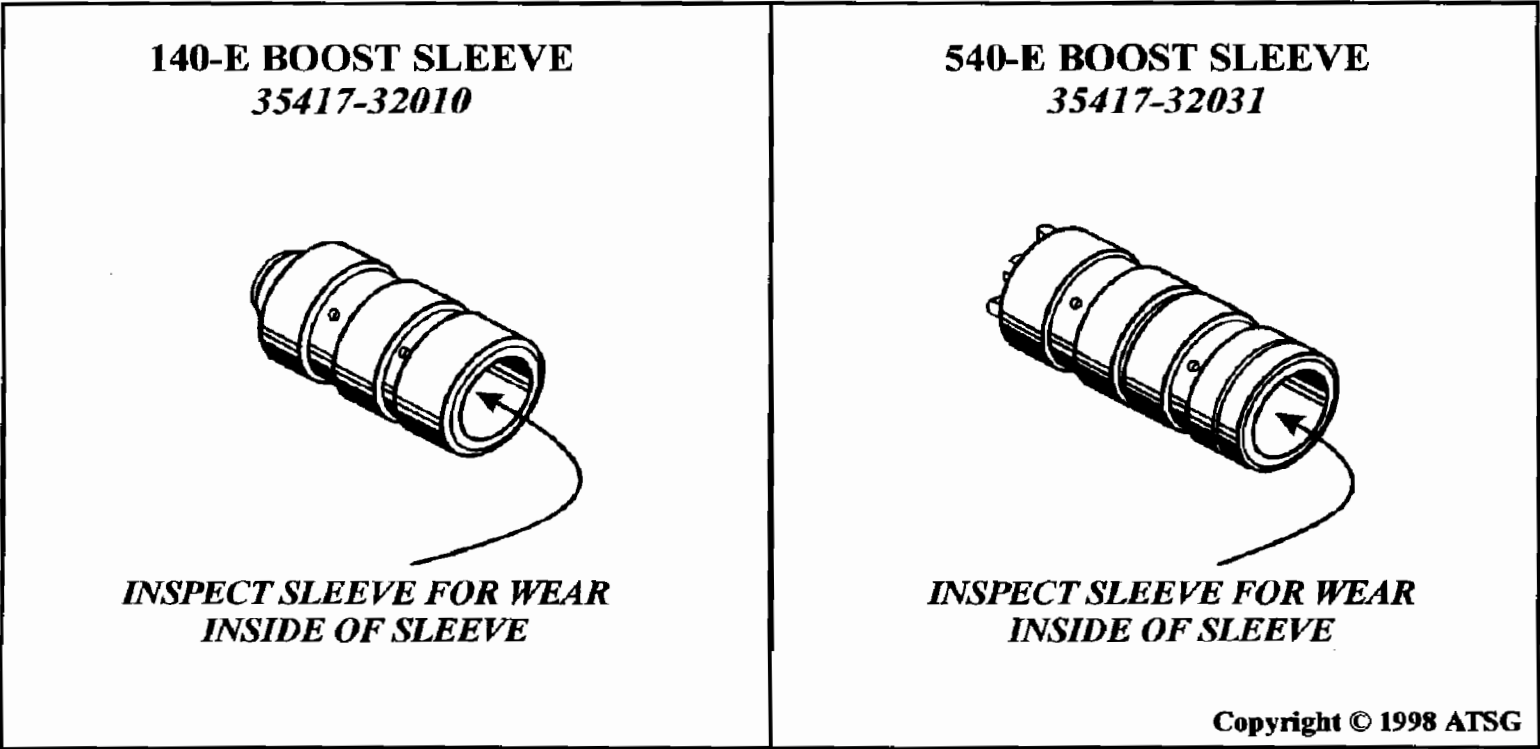
CAUSE: The cause may be, the Boost Sleeve in the Pressure Regulator line up severely worn, allowing T.V. pressure to leak into the reverse boost circuit which is open to exhaust at the manual valve, only when the manual valve is in the Drive ranges. When the selector is in the Reverse range, reverse boost oil can now enter the T.V. circuit forcing the Main Regulator valve to create higher than normal pressures.

CORRECTION: Refer to Figure 2 for the location of the boost sleeve in the valve body, and Figure 1 to check the Boost Sleeve for any wear. Replace as necessary with the OEM part numbers listed below.

- 140-E Boost Sleeve (Toyota NO.).....35417-32010
- 540-E Boost Sleeve (Toyota NO.).....35417-32031

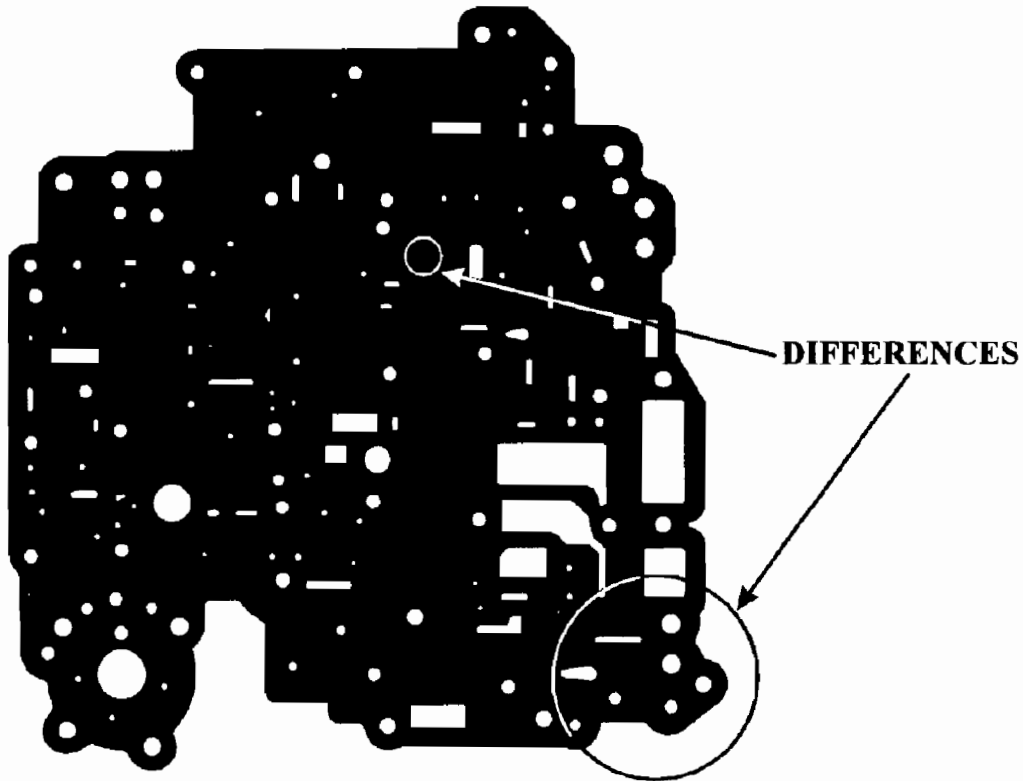
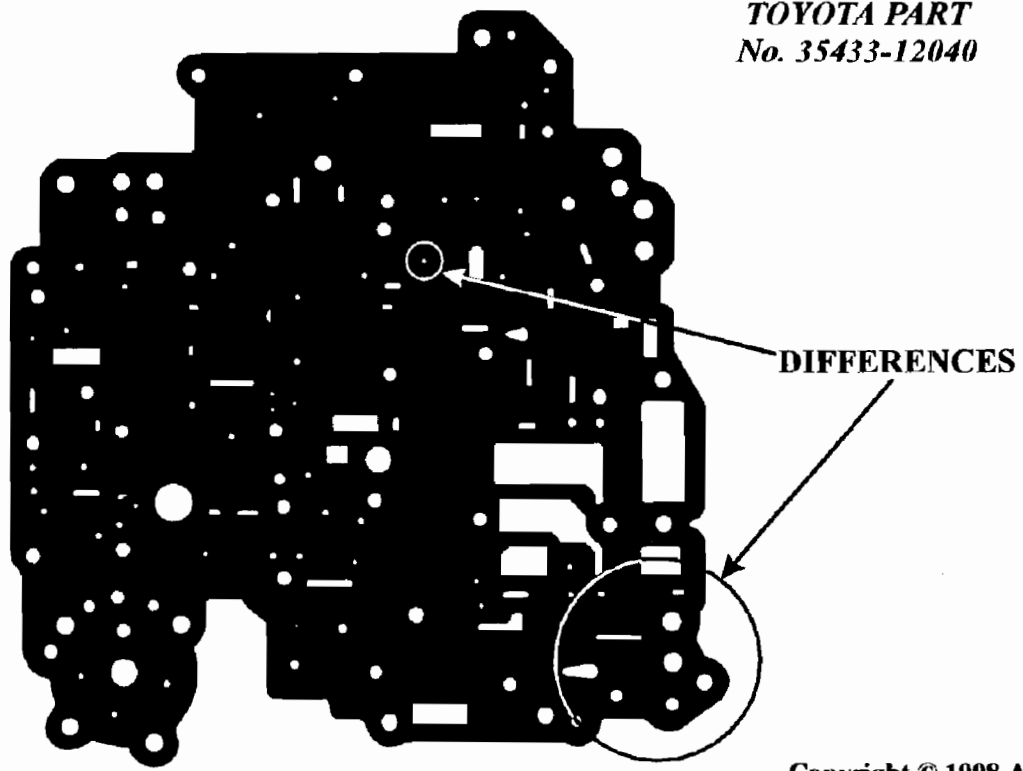
Figure 1

CAUSE: The cause may be, that during overhaul 240-L No.1 and No.2 valve body gaskets were used in place of the 241-H No.1 and No.2 valve body gaskets. The reason is that the two different gaskets sets have subtle differences, as shown in Figures 1 and 2, and the 241-H gaskets *do not* come in current overhaul kits.

*TOYOTA PART
No. 35433-12040*

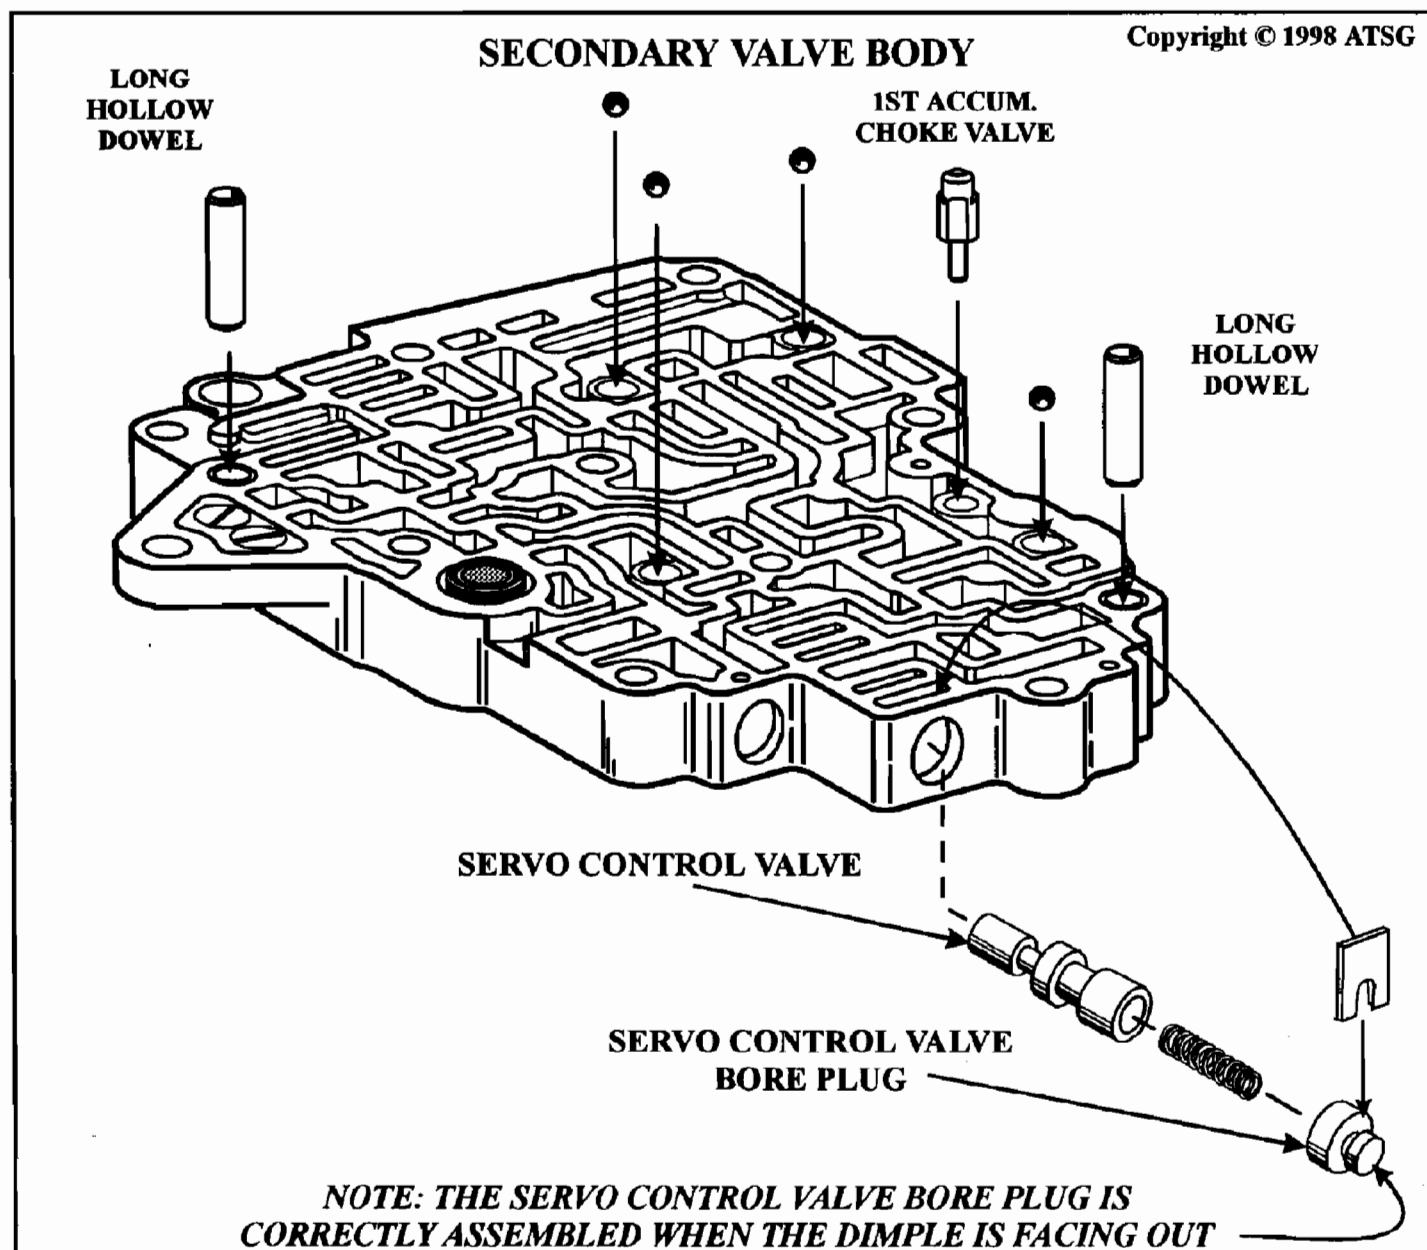
Figure 1

COMPLAINT: After overhaul, vehicles equipped with M24A transaxles may exhibit a no Reverse condition.

CAUSE: The cause may be, that the bore plug, which retains the servo control valve in its bore, was assembled backwards exhausting line pressure from the Manual Valve in Reverse.

CORRECTION: Locate the Servo Control Valve, which is in the Secondary Valve Body, and assemble the bore plug correctly as shown in Figure 1.

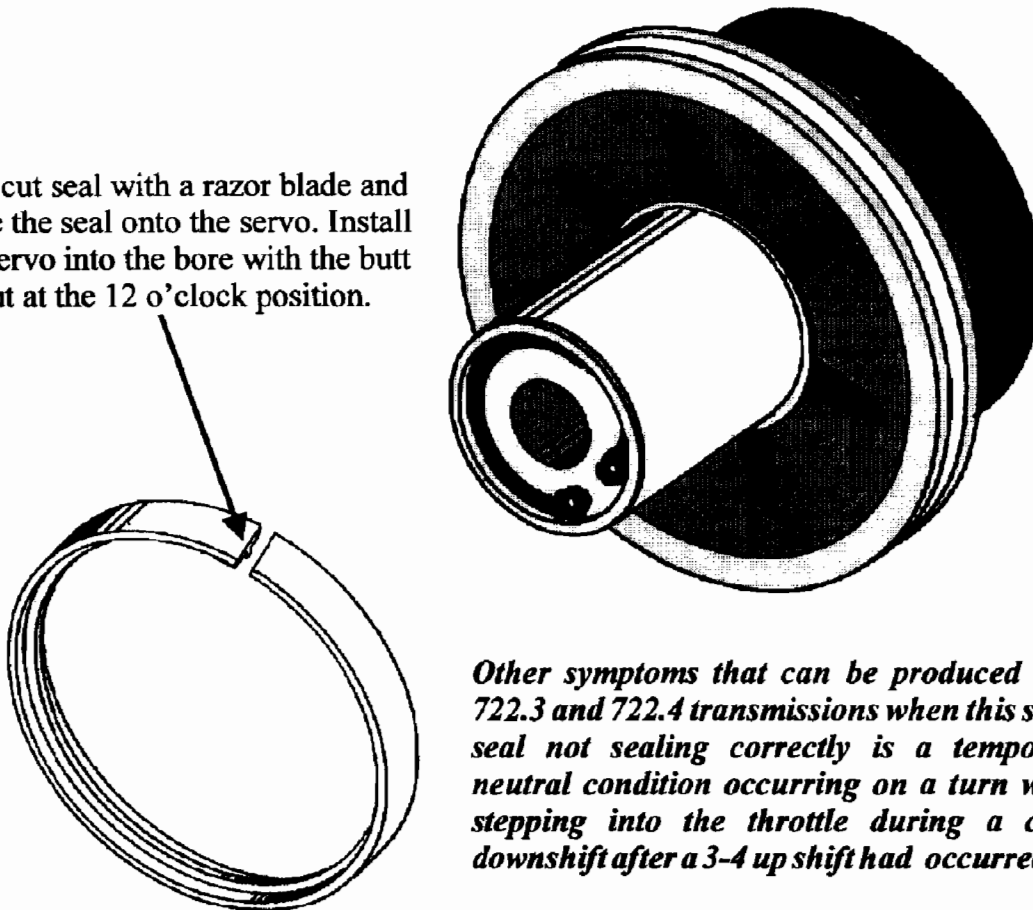
Figure 3

Other symptoms that can be produced with 722.3 and 722.4 transmissions when this servo seal not sealing correctly is a temporary neutral condition occurring on a turn when stepping into the throttle during a coast downshift after a 3-4 up shift had occurred.

Butt cut seal with a razor blade and place the seal onto the servo. Install the servo into the bore with the butt cut at the 12 o'clock position.
