Technical Service Information

THM 440-T4 HARSH 1-2 SHIFT

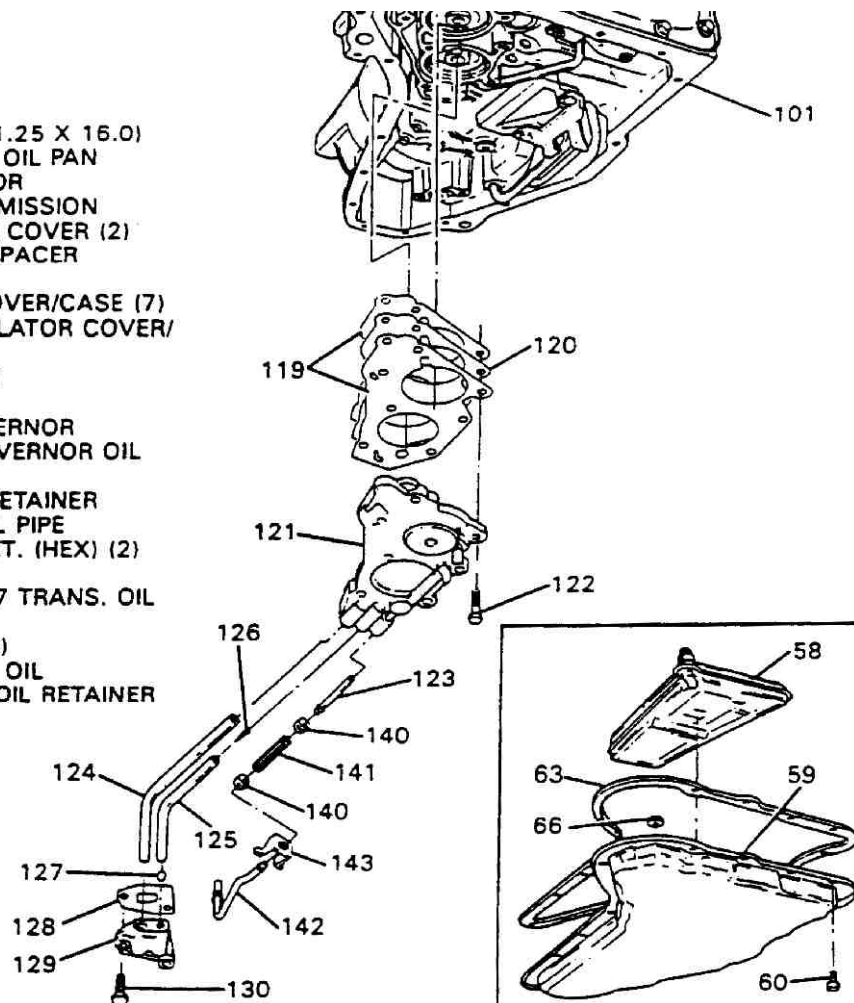
Figure 1

To repair this condition inspect the 2nd feed passage for blockage or in-complete drilling operation. To perform this inspection, remove the transaxle oil pan, filter, accumulator cover (with feed pipes and retainer), accumulator cover spacer plate and gaskets (Figure 1). Inspect the 2nd clutch passage by measuring the depth of the hole, which should be a minimum of 72mm (2-13/16") as shown in Figures 2 and 3.

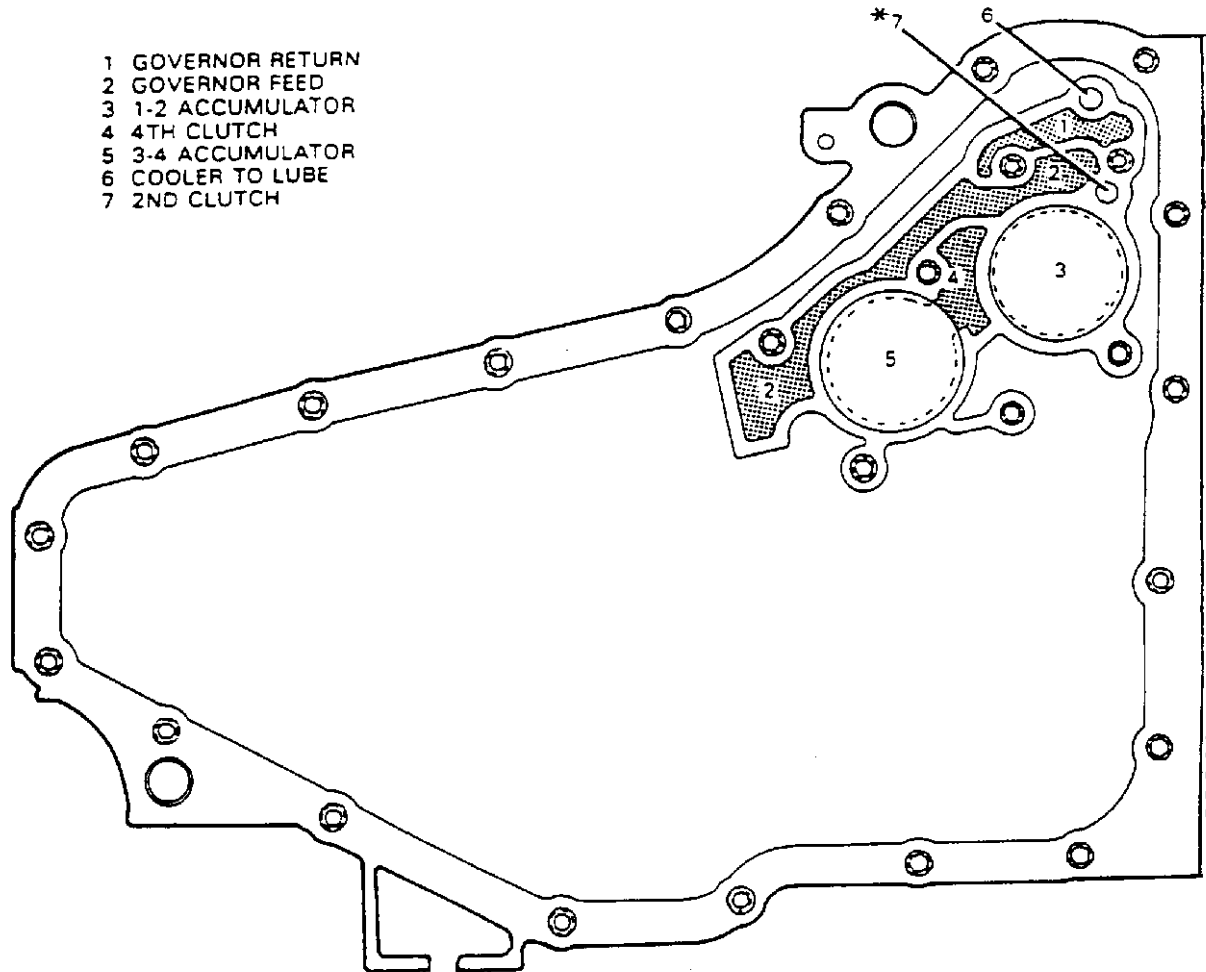
Figure 2

This harsh shift condition may be caused by a blocked or partially drilled 2nd clutch feed passage in the case.

*INSPECT 2ND CLUTCH PASSAGE (#7) FOR DRILLED HOLE DEPTH (SEE FIGURE 3 ALSO). IF REQUIRED USE AN 8.5mm (21/64") DRILL BIT AND FINISH DRILLING THE HOLE TO A DEPTH OF 72mm (2-13/16").

1. Remove the transaxle from the vehicle and disassemble components up to and including the channel plate.
2. Mark an 8.5mm (21/64") drill bit at 72mm (2-13/16") from the end using a drill stop or some other acceptable method. From the oil pan side of the case, finish drilling the 2nd clutch passage to the proper depth as marked on the drill bit.

NOTE: DRILLING TO DEEP INTO THE 2ND CLUTCH PASSAGE WILL RESULT IN DAMAGE TO THE CASE,

3. Remove metal chips caused by drilling and thoroughly flush the repaired case passages with clean solvent.
4. Reassemble the transaxle.

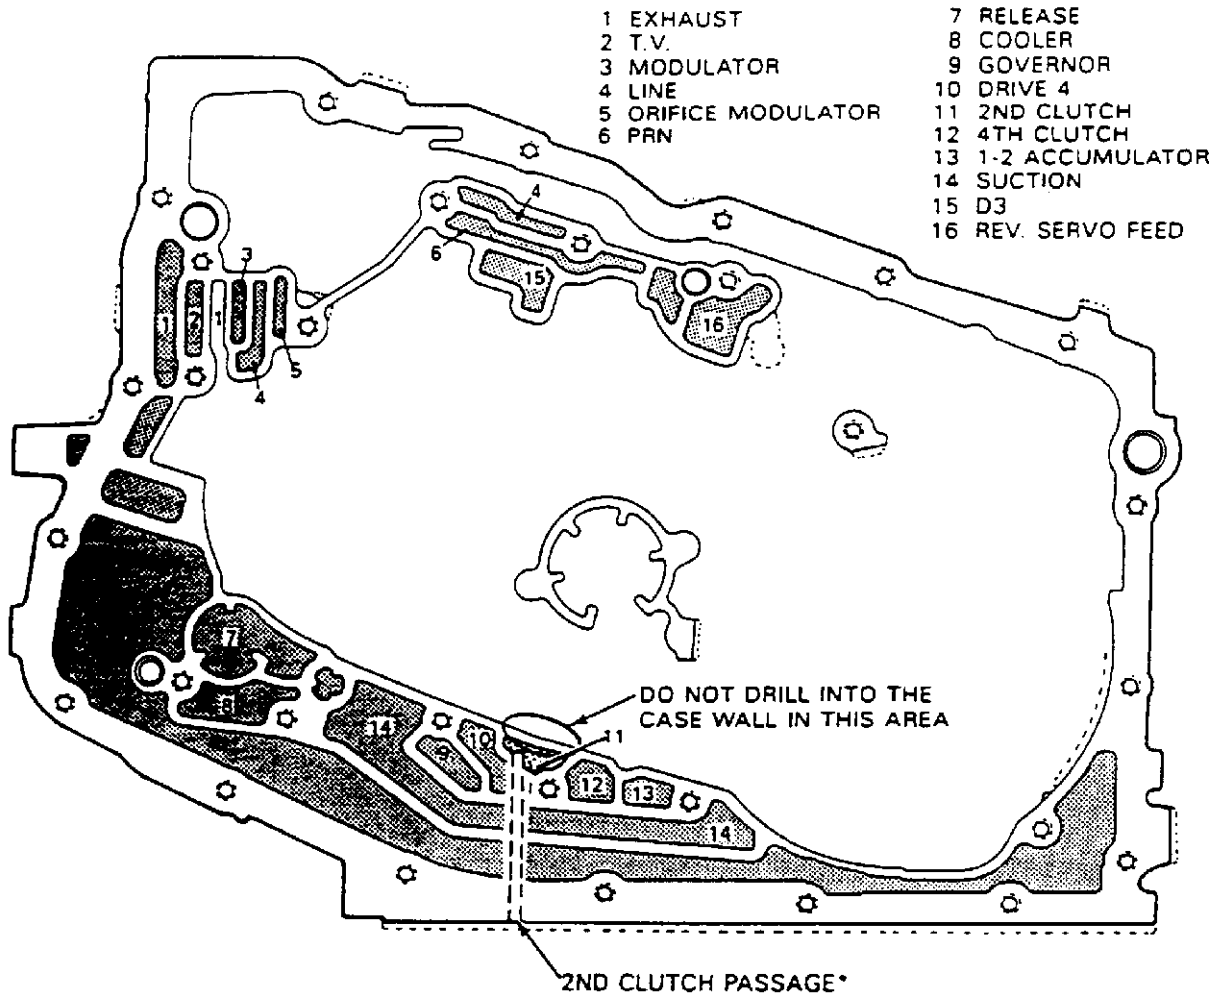
*DRILL BIT SHOULD BE VISIBLE IN 2ND CLUTCH PASSAGE AS SHOWN.
