# Technical Service Information

## SUBARU 3 SPEED HARSH 1-2/3-2 SHUT

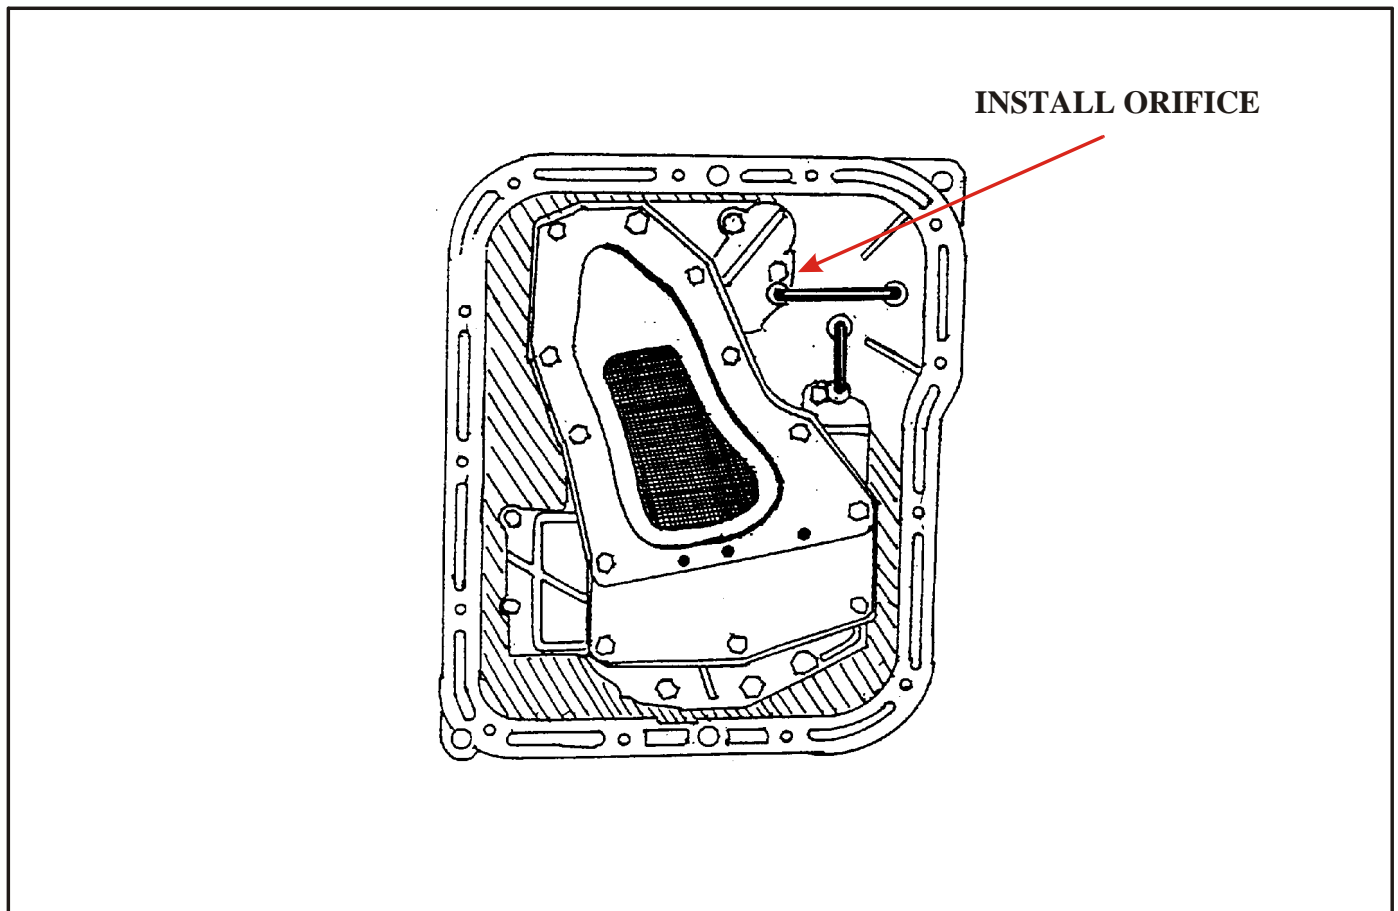
Figure 1

**COMPLAINT:** Harsh 1-2 and 3-2 shift.

**CAUSE:** Servo apply orifice missing.

**CORRECTION:** Install orifice in the apply servo tube on valve body end.
