AUTOMATIC TRANSMISSION SERVICE GROUP

SEMINARS 1990

TECHNICAL INFORMATION PACKAGE

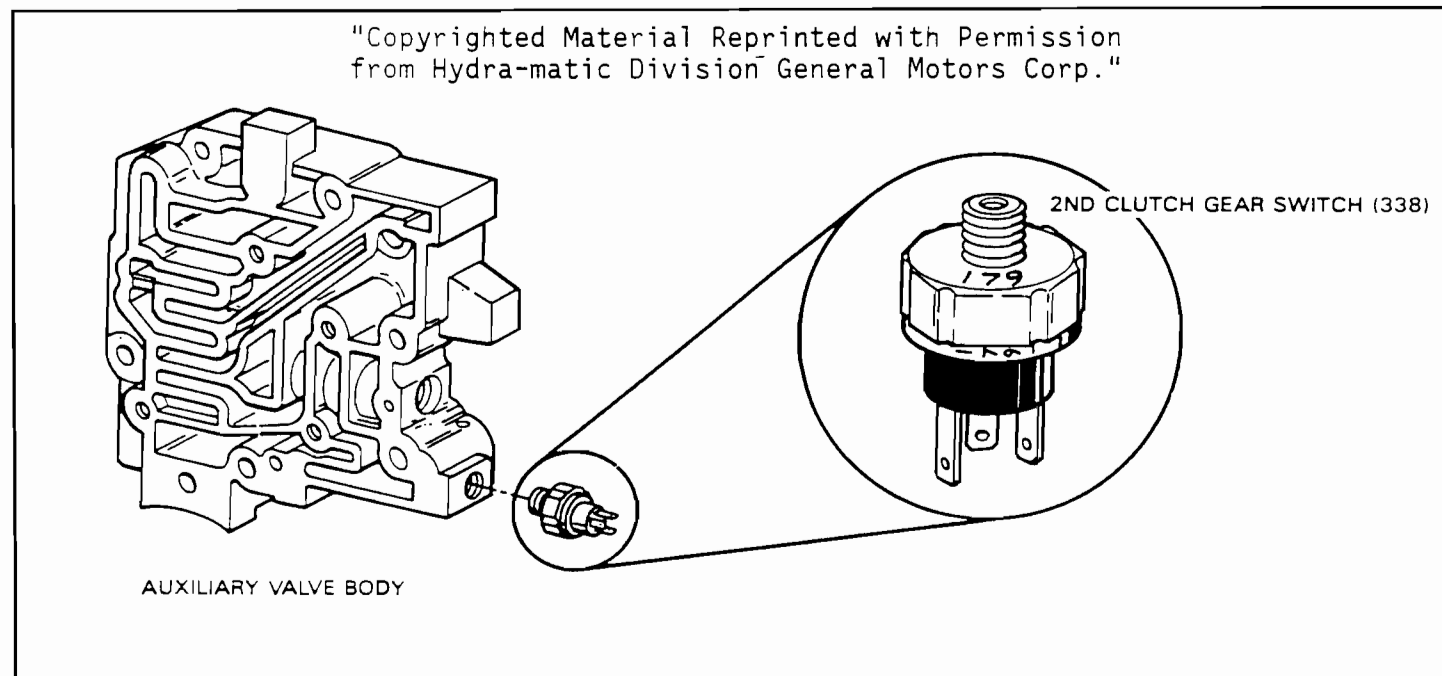
Figure 1

CAUSE: The cause may be a defective 2nd clutch switch located on the auxillary valve body (See Figure 1). The 2nd gear switch has a 3 digit code stamped on the metal portion of the switch (See Figure 1). The first 2 digits in the code represent the week in which the switch manufactured, and the 3rd digit represents the year manufactured. All switches built with number 179 or lower, will not carry the amperage required to operate the converter clutch solenoid, and should be replaced. Terminals will appear black in color and may be loose in the switch.

CORRECTION: Replace the 2nd clutch switch with OEM Part Number 8664388. Inspect the converter clutch solenoid, 3rd gear switch, and entire wiring harness for excessive heat.

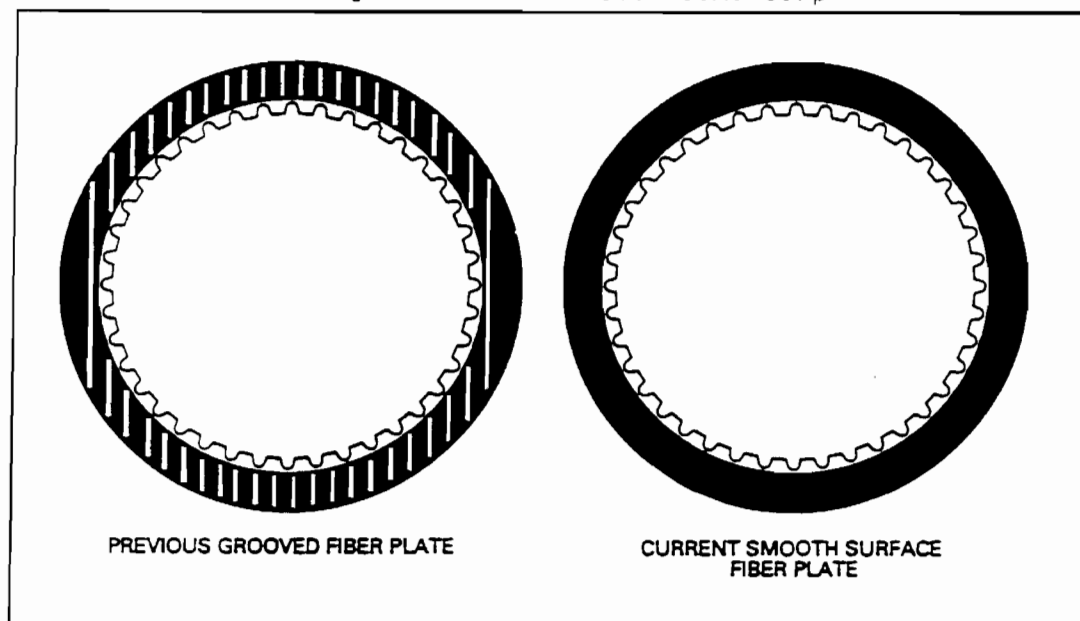
FIGURE 1

- COMPLAINT: An intermittent rattle and/or clicking noise that is most evident in 3rd gear.
- CAUSE: The noise may be caused by " Grooved " 1o-reverse lined clutch plates (See Figure 1).
- CORRECTION: Install " Smooth " 1o-reverse lined clutch plates, available under OEM Part No. 8666667 the new clutch plates went into production May 5, 1989 (Julian Date 125).

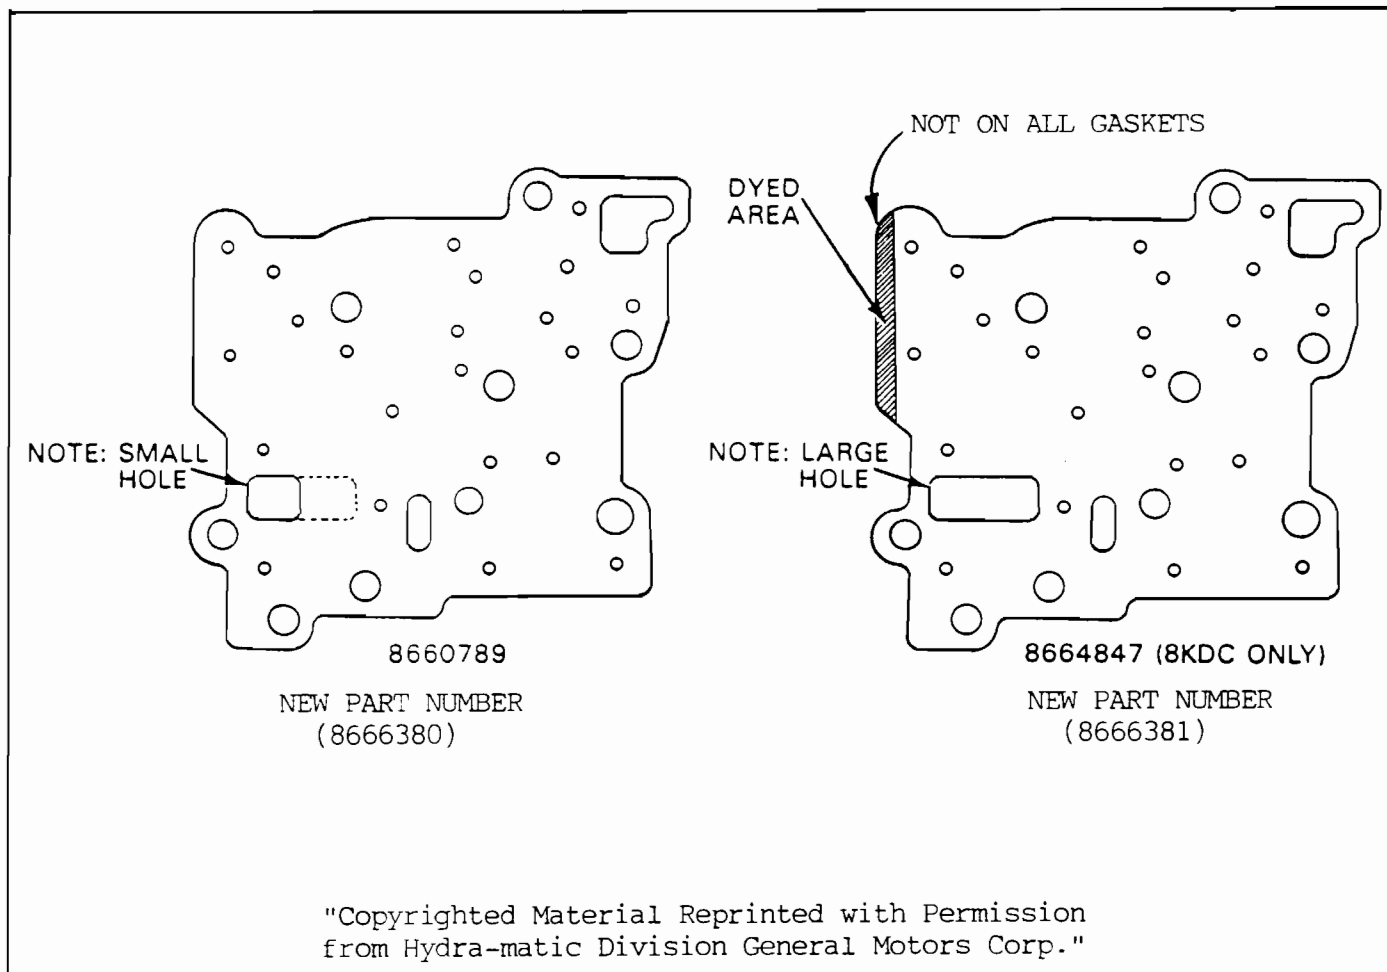
Figure 1

CAUSE: Not enough converter clutch apply oil.

CORRECTION: Install the 1988 (KDC) auxilliary valve body gasket with the large hole (See Figure 1), or modify the 1987 gasket with the small hole, by cutting on the dotted line (See Figure 1).

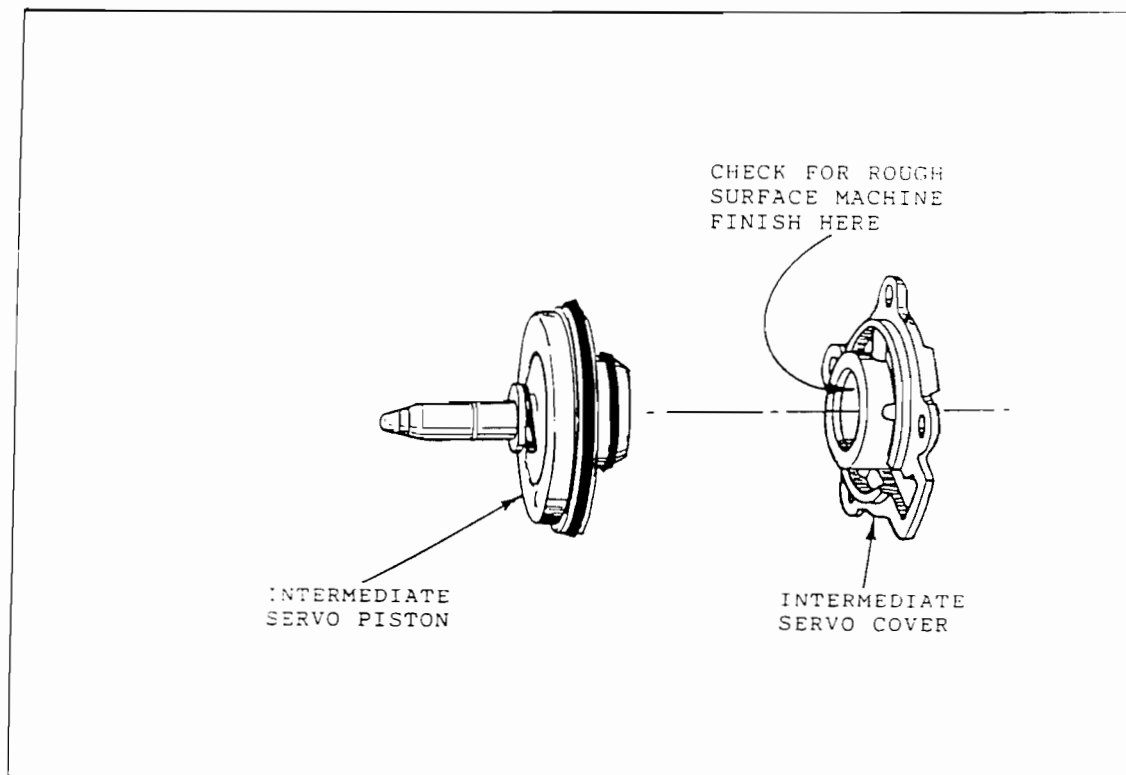
Figure 1

CAUSE: The cause may be a worn or torn lip seal (Small) on the intermediate servo piston, and created by a rough surface machine finish in the bore of the intermediate servo cover (See Figure 1). This rough finish will wear the lip off the (Small) intermediate servo seal.

CORRECTION: Replace the intermediate servo cover and intermediate servo piston lip seals.

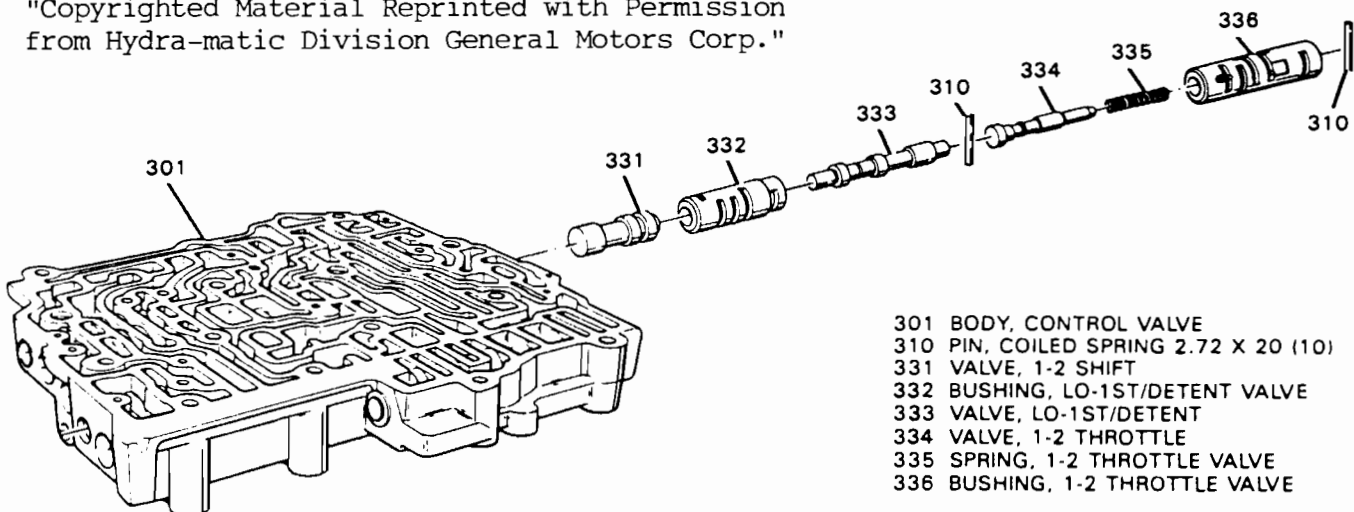
CAUSE: The cause may be an incorrect 1-2 throttle valve spring (See Figure 1). This affects ONLY 1987-1988 models CCF, CHF, CRF, CTF, CYF, and CZF.

CORRECTION: Replace the 1-2 throttle valve spring, available under OEM part number 8643619. Refer to Figure 1 for proper assembly of valves and sleeves.

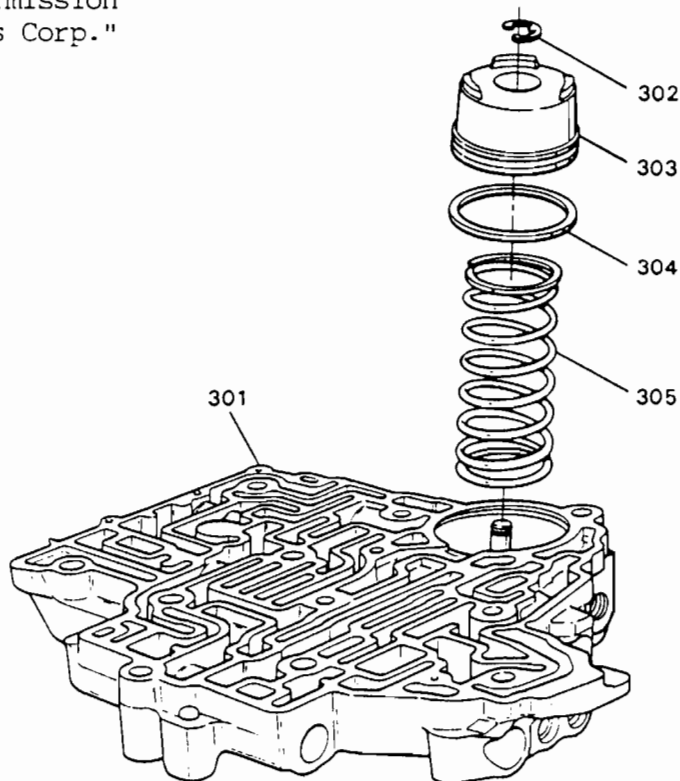
Figure 1

- COMPLAINT:** No engine braking when selector lever is placed in the manual second position.
May also exhibit slippage on upshifts into 2nd gear when in the drive range.
- CAUSE:** The cause may be a broken or cracked 2-3 accumulator piston in the valve body (See Figure 1).
- CORRECTION:** Replace the plastic 2-3 accumulator piston with a new die cast aluminum piston, available under OEM part number 8626883.

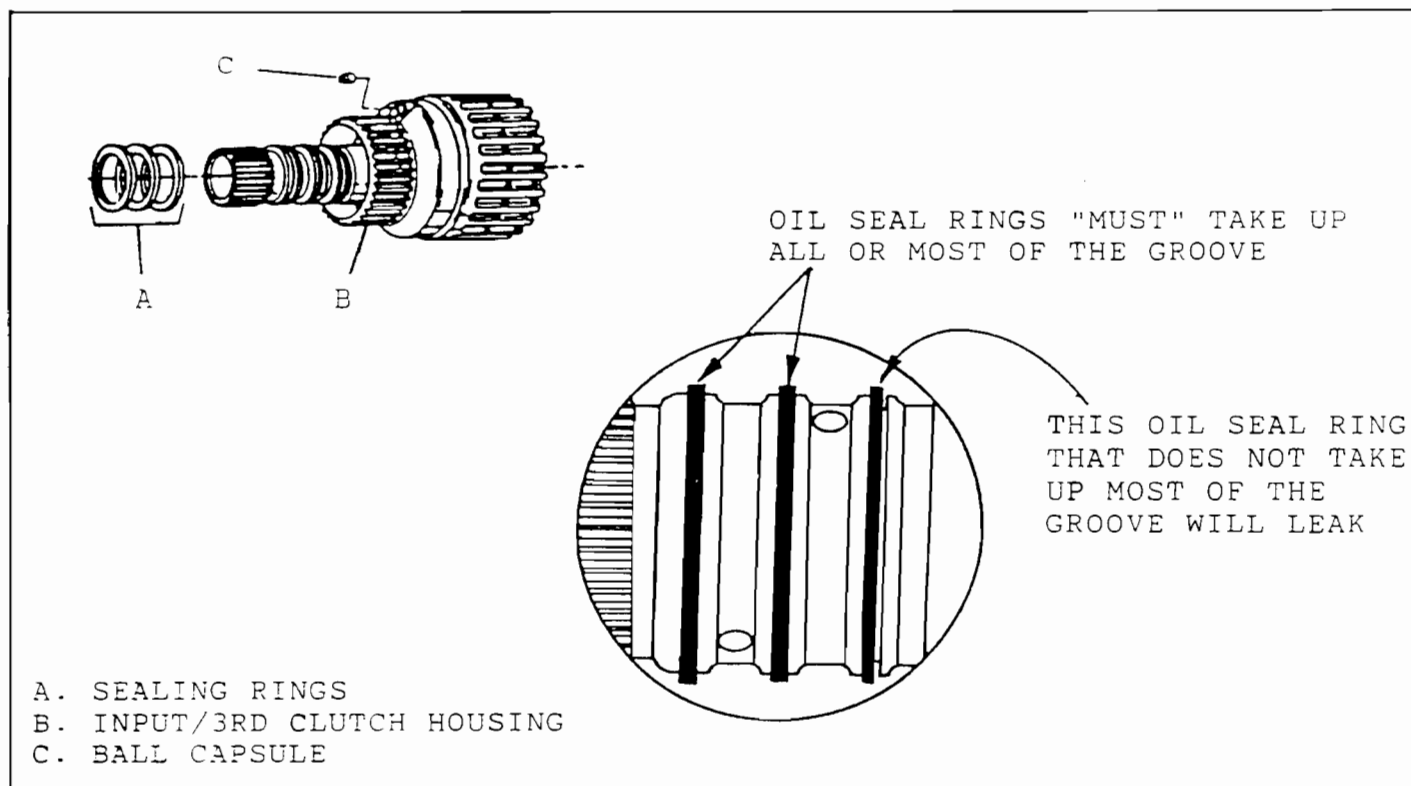
Figure 1

CAUSE: The cause may be due to one or more undersized input shaft oil sealing rings that feed both the input clutch and 3rd clutch. The sealing rings should take up most or all of the groove width (See Figure 1). Thin sealing rings may be found in any groove location, and will be about half the normal thickness. Proper width seals are .108" thick.

CORRECTION: Install proper width sealing rings on the input housing, following procedures outlined in the ATSG service manual. The sealing rings are solid and require special installation and re-sizing tools. The sealing rings are available under OEM Part No. 8656342.

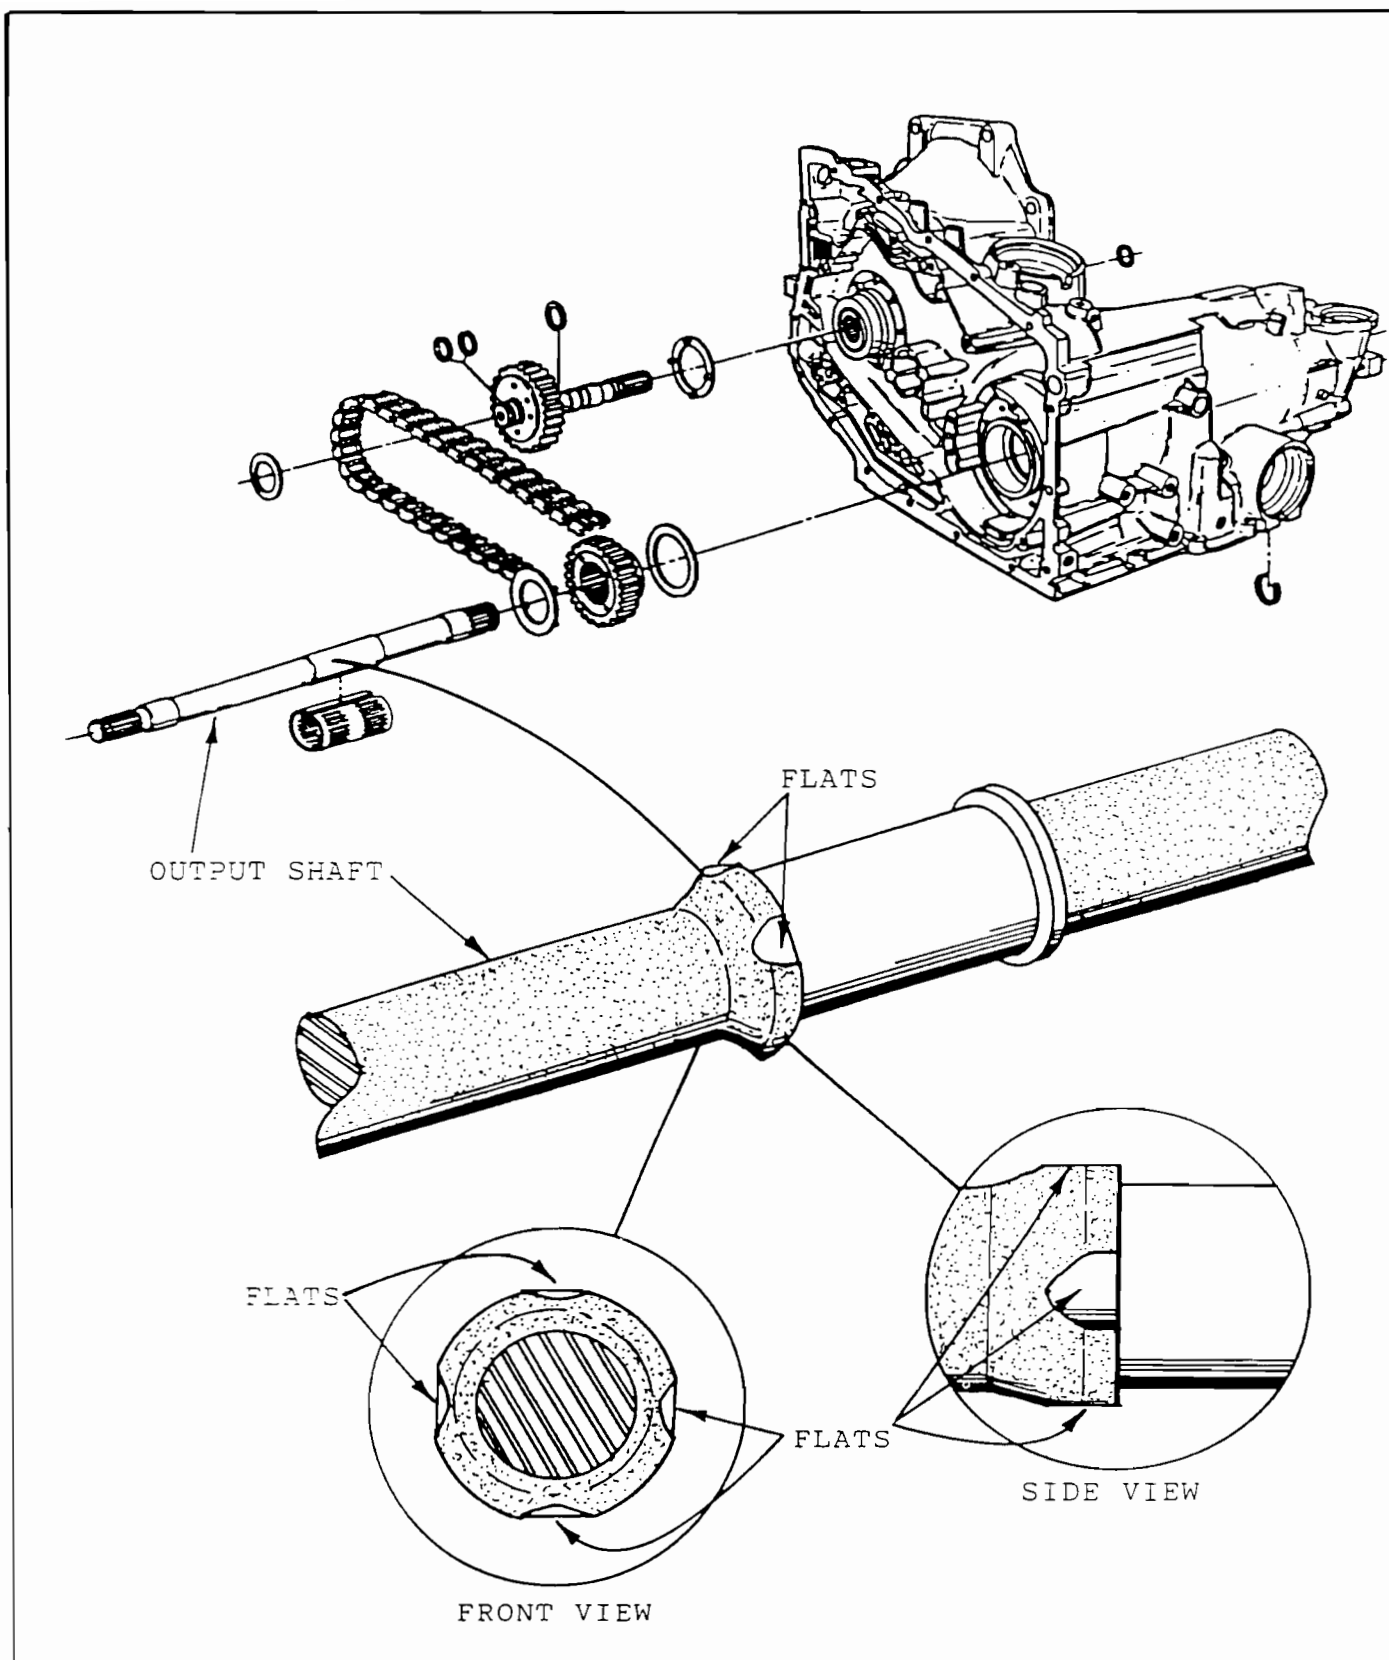
Figure 1

CAUSE: Lack of lube oil to 3rd roller clutch and input sprag.

1. MODIFY OUTPUT SHAFT:
Grind four (4) flats on the output shaft at the front of the bearing in the locations shown in Figure 1.
2. MODIFY OUTPUT SHAFT BEARING:
Remove individual needle bearings as shown in Figure 2, in three equally spaced locations around the bearing, to provide three "Troughs" for additional lube oil to flow. Removing the needles does not impair the durability of the bearing assembly.
3. MODIFY ASSEMBLY PROCEDURE:
When installing the sprag assembly onto the input sun gear, align one of the three lube oil holes in the inner race, with one of the two lube oil holes in the input sun gear, as shown in Figure 3.

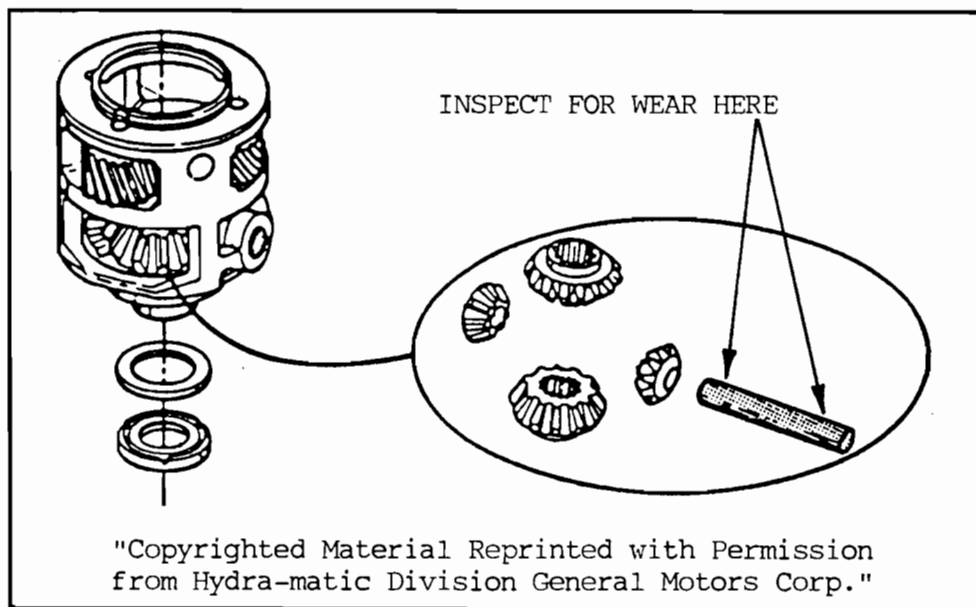
Figure 1

CAUSE: The cause may be a worn or gaulded differential pinion shaft that supports the two pinions in the final drive (See Figure 1). The black coating flakes off of the pinion shaft because of improper hardening at the manufacturer.

CORRECTION: Inspect the differential pinion shaft for wear in the pinion gear area (See Figure 1). If the pinion shaft is worn (Black Coating Gone), replace the pinion shaft and both pinion gears. The pinion shaft and pinion gears in the 1989 models are different dimensions than the previous models and will not interchange. If the pinions are seized to the pinion shaft, then the entire final drive assembly should be replaced. Make certain that you select the same final drive ratio.

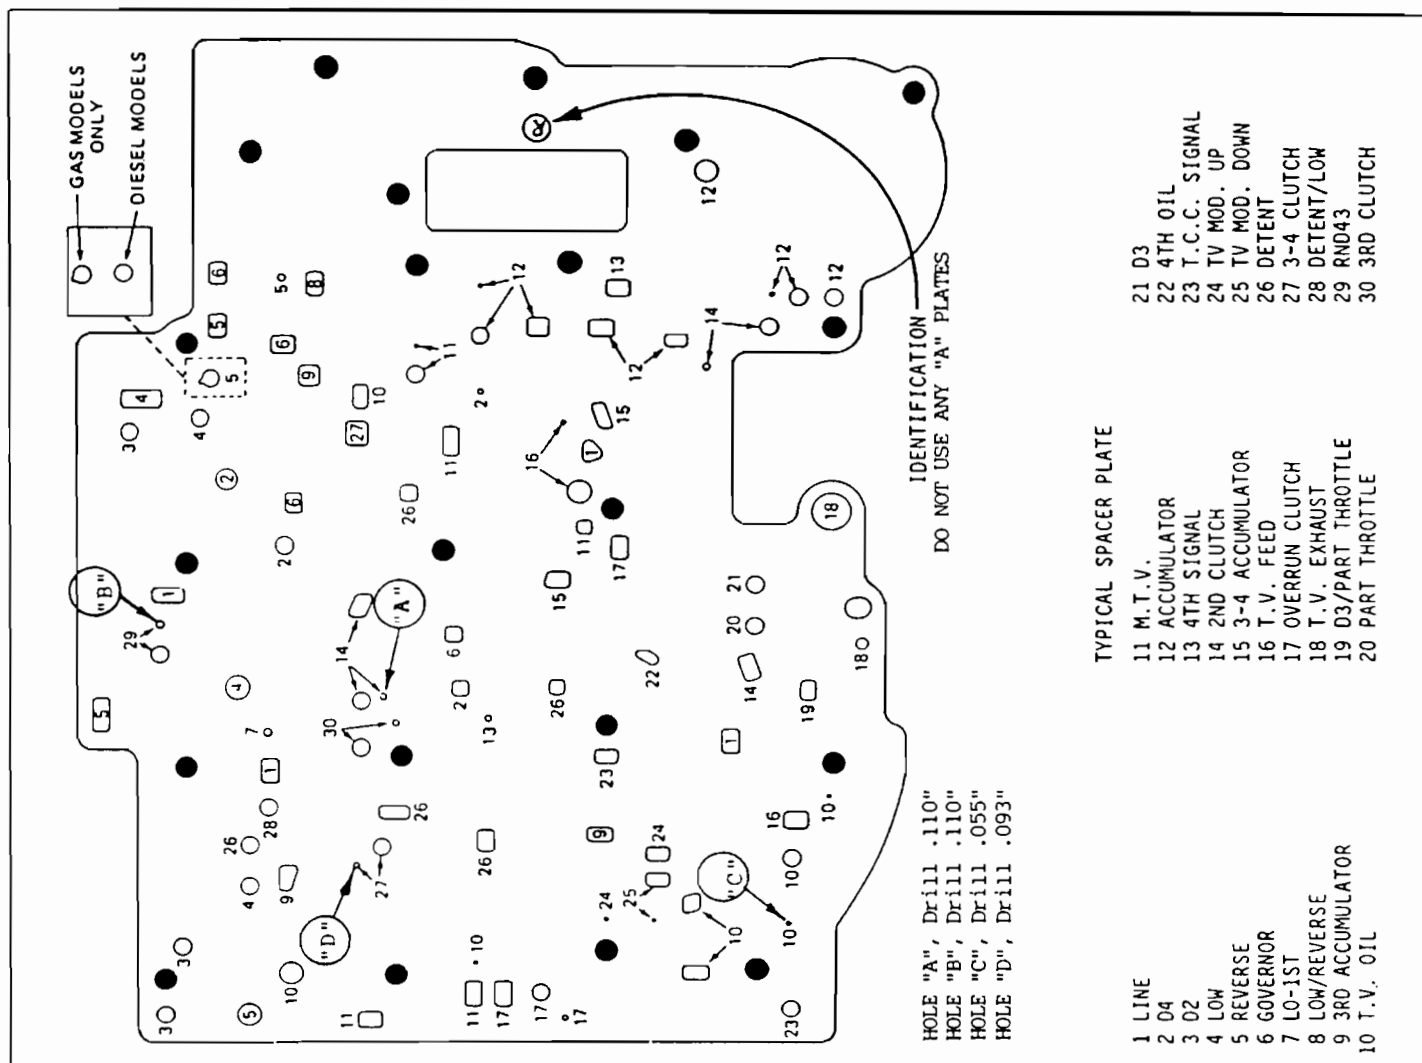
CAUSE: Not enough oil feed to band and 3-4 clutch pack.

CORRECTION: Drill spacer plate at locations shown in Figure below, using drill sizes indicated.

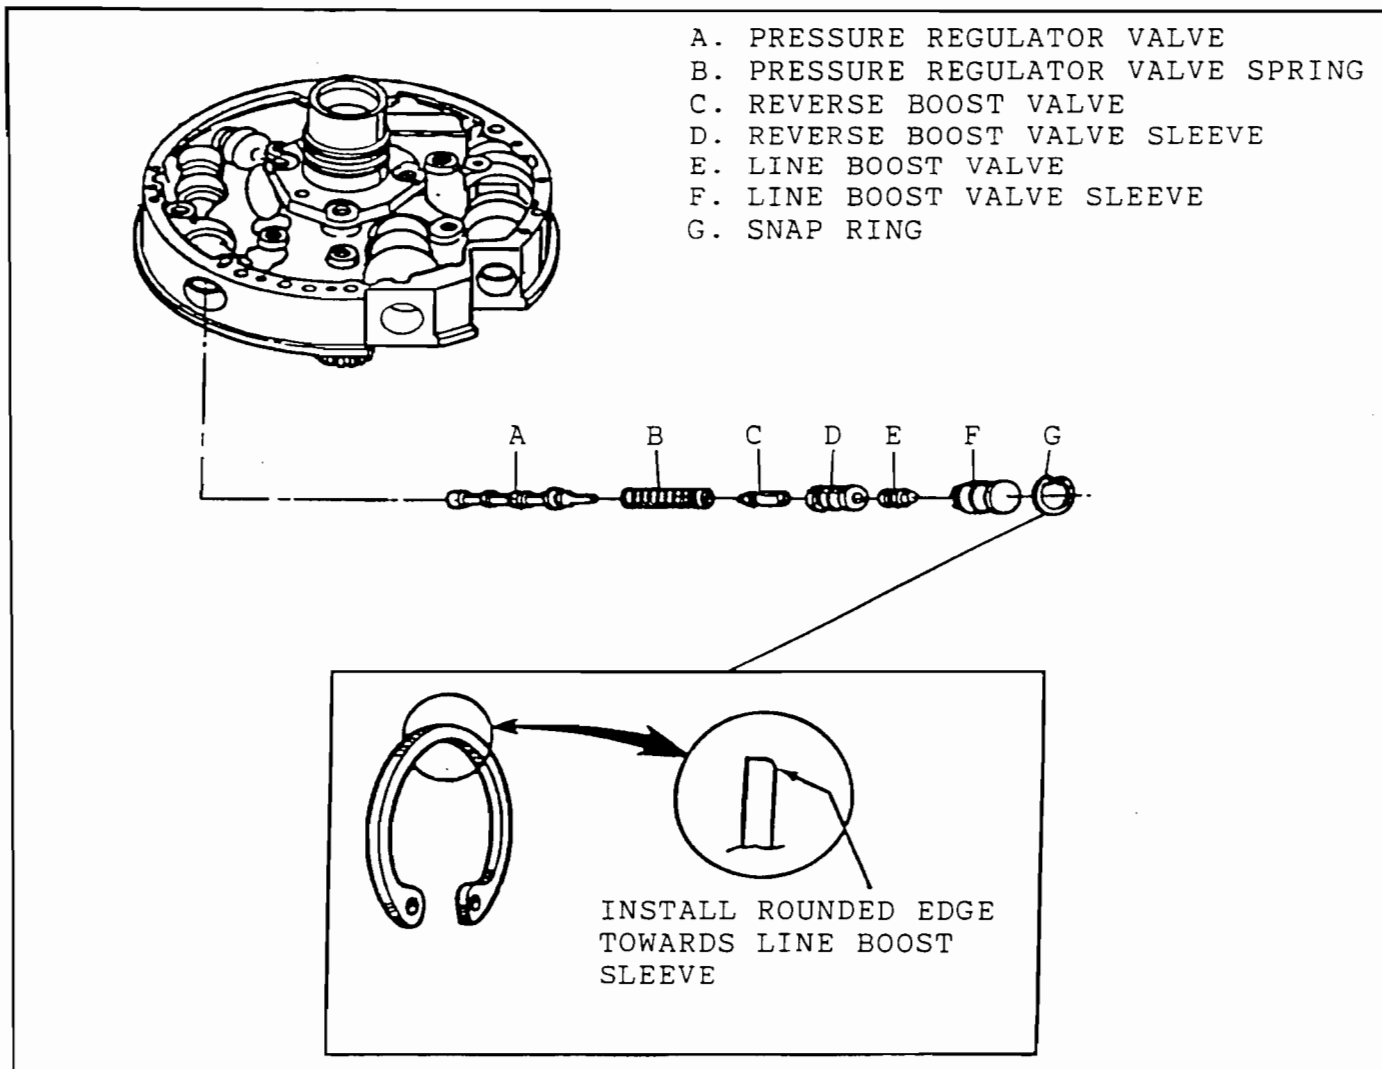
Figure 1

CAUSE: The cause may be the snap ring popped out of the pressure regulator valve train in the pump cover.

CORRECTION: Install the snap ring with the rounded edge towards the line boost sleeve (See Figure 1). This will prevent the snap ring from popping out again.

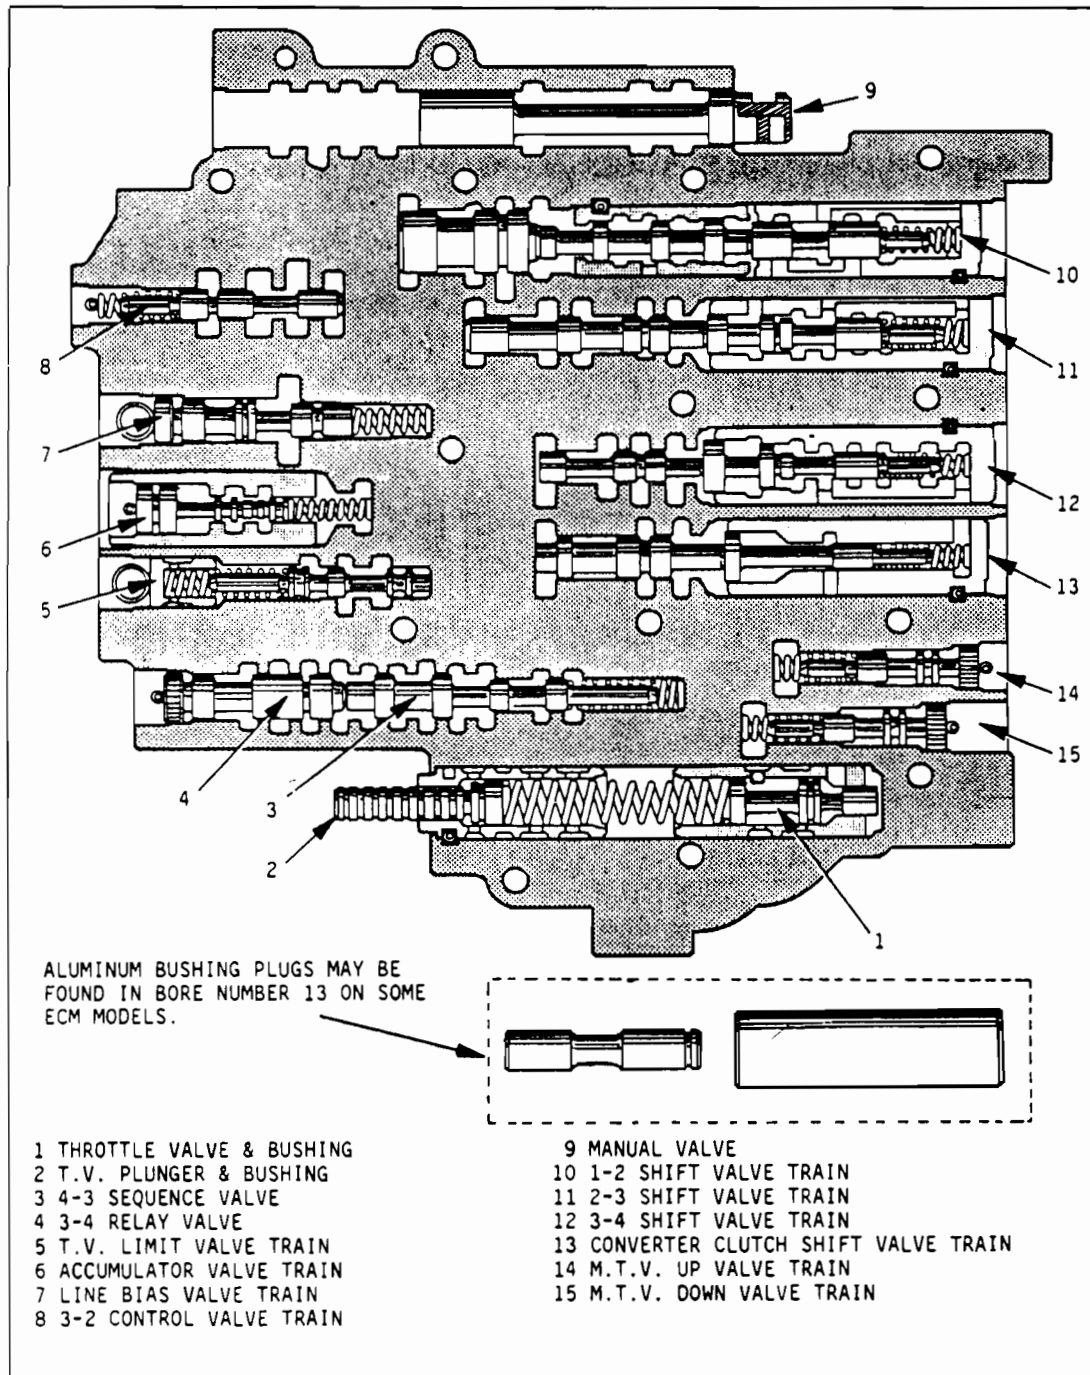
Figure 1

CAUSE: The cause may be a stuck 4-3 sequence valve and/or a stuck 2-3 shift valve, both of which are located in the main valve body (See Figure 1).

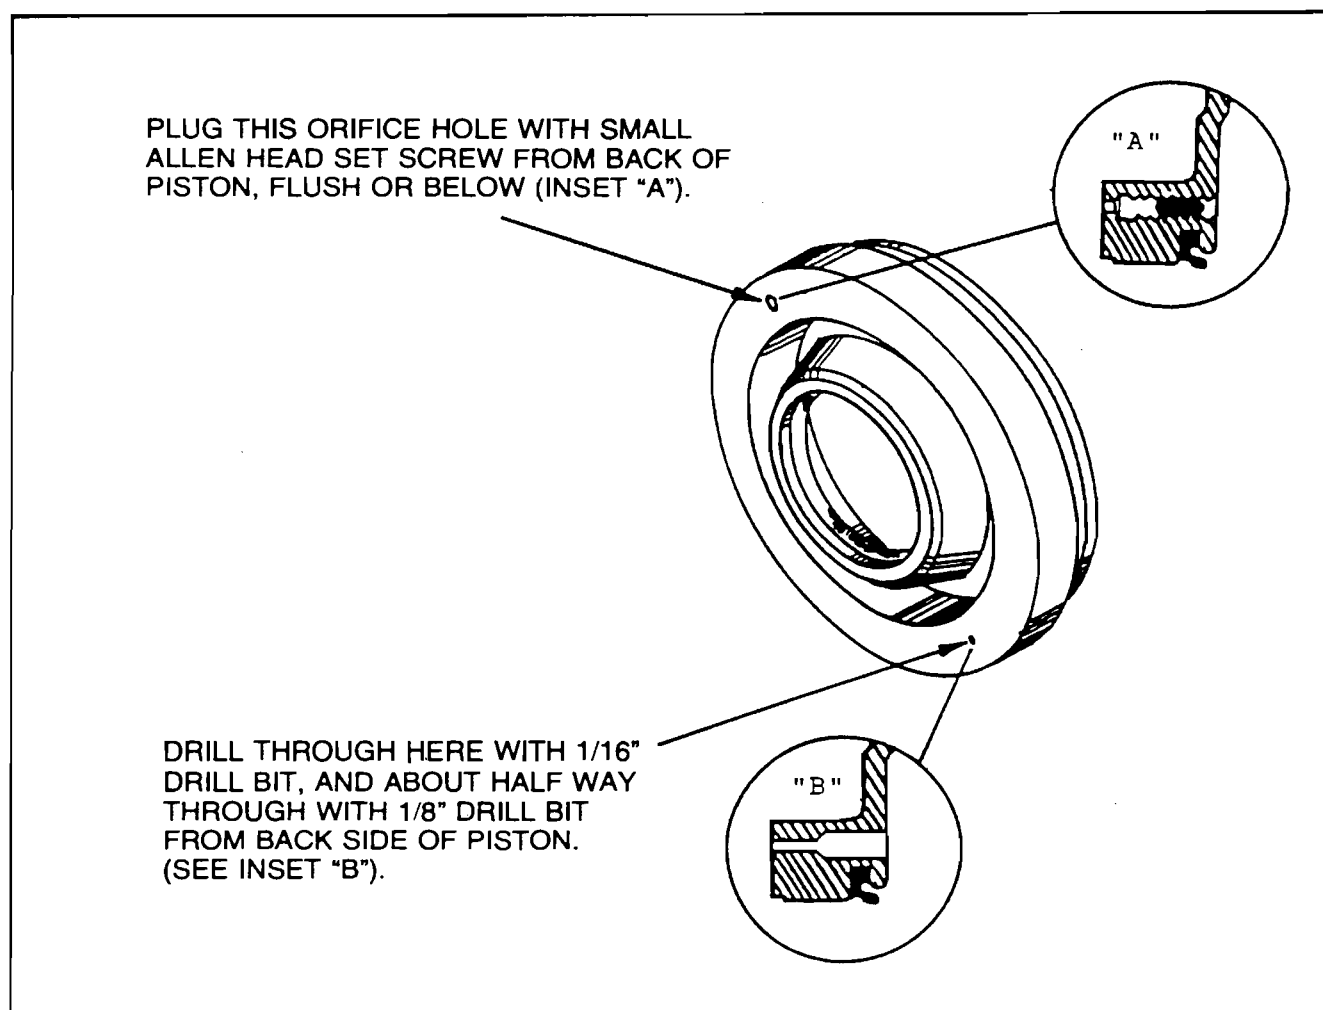
Figure 32

CAUSE: The cause may be the orifice hole in the new aluminum piston, drilled too large (Original was .116").

180 degrees from original orifice hole you will find a hole started but not drilled through. Drill through here with a 1/16" drill bit, from the front side of piston. Turn the piston over and from the back side of piston, drill about half way through with a 1/8" drill bit. (See Figure 32, Inset "B").

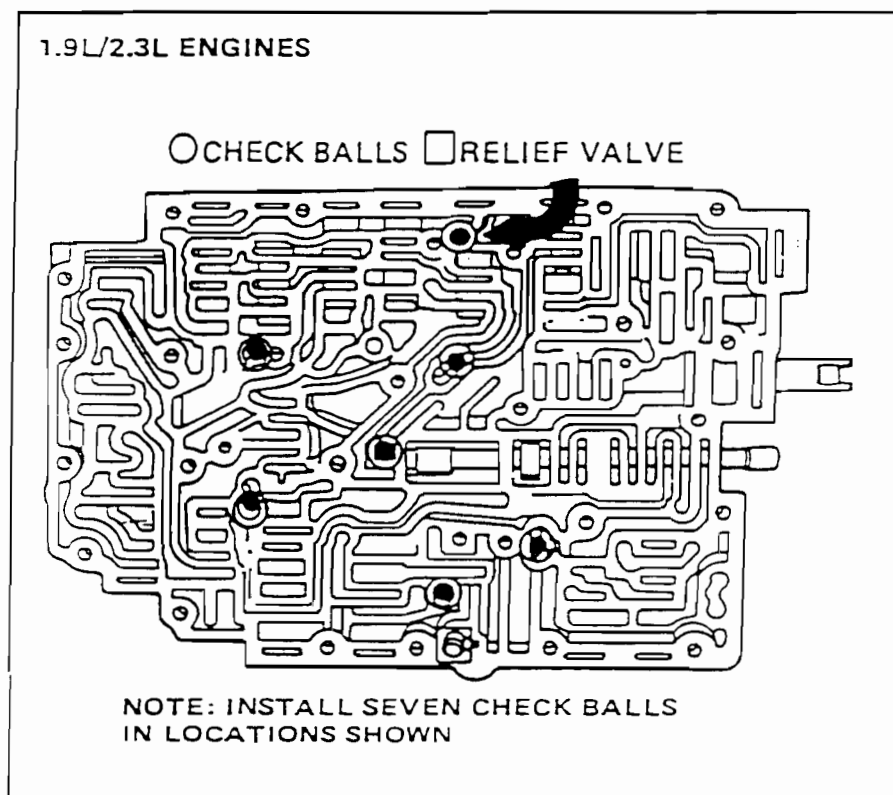
The number of main control check balls and their locations for the ATX transaxle as published in the 1989 Tempo/Topaz-Escort Car Shop Manual, Section 17-25-82 is incorrect. The correct number of main control check balls for the 1.9L ATX transaxle is seven (7) not six (6). Failure to install the seventh check ball will cause a harsh 2-3 upshift.

ACTION: When servicing the ATX transaxle main control make sure that all seven (7) check balls are installed. Refer to Figure 1 for the correct location of the main control check balls.

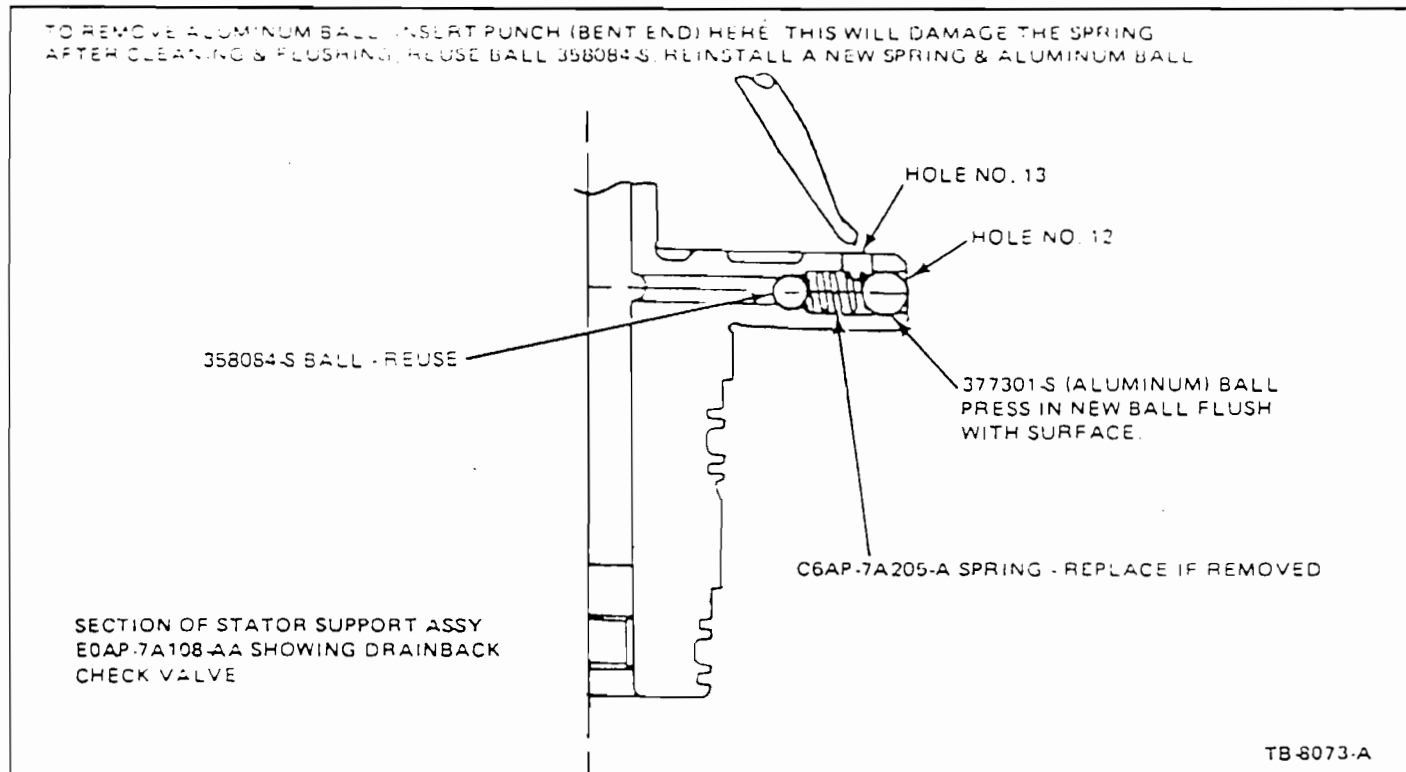
Figure 1

CAUSE: The cause may be the converter drain back cross hole passage in the pump stator support blocked with debris, or the checkball stuck (See Figure 1).

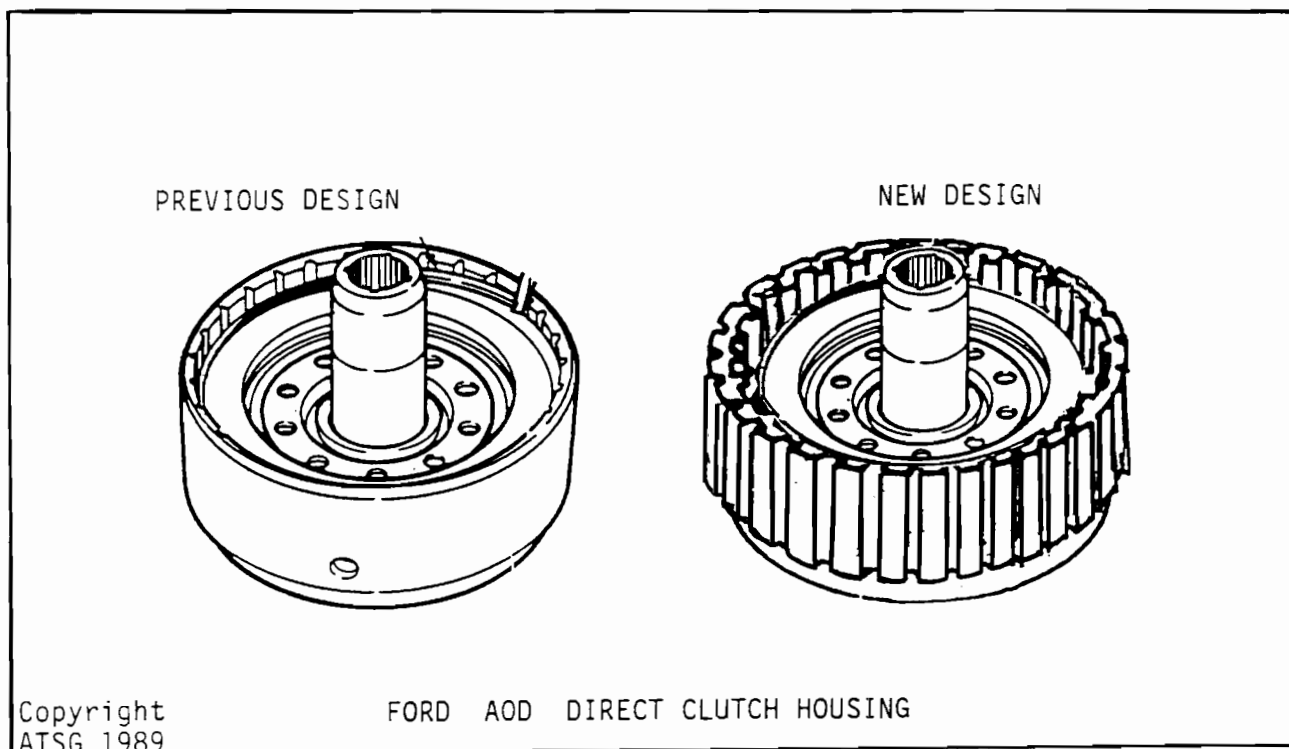
Figure 1

CAUSE: In 1989 there was a new design stamped steel direct clutch housing (See Figure 1) introduced, that creates the noise.

CORRECTION: Install the previous design cast steel direct clutch housing.

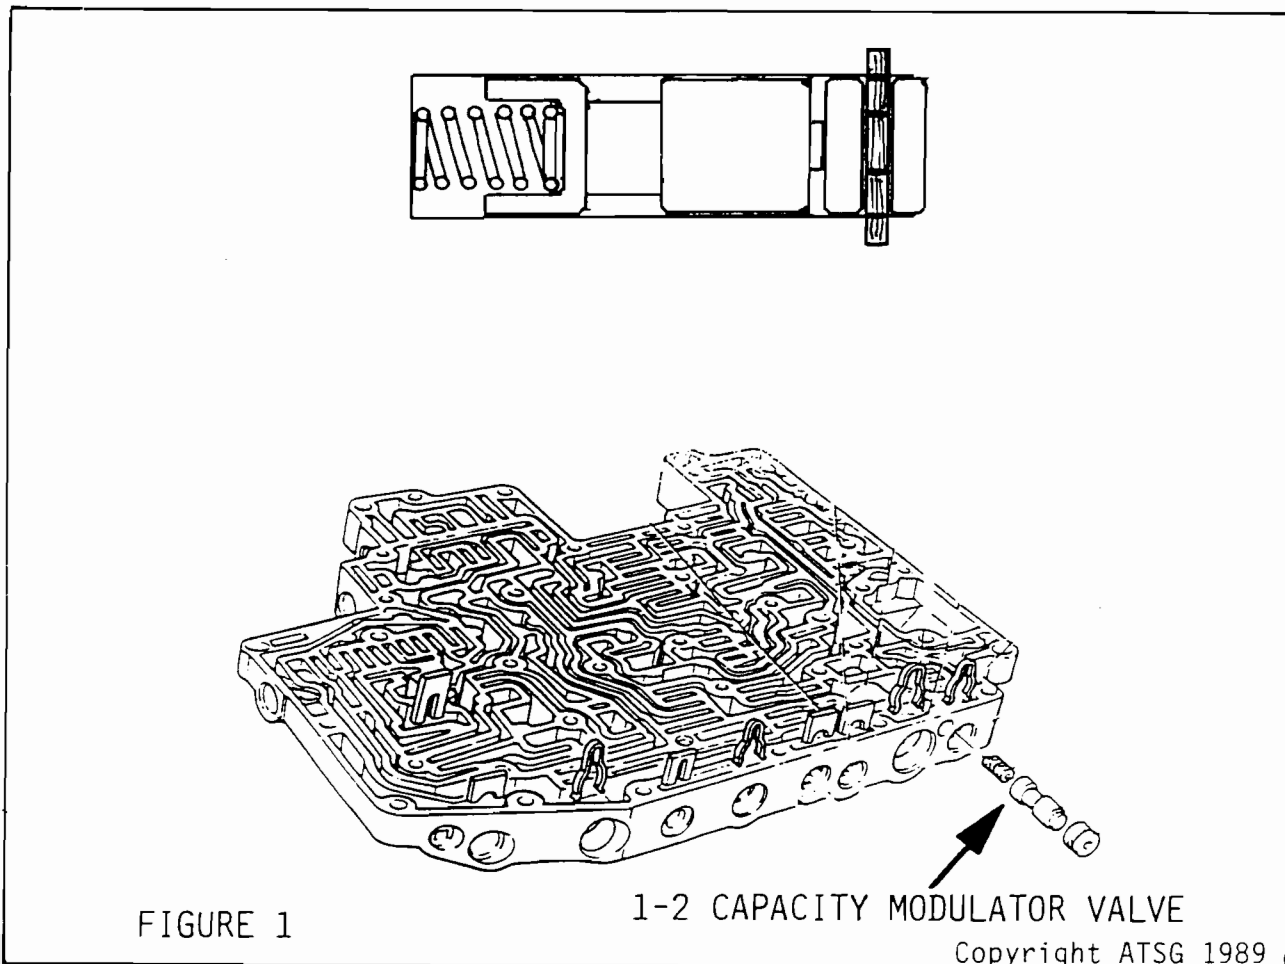
CAUSE: 1-2 CAPACITY MODULATOR VALVE SPRING NOT FULLY SEATED IN MODULATOR VALVE POCKET. SEE FIGURE 1 FOR "PROPER" ASSEMBLY.

CORRECTION: REPOSITION SPRING PROPERLY, AS SHOWN IN FIGURE 1, USE PETROLATUM TO RETAIN SPRING IN MODULATOR VALVE POCKET DURING ASSEMBLY.

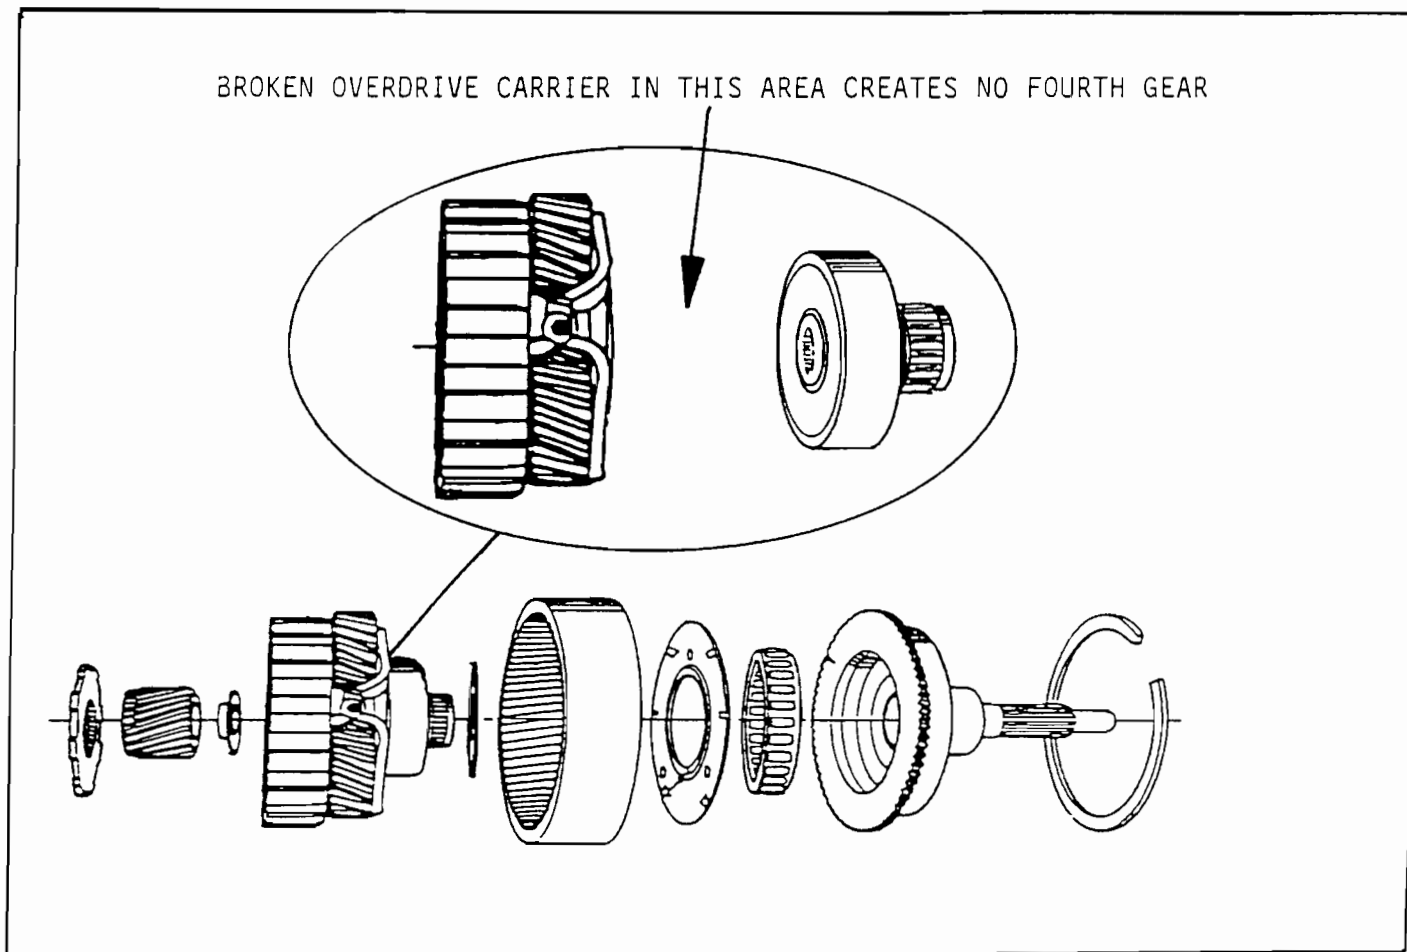
Figure 1

CAUSE: The cause may be the splined portion of the O.D. carrier and the sprag inner race broken (See Figure 1). The splined portion and inner race will remain in one piece, and usually turn in the carrier, but will not always separate itself from the carrier. The problem is not always detectable because the bearing inside the carrier hides the broken area of the carrier. The sprag inner race and splined area for the turbine shaft "MUST NOT" turn. Use a little force if necessary to check this.

CORRECTION: Replace overdrive carrier complete.
