AUTOMATIC TRANSMISSION SERVICE GROUP

SEMINARS 1990

TECHNICAL INFORMATION PACKAGE

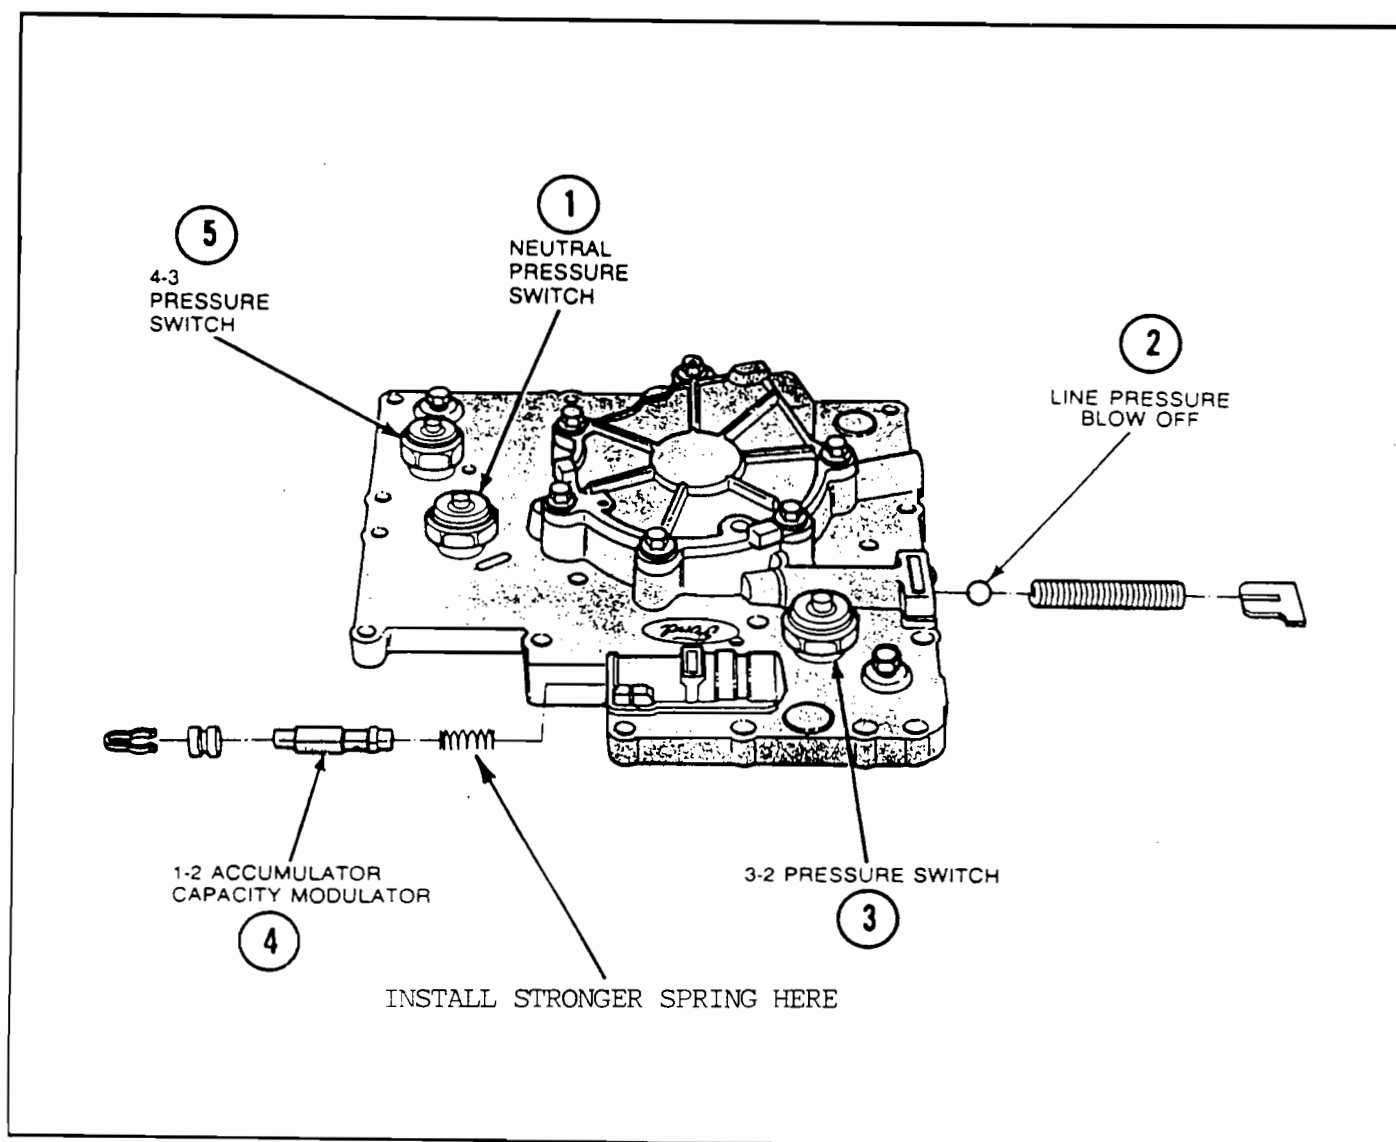
Figure 1

CAUSE: Fill time for intermediate clutch too slow.

CORRECTION: Install stronger spring on the 1-2 capacity modulator valve located in pump body (See Figure 1).
