# Technical Service Information

## THM 4L60 (700-R4)

### 3-2 COAST DOWN CLUNK (CORVETTE ONLY)

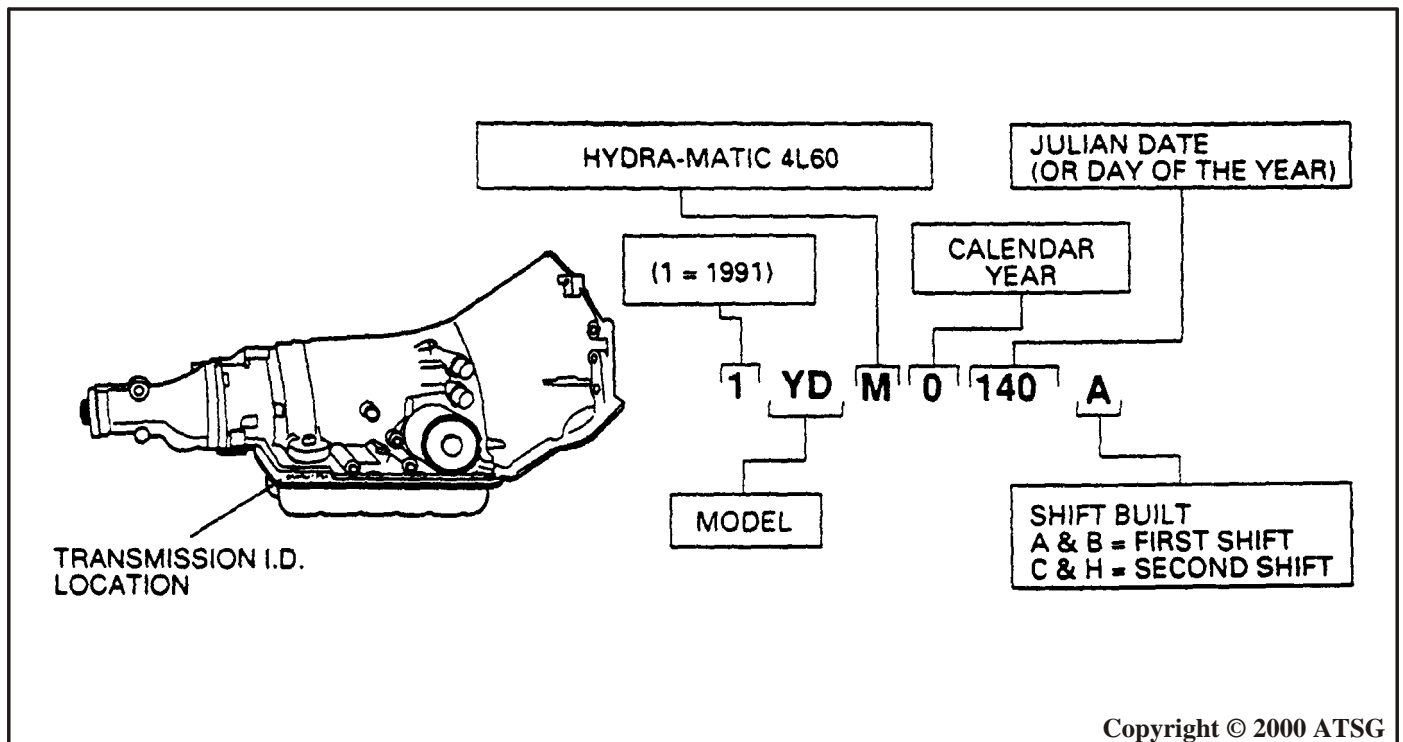
Figure 1

**COMPLAINT:** Some 1990 and 1991 Corvettes may experience a 3-2 coastdown clunk, and can be felt around 10-15 MPH while lightly braking to a stop. It is most noticeable in the D3 range, but can also occur in D4 range.

**CAUSE:** The cause may be, timing of the release of the 3-4 clutch and re-apply of the 2-4 band. A new conical 2-4 servo cushion assist spring has been released to alleviate this condition, along with enlarging the 3rd clutch exhaust hole in the spacer plate.

**CORRECTION:** (1) Install the new conical 2-4 servo cushion assist spring, OEM part number 8681195, inside of the current servo cushion spring with the small end towards the retainer, as shown in Figure 1.
