Technical Service Information

4T65-E

ERRATIC OR NO ISS SIGNAL WITH CODE P0716

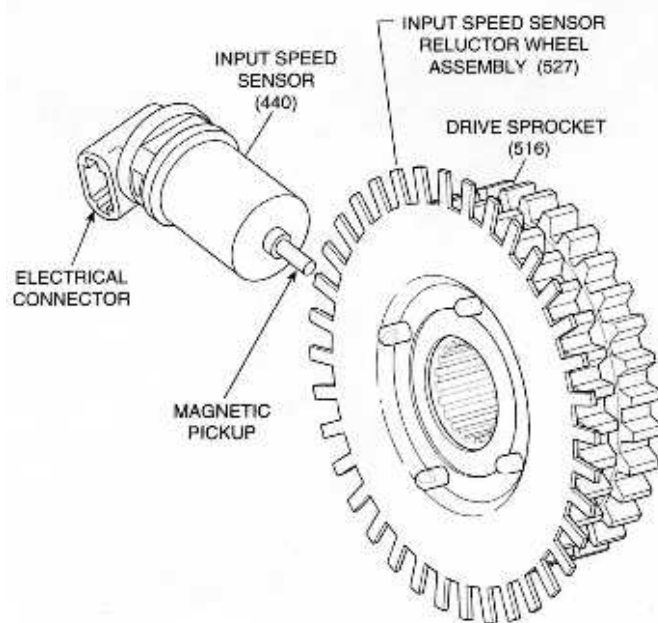
Figure 1

CAUSE: One cause may be that an incorrect Input Shaft Speed Sensor was installed into the vehicle. All General Motors applications utilize an AC Pulse Generator (Figure 1) while Volvo applications uses a two wire Hall Effect Sensor (Figure 2). Both will install into the channel plate and plug into the wire harness without incident. These speed sensors will not interchange.

Typically the AC Pulse Generator type can be quickly identified by the magnetic pole protruding off the tip of the sensor while the Hall Effect does not. Also, if the sensors are not defective the Hall Effect will NOT have any resistance values while the AC generator has a resistance of 893 to 1127 ohms.

The most common error is that the AC pulse generator is used in Volvo's instead of the Hall Effect as the AC pulse generator is less expensive than the Hall Effect.

CORRECTION: Install the correct ISS.

Volvo ISS Hall Effect Sensor.....	1275599
GM ISS AC Pulse Generator.....	10456509
