Technical Service Information

THM 4T80E **SLIPS IN FOURTH OR NO FOURTH**

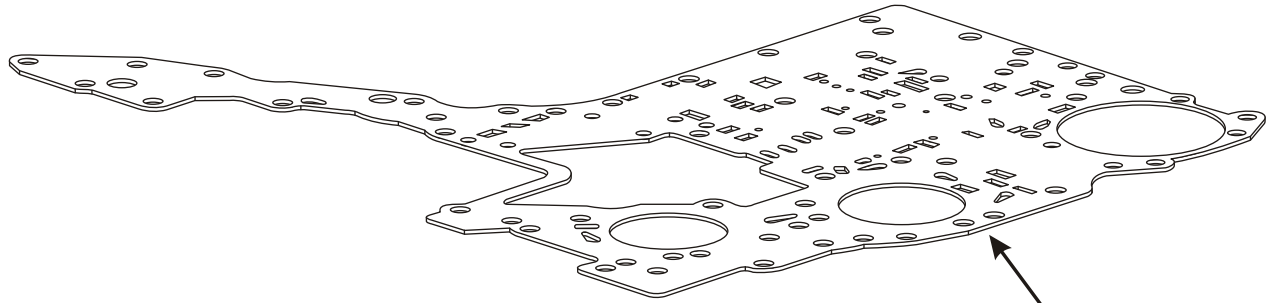
**LOWER CONTROL VALVE
BODY SPACER PLATE**

*Note: Gaskets Are Molded
To Spacer Plate*

REPLACE "ALL" ITEMS SHOWN

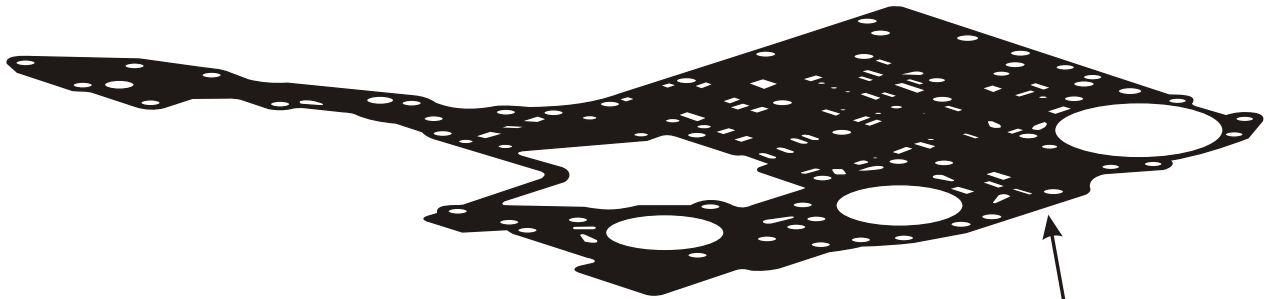
**LOWER CONTROL VALVE
BODY SPACER PLATE GASKET**

*Note: Gaskets Are Molded
To Spacer Plate*

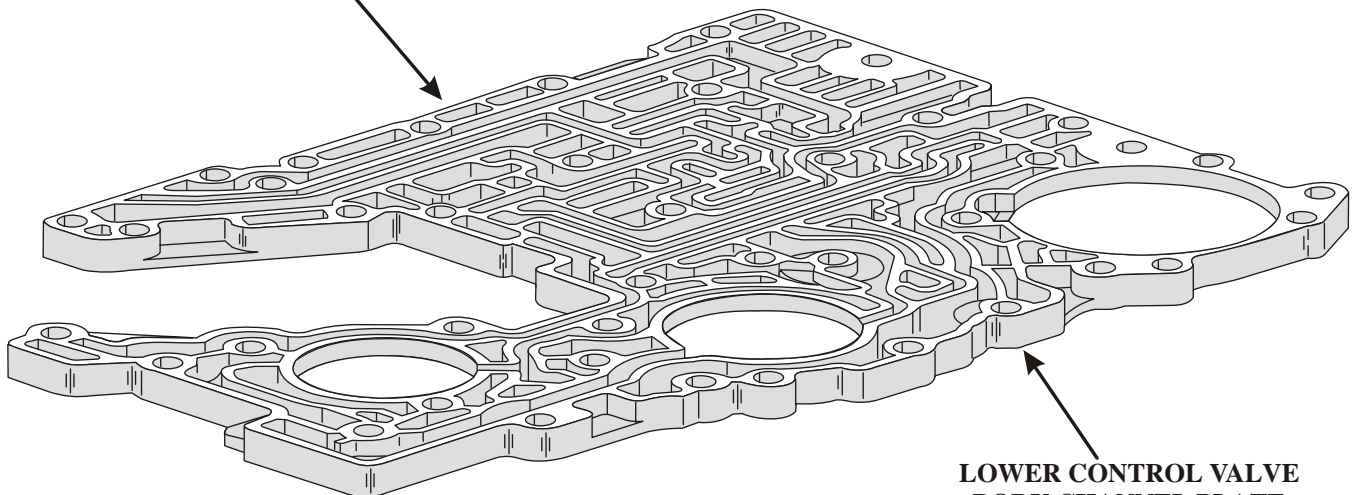
**LOWER CONTROL VALVE
BODY CHANNEL PLATE**

CAUSE: This complaint may be caused by a warped lower control valve body channel plate, shown in Figure 1. The warped channel plate creates a loss of fourth band apply pressure resulting in damage the fourth band and the reverse clutch housing.

**CHANNEL PLATE WARPS,
CHECK WITH STRAIGHT EDGE**

CORRECTION: Inspect the fourth band and the reverse clutch housing and replace them as necessary. Replace the lower control valve body channel plate, spacer plate and gasket, using the OEM part numbers shown below..
