## 4L60/65/70-E

### PRODUCTION CHANGES / INPUT SPEED SENSOR ADDED

## Technical Service Information

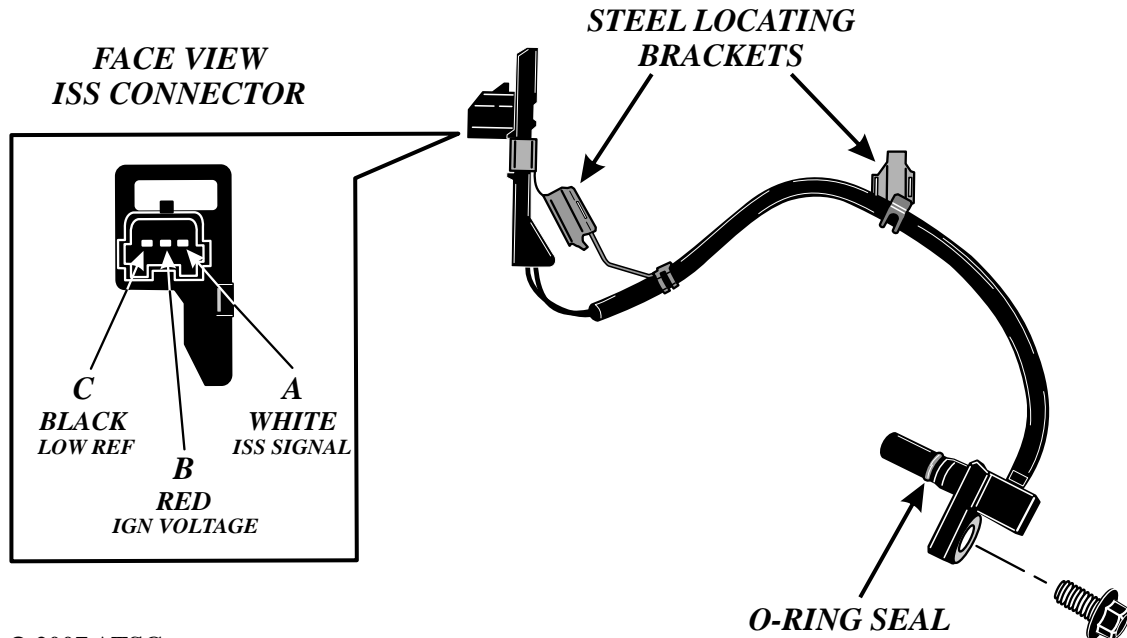
Figure 2

**Input Speed Sensor** - The ISS assembly as shown in figure 2, is internal to the transmission. Operation of the ISS should be thoroughly evaluated with a scan tool to monitor RPM prior to transmission removal for any repairs. Due to the ISS circuitry design with its internal integrated circuit (IC) chip, it is not beneficial to measure the internal resistance and therefore no internal resistance values have been made available. Improper converter clutch operation or possible converter drain back concerns may be caused if the o-ring seal is damaged or omitted when servicing the ISS. The steel locating brackets are necessary to keep the ISS wiring from coming in contact with the rotating reverse input clutch housing. These brackets push fit on to aluminum bosses that are cast into the oil pump cover.  
At the time of this printing, the OEM part number for the ISS assembly is **24237866**.

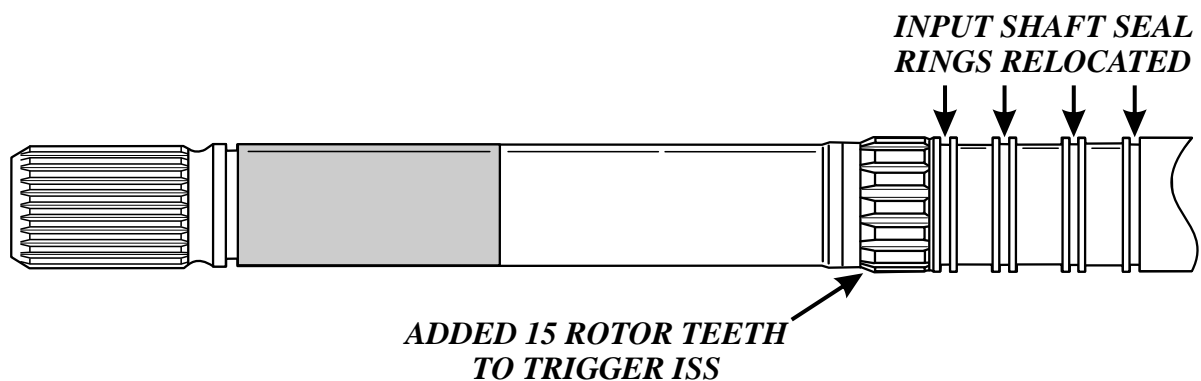
Figure 3

**Turbine Input Shaft** - The turbine input shaft as shown in figure 3 now has 15 rotor teeth added to trigger the ISS. The oil seal ring grooves have been relocated inboard towards the rear of the unit approximately 0.190”(in.) when compared to the previous design. Some pre ISS model turbine input shafts may have the rotor teeth machined in place and some may not. This was a manufacturing option. For this reason, great care must be taken when replacing the input clutch housing and turbine shaft assembly. A measurement from the front most oil seal ring groove to the base of the input shaft where it is pressed into the clutch housing must be taken and compared to the replacement component to ensure compatibility or transmission failure will be the result.

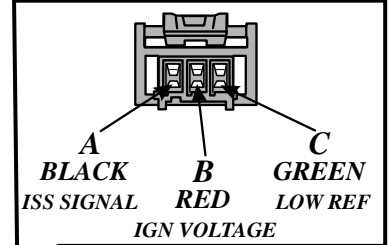
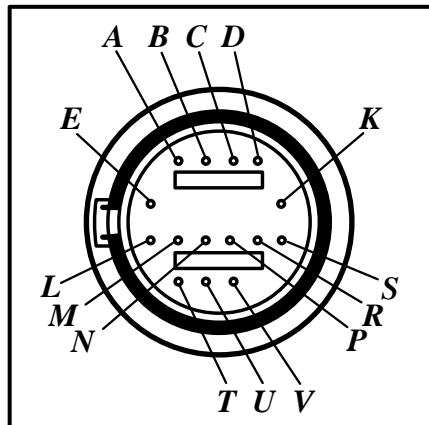
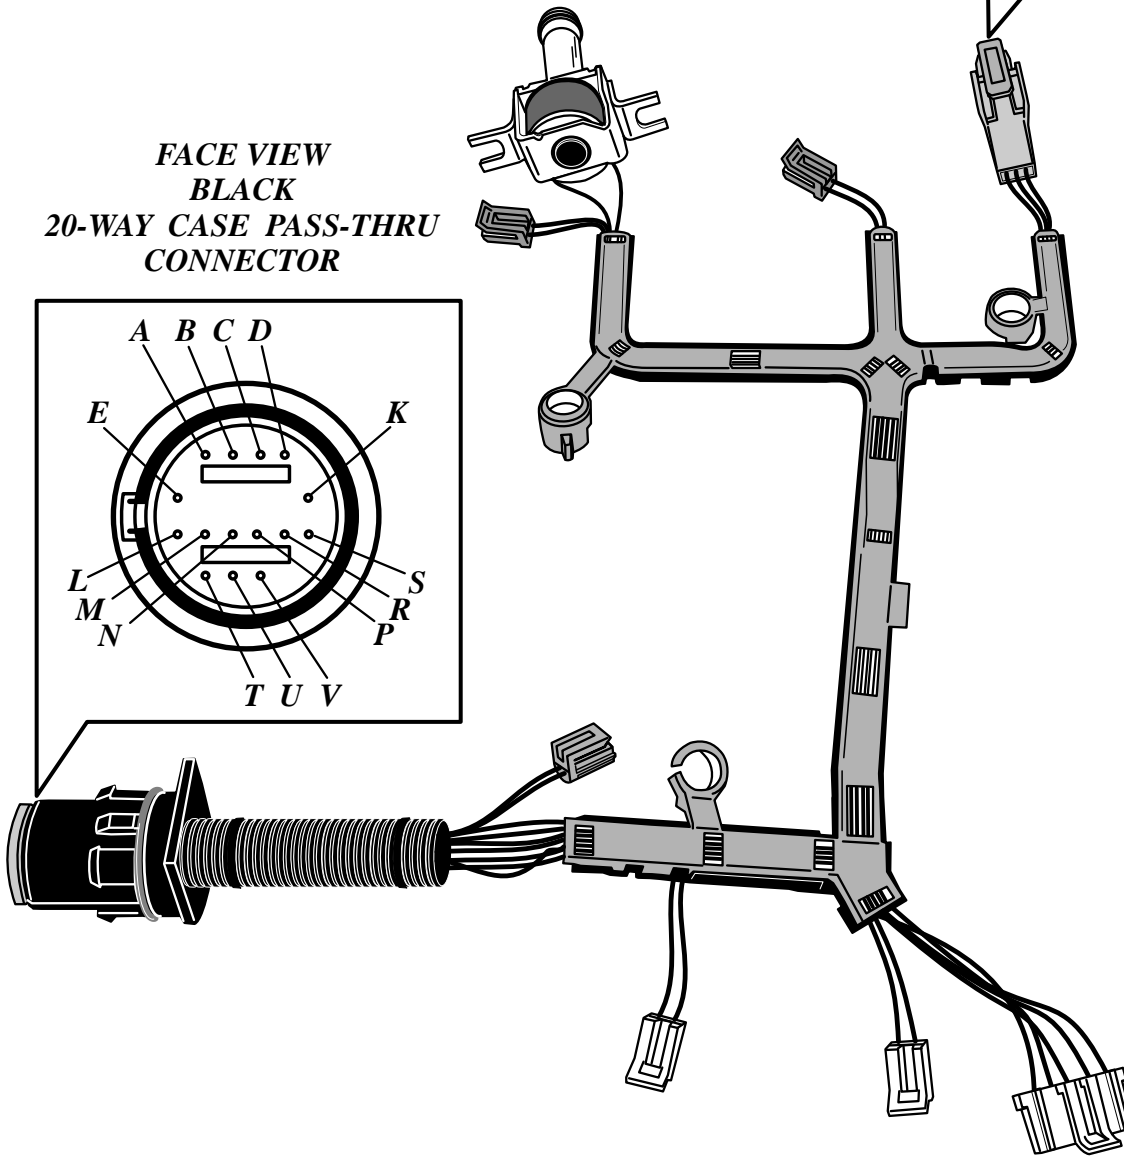
Figure 4

**Internal Wire Harness** - The internal wiring harness as shown in figure 4 contains additional circuits for ISS equipped transmissions and can be easily identified by the black 20-way pass-thru connector. Non ISS transmissions use the previous design harness which has a light grey connector. The ISS circuit shares pin position E (Ckt 839) for ignition feed voltage. This is a pre existing circuit and is spliced internally to supply power to the ISS. The additional pin terminals are K (Ckt 1230) for ISS signal and also V (Ckt 1231) for low reference.

At the time of this printing, the OEM part number for the new internal wire harness for ISS equipped transmissions is **24234121**.

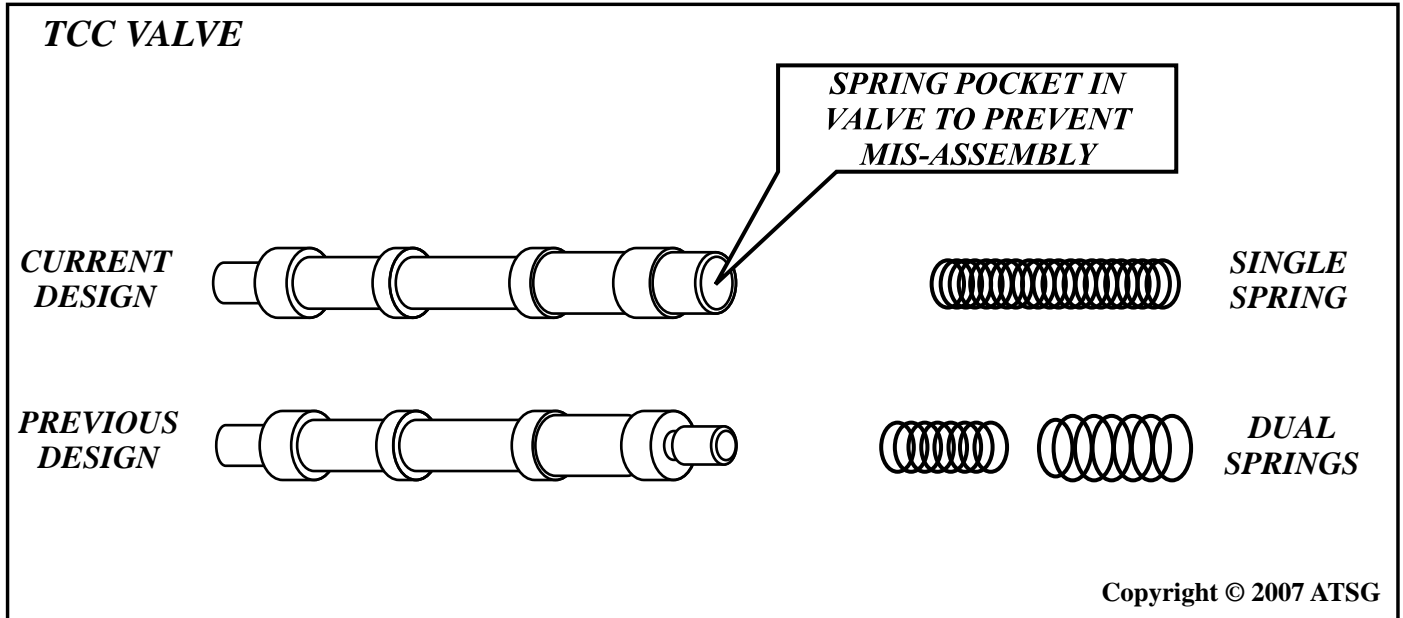
Figure 5

- CHANGE:** (1) Effective February 1st, 2005, the oil pump cover now uses a new design TCC valve with a single spring. (See figure 5)
- REASON:** Simplifies the assembly process, eliminates the possibility of springs becoming bound or bent and reduces material cost.

**TCC Valve** - The new design TCC valve uses a single spring and is shown along with the previous design level valve with dual springs in figure 5. The new valve incorporates a spring pocket to prevent incorrect installation by only allowing the spring to be assembled into the pocket end of the valve. Components of the previous and current designs may not be intermixed. However, the current design TCC valve and spring can be used to back service the previous design level.

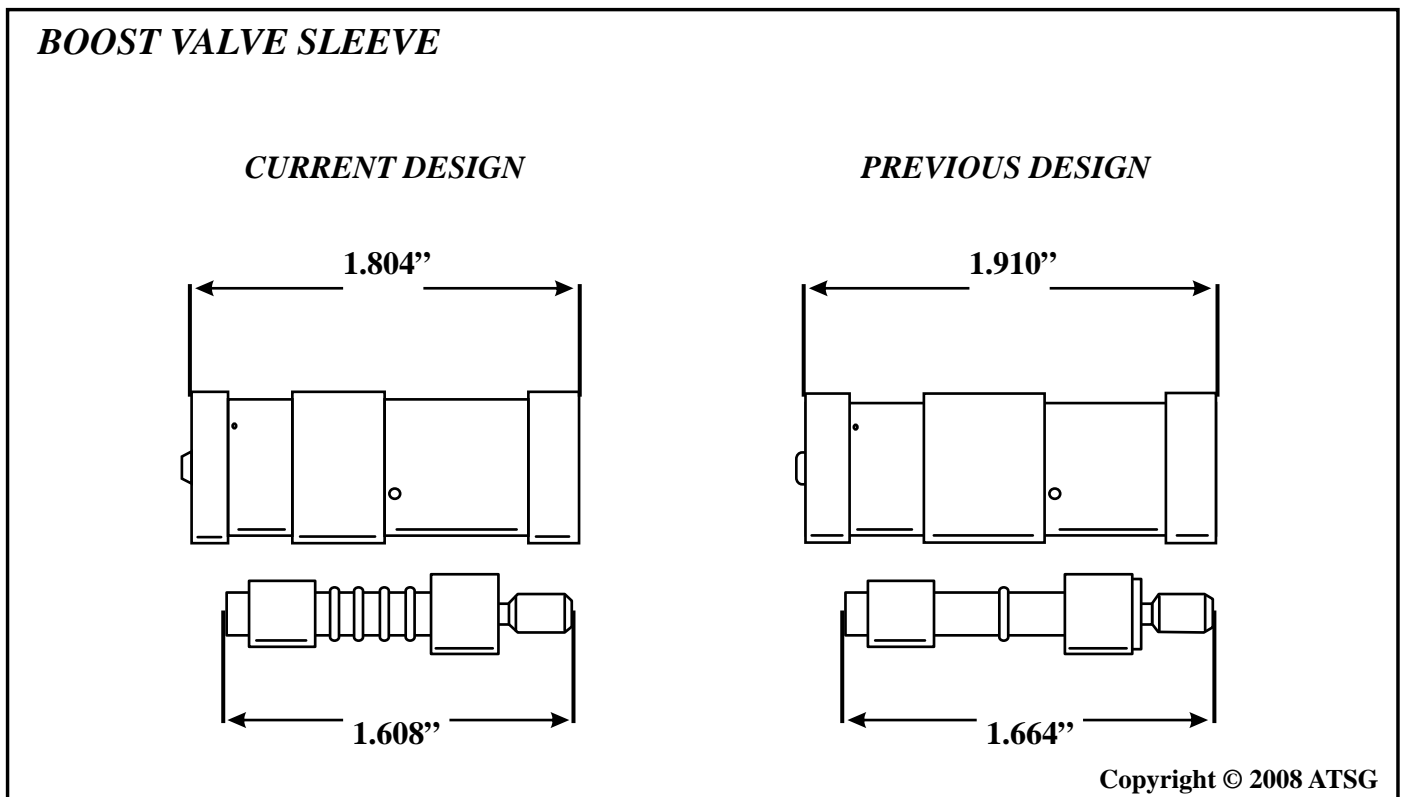
Figure 6

- CHANGE:** (2) Effective March 7th, 2005, the oil pump cover now uses a more compact boost valve and sleeve. (See figure 6) The snap ring groove location for the boost sleeve is now situated 2.57"(in.) from the bottom of the bore compared to 2.68"(in.) for the previous design. (Refer to figure 7) The bore length for the boost sleeve and snap ring has been reduced by 0.106"( in.).

**Boost Valve and Sleeve** - The boost sleeve as shown in figure 6 and its corresponding valve have been made shorter in overall length. No components of the current and previous designs may be intermixed, nor interchanged together as an assembly in place of the other. There are two versions of the current design boost valve and sleeve assembly with different valve land dimensions for standard and high performance use. The pressure regulator valve, pressure regulator valve spring and pressure regulator isolator spring remain the same as the previous design.

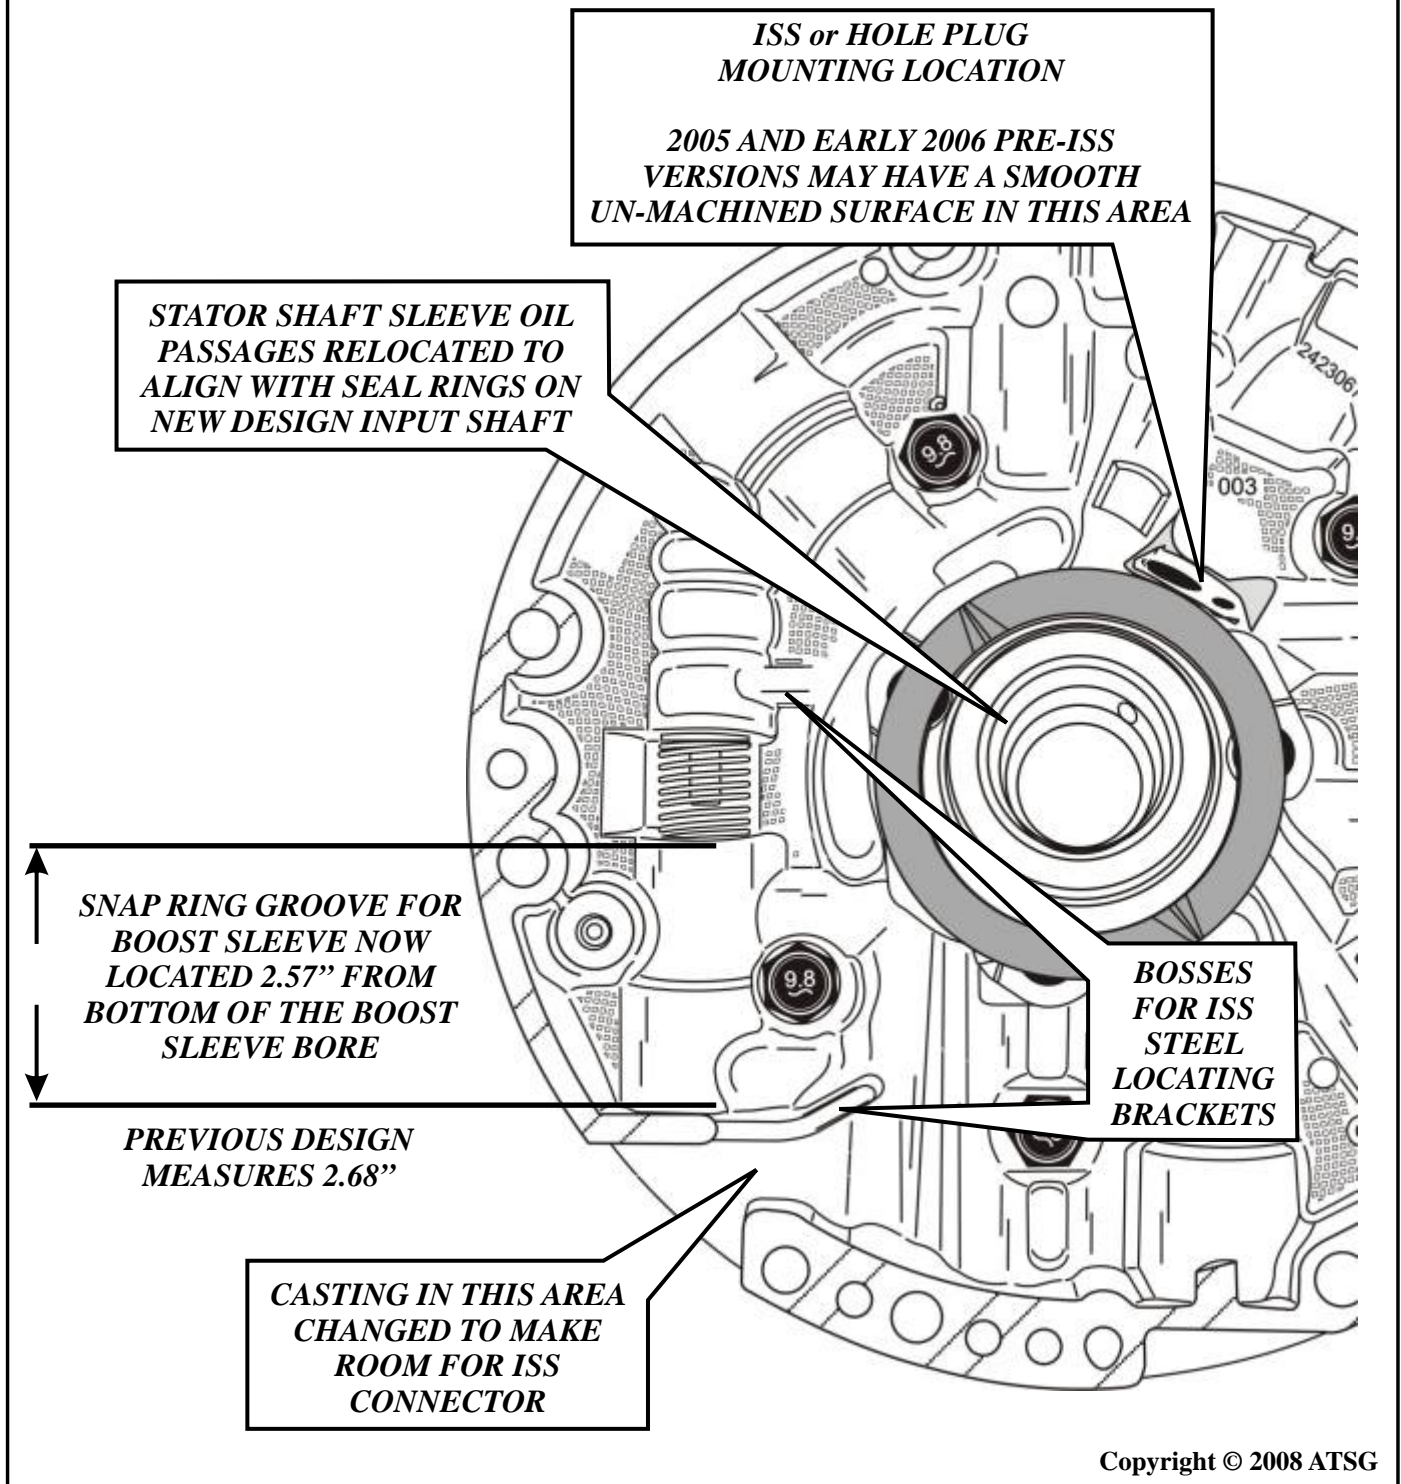
Figure 7

- REASON:** Necessary in order to prepare for the new input speed sensor (ISS) assembly that will be packaged into the pump cover.
- CHANGE:** (3) After July 16th, 2005, the pump cover casting was modified in order to situate the ISS connector. This modification removed metal directly below the PR valve and boost sleeve bore and extended a cast wall inward. The internal TCC release passage was also modified at this time. The ISS mounting holes are not yet machined into the oil pump cover. (This is shown in figure 7 also )

**Oil Pump Cover** - An outline of the oil pump cover and stator shaft changes can be seen in figure 7. Great care must be taken if the oil pump cover and/or stator shaft are to be replaced. This is due to the many changes in the oil pump cover casting and corresponding stator shaft sleeve oil passages. These pieces must be compatible with the turbine input shaft being used or transmission failure will be the result.

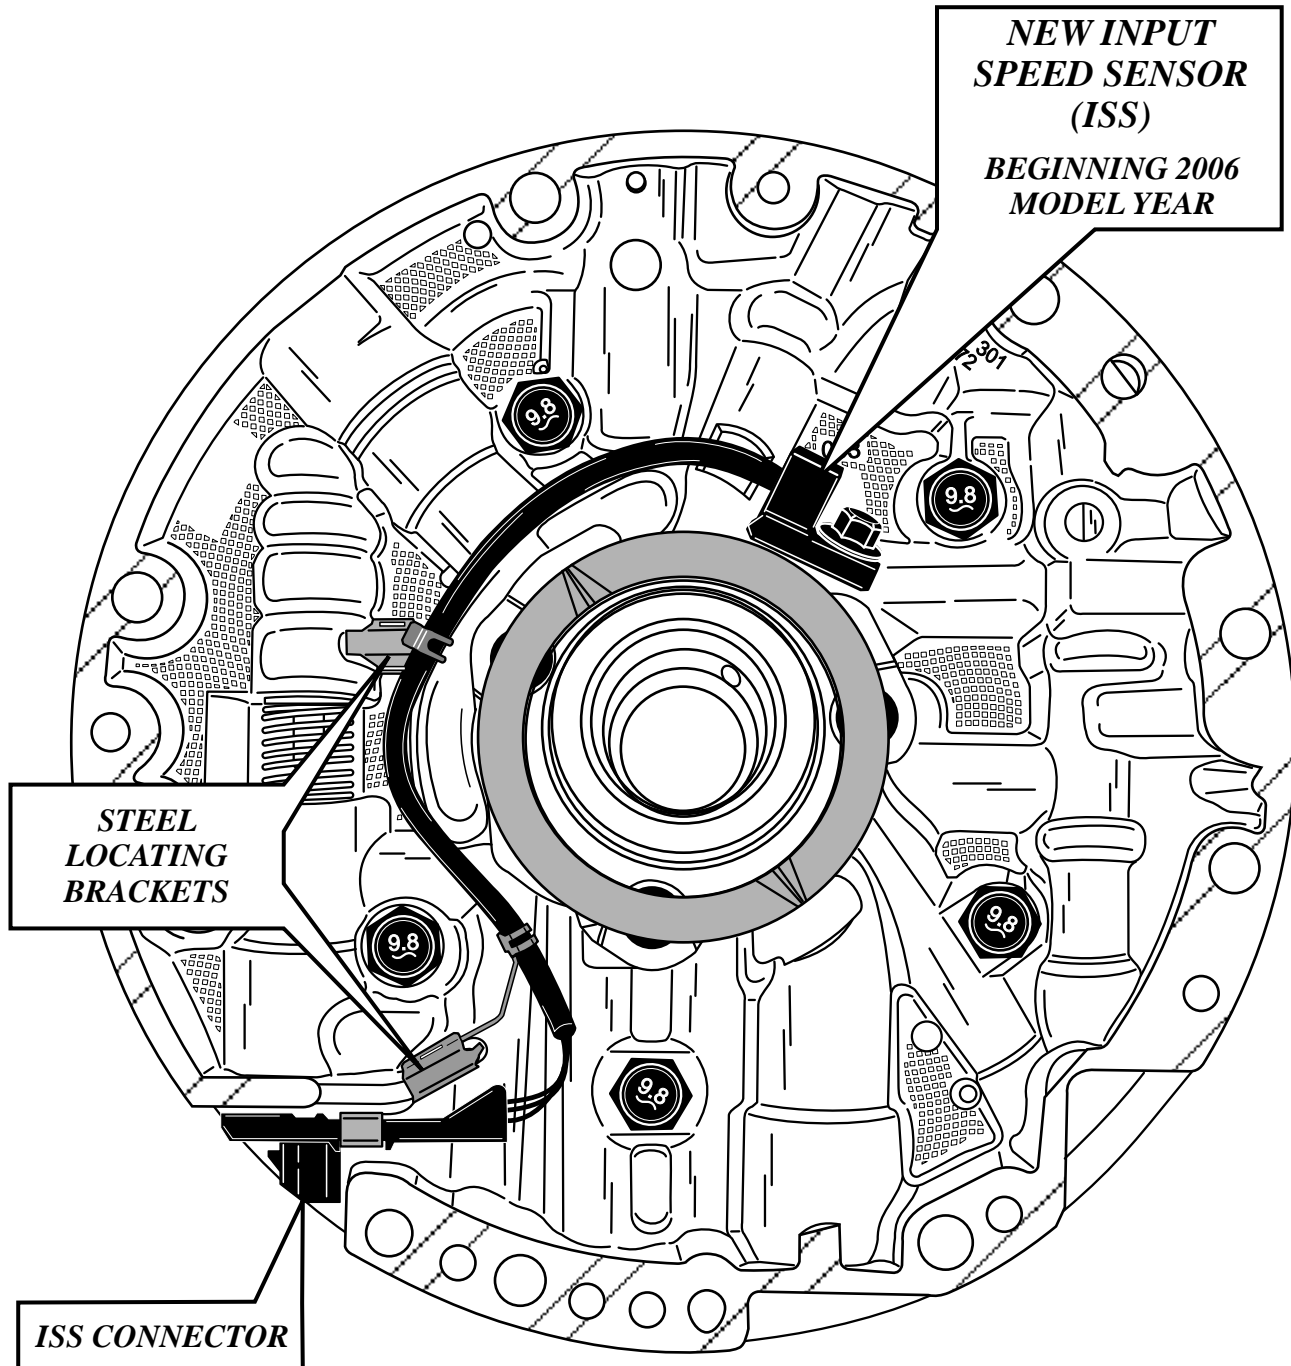
Figure 8

The boost sleeve and pressure regulator valve can not be serviced from the sump area on units equipped with an ISS because of the location of the ISS connector as shown in figure 8. This operation will require removal of the transmission and oil pump assembly. Pre ISS or non ISS models equipped with an ISS hole plug as seen in figure 9 will still allow access to the boost valve sleeve and pressure regulator valve from the sump. If the o-ring is damaged or omitted from the ISS hole plug then improper converter clutch operation or converter drain back concerns may be evident. Failure to install the ISS hole plug if required will result in low or no converter charge and no movement.

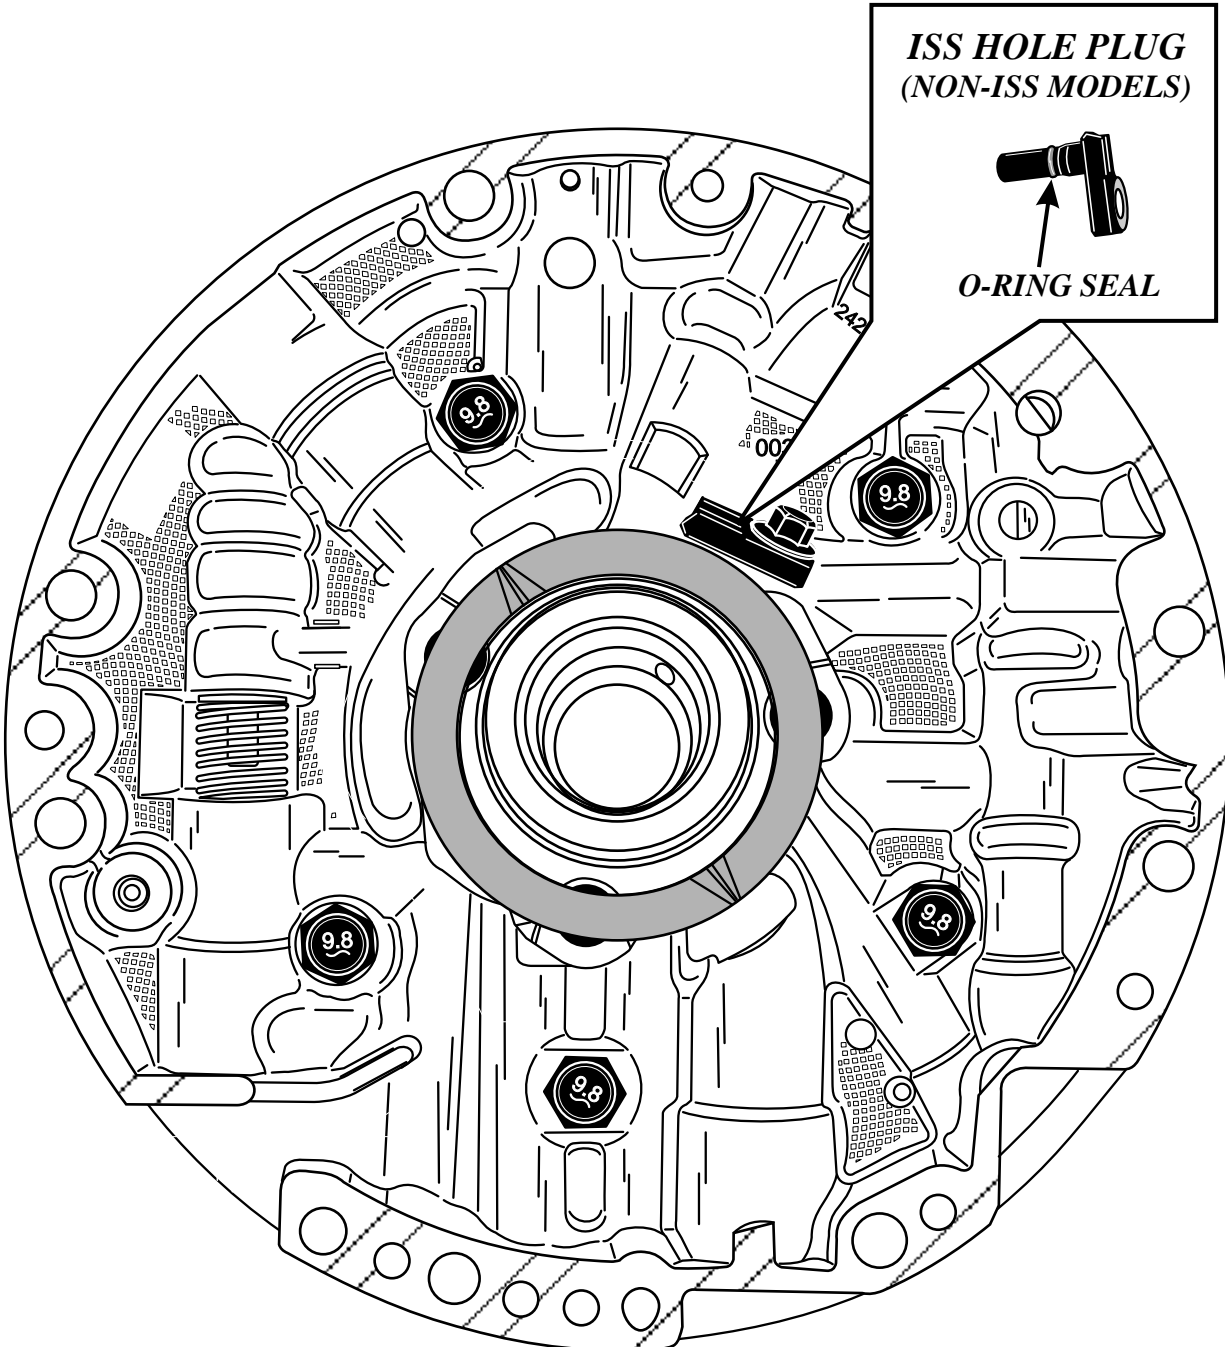
Figure 9

- CHANGE:** Oil pump cover changes also affected the stator shaft and stator shaft sleeve so as to relocate with oil passages within the oil pump cover.  
At the same time, the turbine shaft oil seal ring grooves were moved inboard towards the rear of the unit approximately 0.190”(in.) to create an area to manufacture 15 rotor teeth.
- REASON:** To correlate with changes in the stator shaft and sleeve assembly.
- CHANGE:** (4) Late in 2005 and early in the 2006 model year, some pre ISS models may still not have the ISS mounting holes machined into the cover. This will be evident as a smooth un-machined surface without the ISS mounting holes. As ISS models were introduced, the machining took place and the input speed sensor (ISS) was added. (See figure 8)  
For non ISS models, an ISS hole plug will be used in place of the ISS assembly.  
(See figure 9)
