# Technical Service Information

## **VOLVO "850" 50-42LE SLIPPING OR "NO" FORWARD ENGAGEMENT**

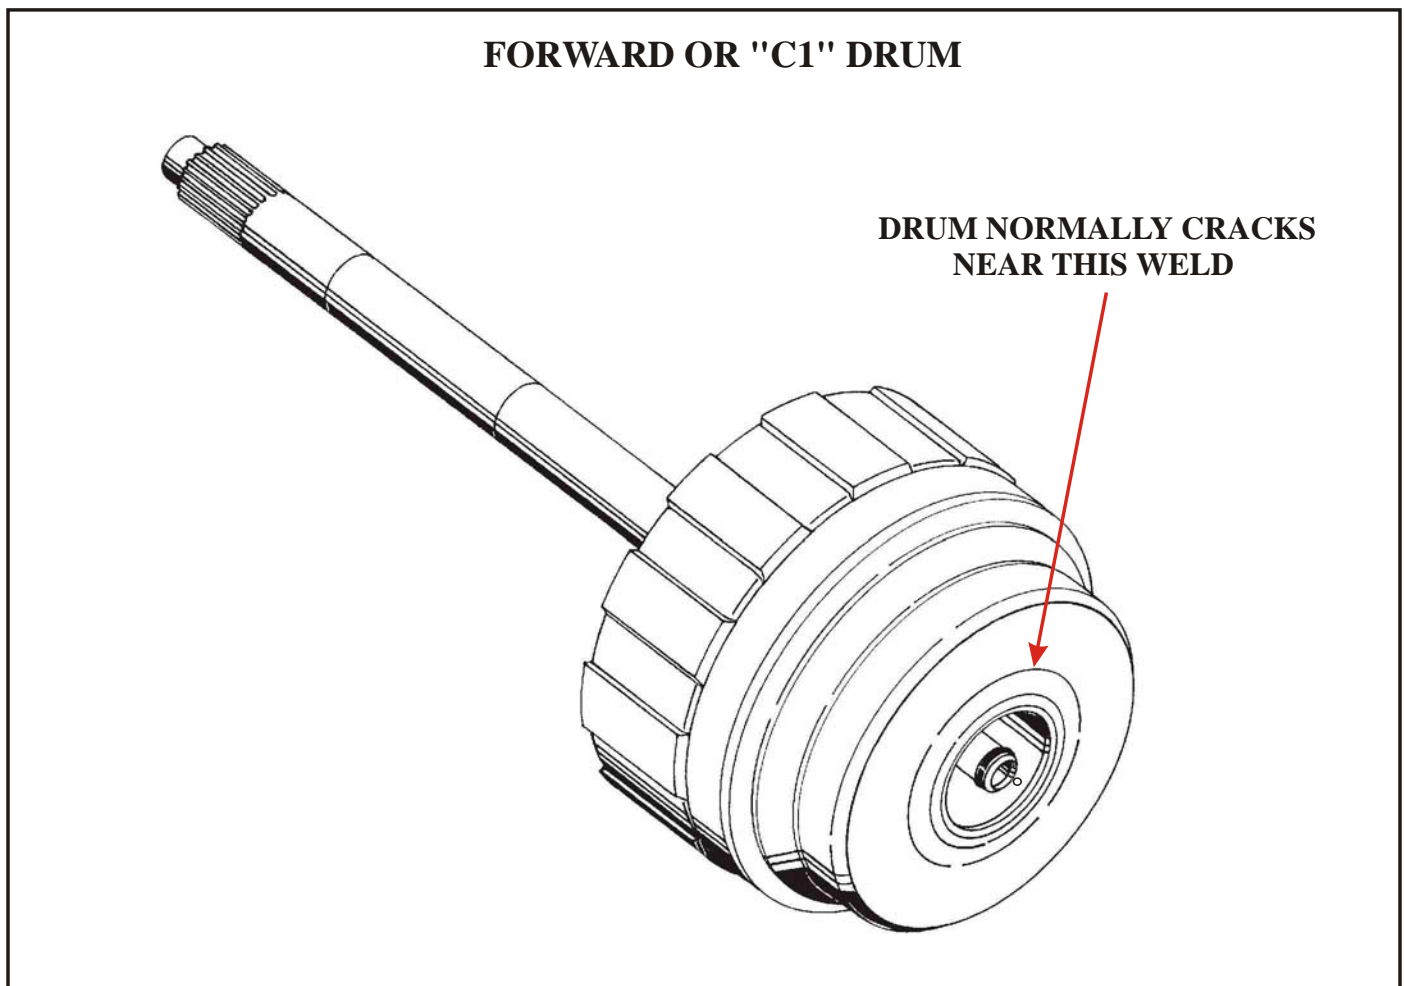
**COMPLAINT:** Volvo "850" series equipped with 50-42LE transmissions may exhibit a slipping or "NO" forward engagement condition.

**CAUSE:** The cause may be, the forward or C1 clutch drum is cracked (See Figure 1).

**CORRECTION:** Locate the crack as shown in Figure 1 and have the drum welded on the inside as well as the outside of the drum. At the time of this printing, the forward or C1 drum is not sold separately from the transmission.
