Technical Service Information

AUDI 4000/5000 SERIES LATE AND/OR NO UPSHIFTS "COLD ONLY"

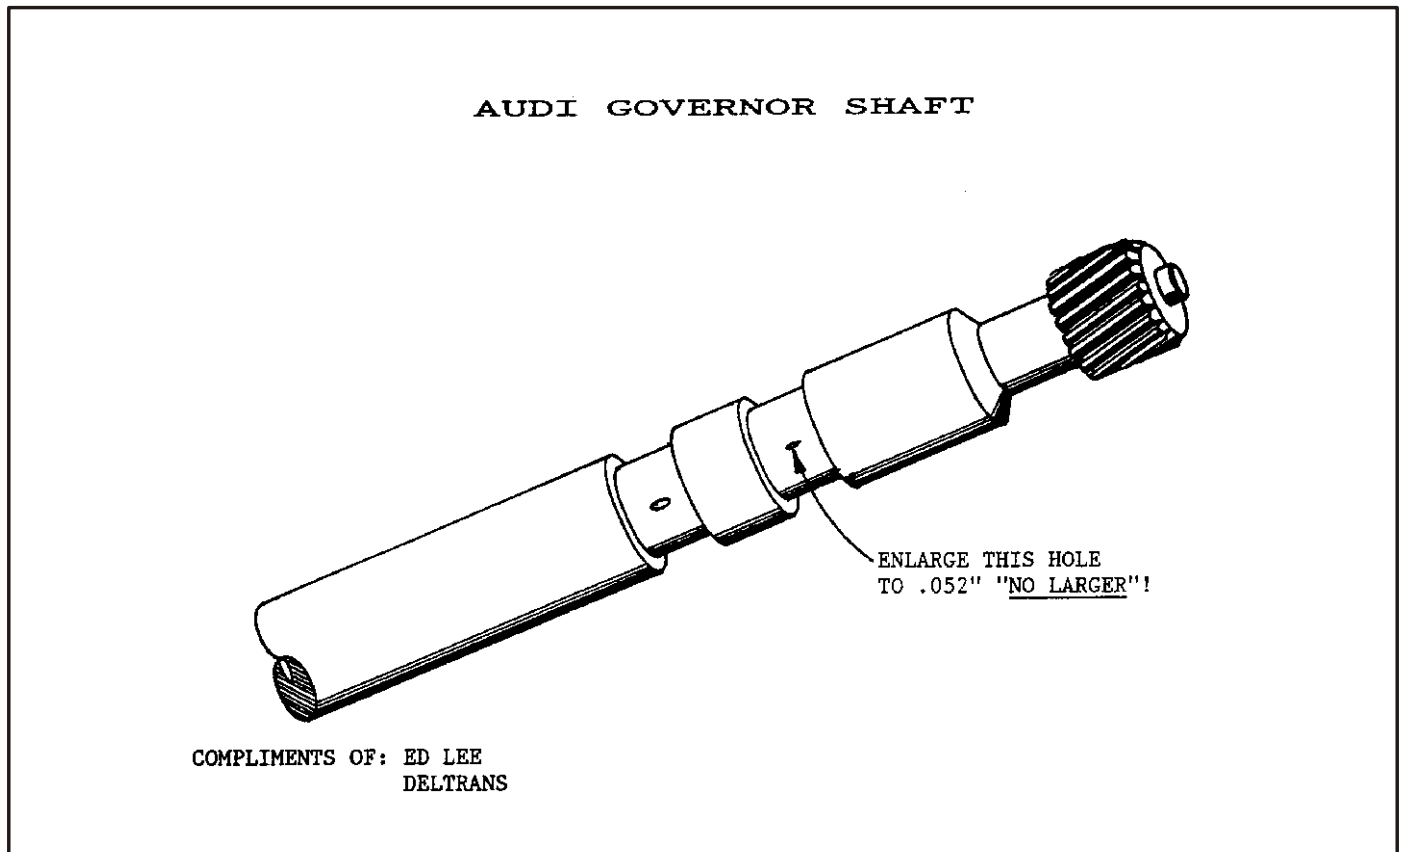
Figure 1

- COMPLAINT:** Some Audi 4000-5000 series vehicles may experience late upshifts and/or no upshifts "COLD ONLY". After the transmission fluid is warm, the transmission shifts properly for the rest of the day.
- CAUSE:** If all other possibilities have been eliminated, the cause may be not enough drive oil being fed to the governor. The volume of COLD oil that can get through the governor shaft orifice may not be sufficient to return governor pressure to the shift valves in the valve body.
- CORRECTION:** Enlarge the small governor shaft feed hole from the present size to .052", "NO LARGER". The governor feed hole is the one that is closest to the governor gear, as shown in Figure 1. The difference in size is very minimal and not much material will be removed from the governor shaft. Be certain to clean all material from governor and the governor shaft after this procedure.
