SATURN TAAT

DELAY IN "D" AND / OR BIND IN REVERSE

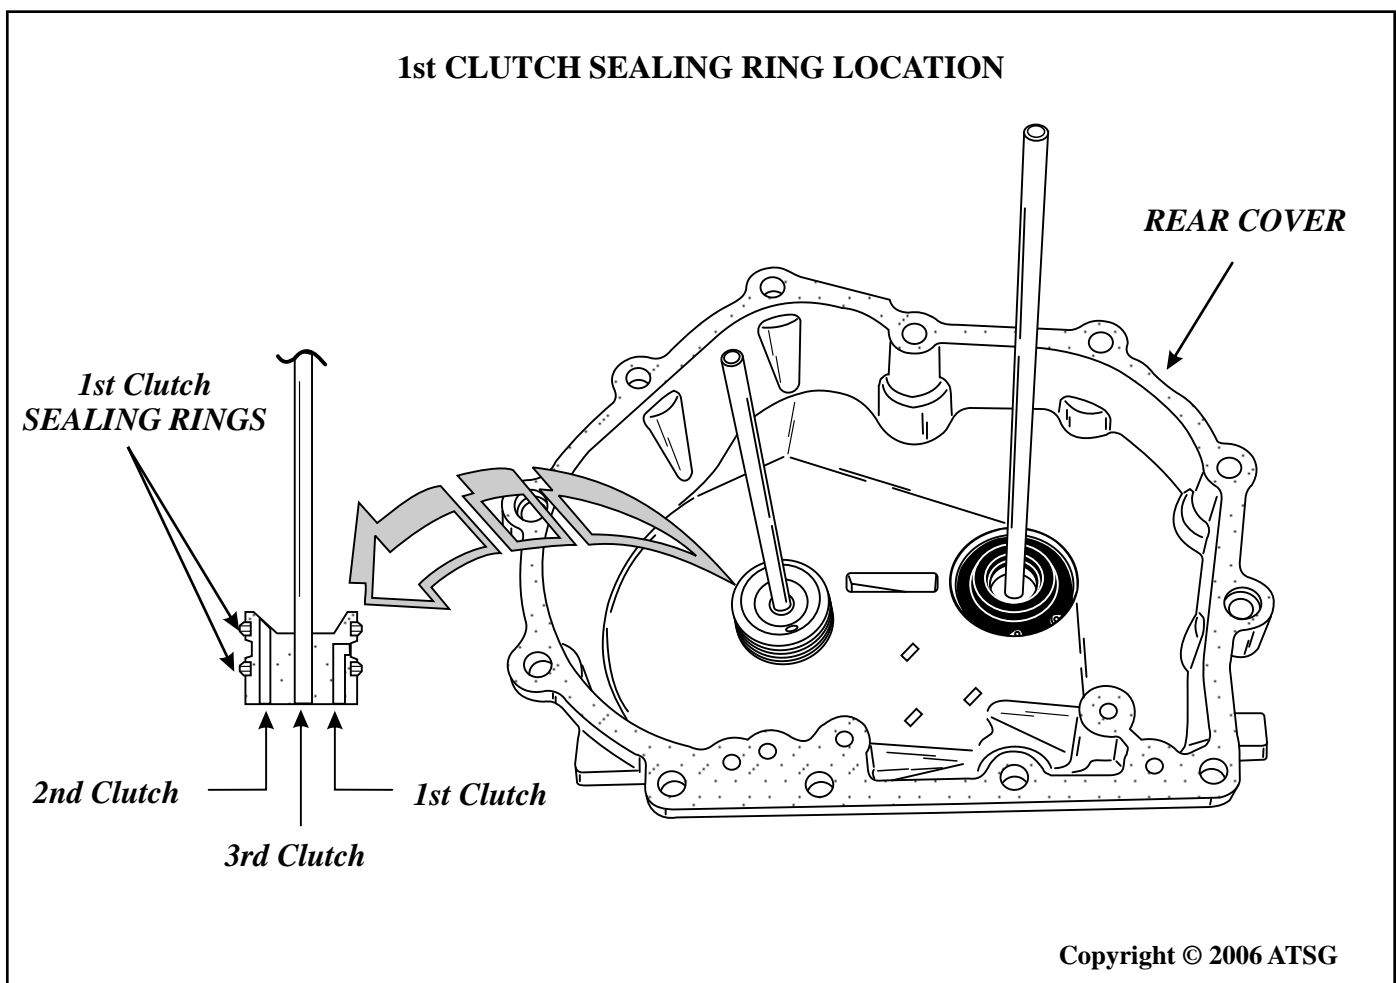
Figure 1

CAUSE: The cause may be, shrunken or damaged 1st Clutch sealing rings, as shown in Figure 1. When these rings leak they can cause a slow fill of the 1st Clutch, which results in a delayed engagement in "D." The first sealing ring also separates the 2nd clutch from the 1st Clutch. When this ring leaks while in the Reverse range, the 1st Clutch can now be applied with 2nd clutch pressure, which results in a bind-up. See Figure 2 for a cross-sectional view of the Main shaft.

CORRECTION: Replace the 1st Clutch sealing rings as part of every overhaul.

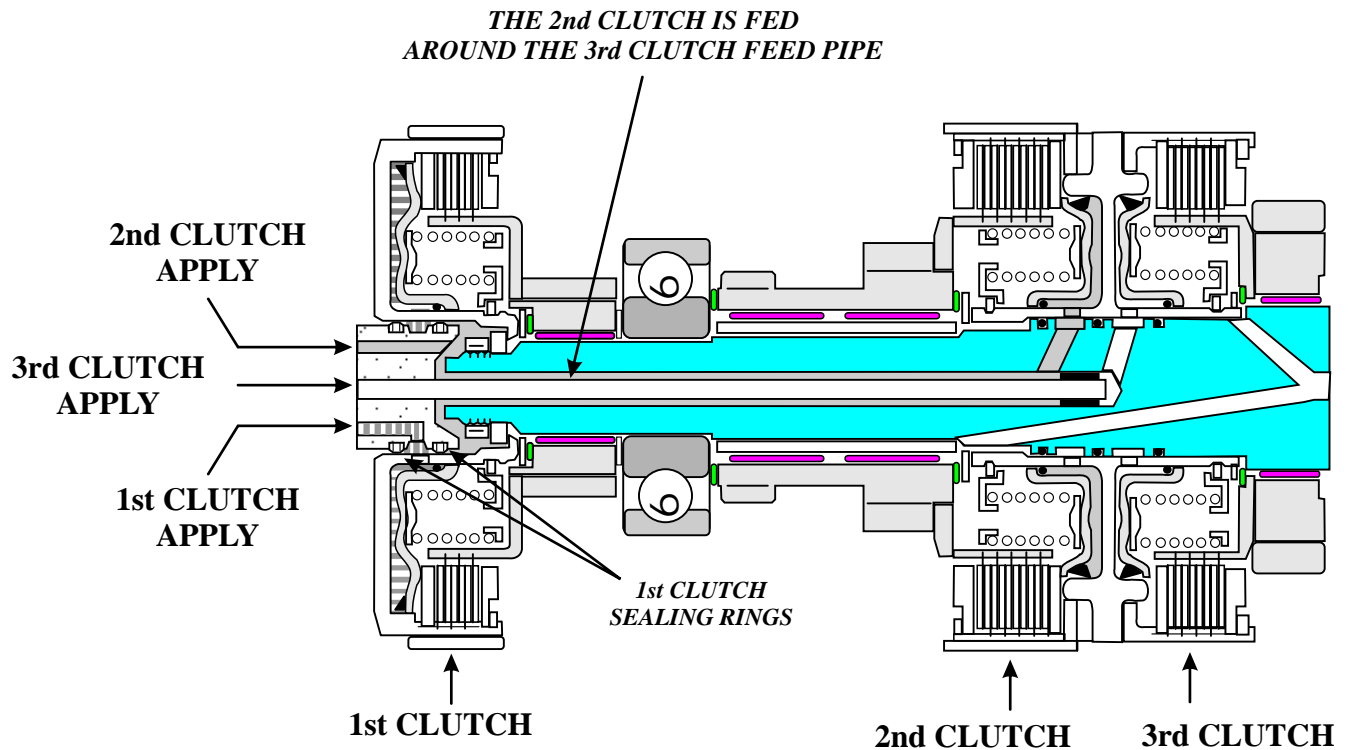
Figure 2

Summary: When the 2nd Clutch is applied in Reverse, shrunk 1st Clutch sealing rings may allow the 1st Clutch to be applied at the same time, causing a bind-up
