FORD ATX HARSH 2-3 UPSHIFT

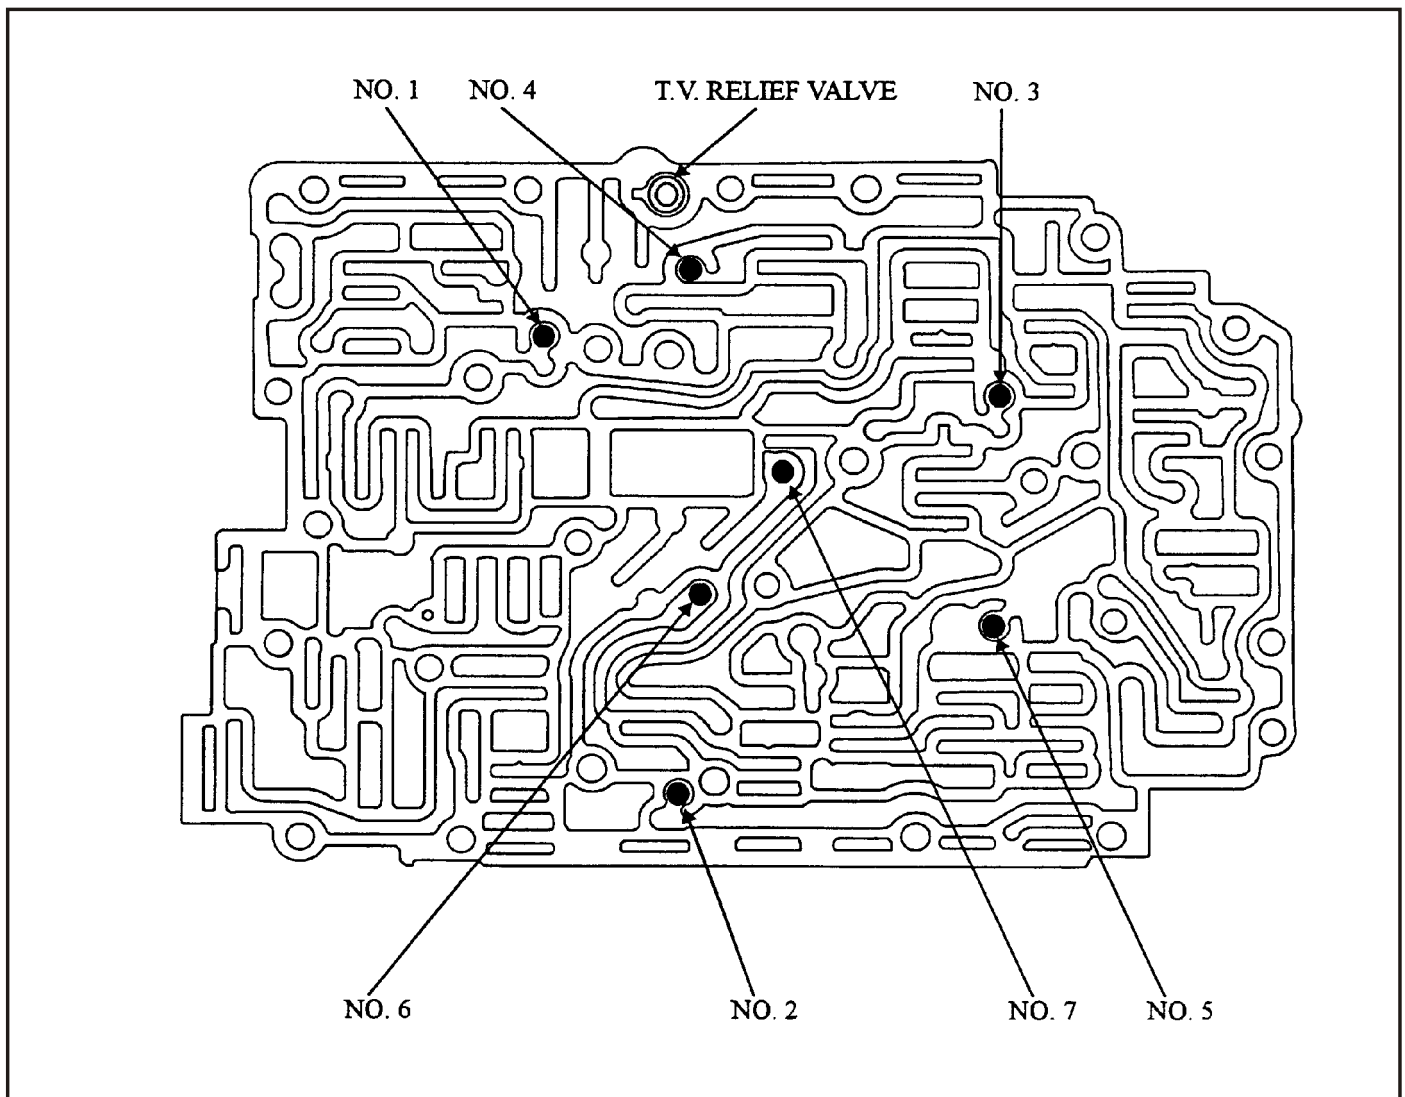
The number of main control check balls and their locations for the ATX transaxle as published in the 1989 Tempo/Topaz-Escort Car Shop Manual, Section 17-25-82 is incorrect. The correct number of main control check balls for the 1.9L ATX transaxle is seven (7) not six (6)(See Figure 1). Failure to install the seventh check ball will cause a harsh 2-3 upshift.

ACTION: When servicing the ATX transaxle main control make sure that all seven (7) check balls are installed. Refer to Figure 1 for the correct location of the main control check balls.
