Technical Service Information

FORD AXOD

SHUDDER ON 1-2 UP SHIFT DELAYED OR HARSH UP SHIFTS

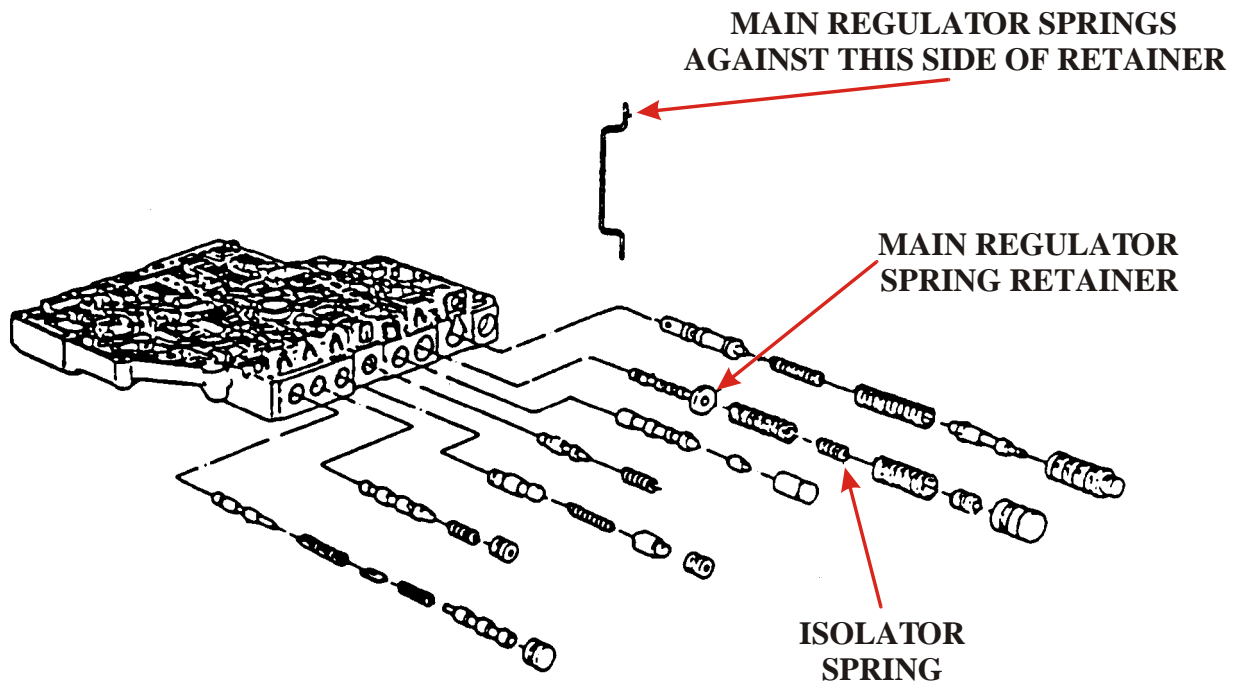
Figure 1

COMPLAINT: NO. 1. A "Shudder" during a 1-2 upshift at moderate to heavy throttle after cleaning the valve body. The transmission will perform normally at light throttle openings.

NO. 2. Delayed and/or harsh upshifts after cleaning the valve body.

CAUSE: NO. 1. A "Shudder" during a 1-2 upshift will occur if the main pressure regulator "Isolator" spring is not installed after cleaning the valve body (See Figure 1). This is caused by fluctuations in main line pressure at the time of the 1-2 shift.

NO. 2. Harsh and/or delayed upshifts can be caused by the pressure regulator spring retainer being installed backwards. This will create high main line pressure (See Figure 1).

CORRECTION: NO. 1. Insure that all three (3) pressure regulator springs are re-installed in the valve body regulator bore (See Figure 1).

1. Main Pressure Regulator Spring (Largest Diameter).
2. Main Regulator Boost Spring (Medium Diameter).
3. Main Regulator Isolator Spring (Smallest Diameter).

NO. 2. Insure that the main regulator spring retainer is installed in the proper direction (See Figure 1). The retainer is very similar to the one used in the AOD valve body, but is installed in the opposite direction of the AOD.
