# Technical Service Information

## FORD ATX

### 2-3 SHUDDER

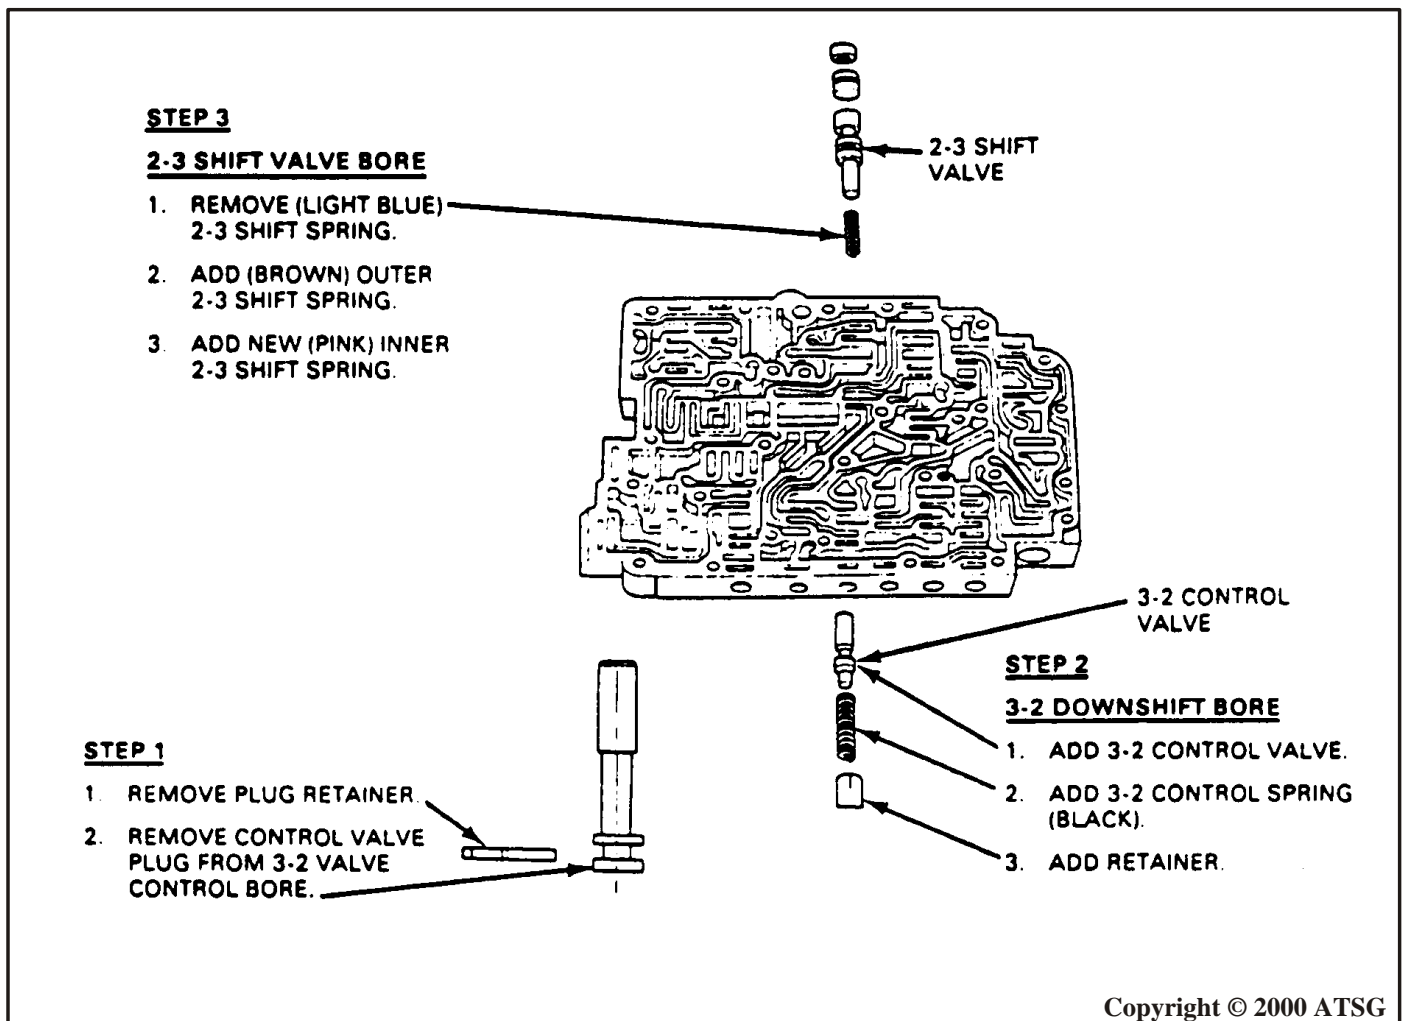
Figure1

**COMPLAINT:** A low speed shudder and/or boom while driving in third gear.

**CAUSE:** The cause may be shift point variances in the 2-3 upshift and the 3-2 downshift pattern.

**CORRECTION:** Install a new design main control service kit, OEM part number E6F'Z-7A230-A, that revises the part throttle 2-3 upshift and 3-2 downshift pattern. Refer to the following procedure.

1. Remove and discard the 3-2 control valve plug and retainer. (See Figure 1)
2. Install the new 3-2 control valve, control valve spring, and flat plate retainer from the main control service kit. (See Figure 1).
3. Replace the 2-3 shift valve spring with the two spring "Nested" assembly from the main control service kit (See Figure 1).
