# Technical Service Information

## **FORD AX4N** **ACCUMULATOR SPRING IDENTIFICATION**

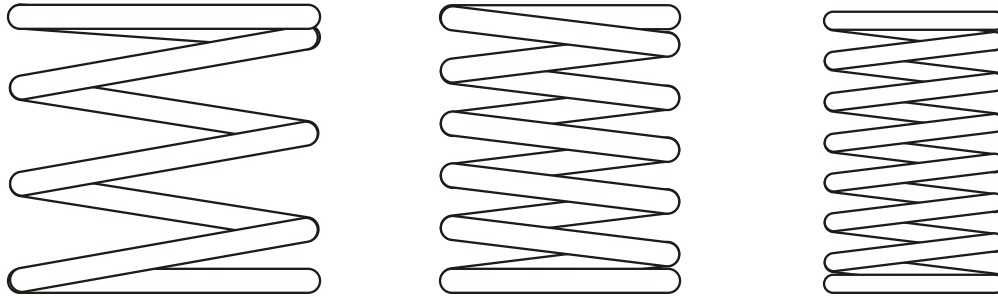
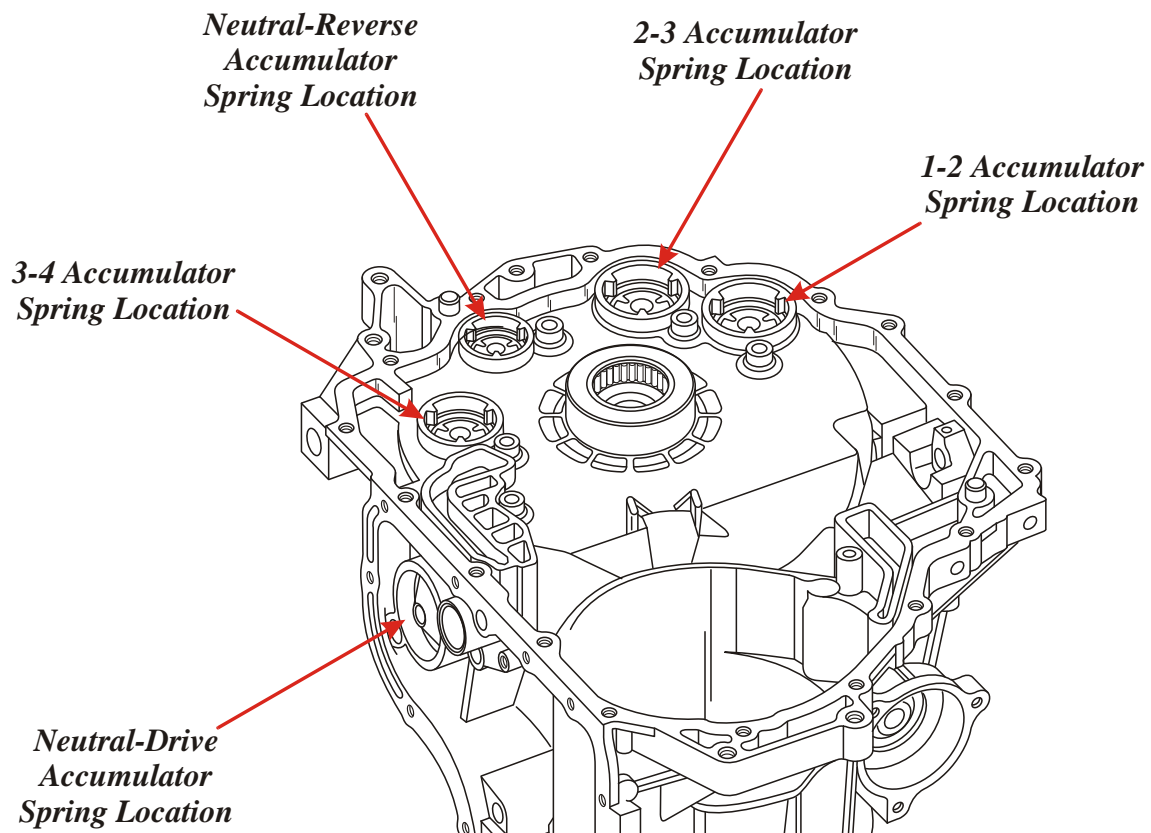
**COMPLAINT:** Shift quality complaints of various types, mostly harsh shift complaints, after the transmission has been overhauled.

**CAUSE:** The accumulator springs may have been installed in incorrect positions, or the accumulator piston shafts are scored or worn and are interfering with proper accumulator piston movement. It is also important to insure that multiple accumulator spring applications must have the springs wound in opposite directions of each other to avoid coil bind, as shown in Figure 1.

**SPRINGS ARE WOUND OPPOSITE OF EACH OTHER TO AVOID COIL BIND**

**CORRECTION:** Ensure that the accumulator springs have been installed in their proper locations. Refer to Figure 2 for accumulator spring identification and Figure 1 for position. We have also provided you with the accumulator spring specifications in Figure 3.
