# Technical Service Information

## **FORD AODE/4R70W LINE PRESSURE INSTABILITY**

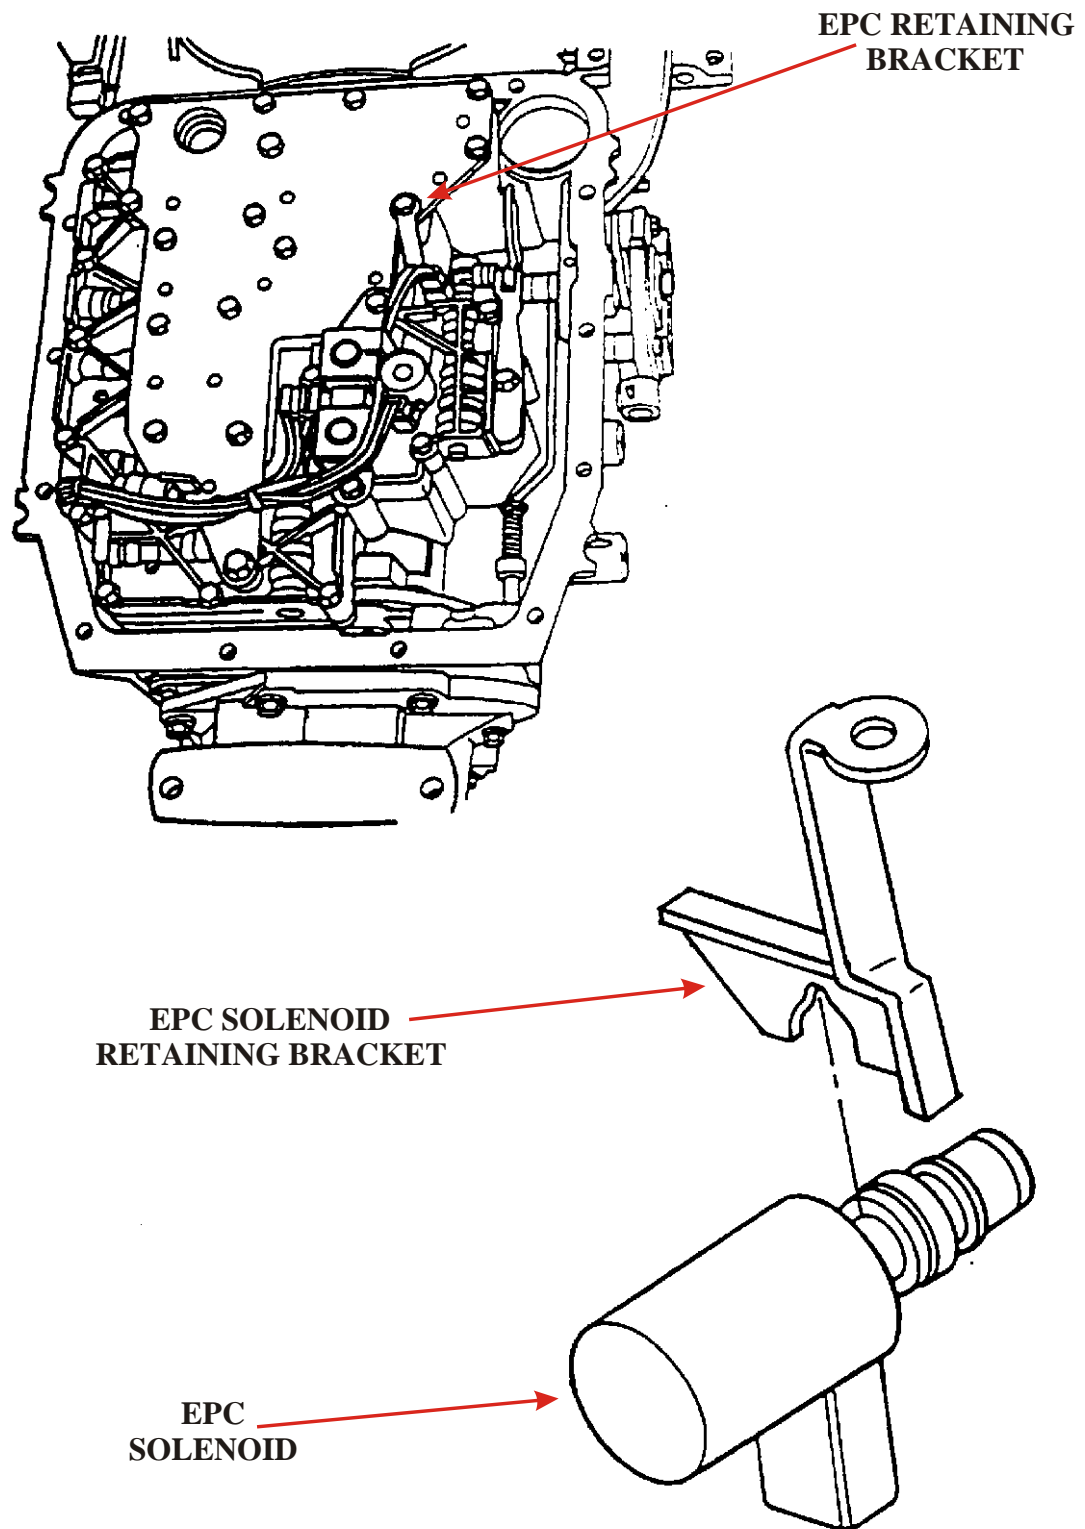
**Figure 1**

**COMPLAINT:** Line pressure instability created by lack of EPC Solenoid function and can create a variety of different concerns including soft shifts, soft engagements and repeated transmission clutch and band failures.

- CAUSE:**
- (1) Solvent or other cleaning solutions, which are used to clean the transmission case are being used while the EPC Solenoid is still mounted in the case. Contamination from the case is being washed into the case and EPC Solenoid assembly.
  - (2) The EPC Solenoid Retaining Bracket not installed back in the proper position to retain the EPC Solenoid into the case.
  - (3) Moisture or water contamination that has gathered in the vehicle wiring harness connector at the case connector on the passenger side of the vehicle.
  - (4) Defective and/or contaminated EPC Solenoid.

- (2) The EPC Solenoid Retaining Bracket must be installed with the "Fork" of the bracket securely over the body of the EPC Solenoid and the bracket secured with valve body bolt in the location shown in Figure 1. The EPC Solenoid may have to be repositioned slightly for "Fork" to engage in the proper position (See Figure 1).

- (4) Replace the EPC Solenoid with OEM part number F2VY-7G383-A, and insure retaining bracket is secured in proper position as shown in Figure 1. Manual shift linkage must be removed from case to replace the solenoid.
