TIME OUT

INTRODUCTION

THM 4L60 (700-R4) SOFT UPSHIFTS AND OTHER THINGS

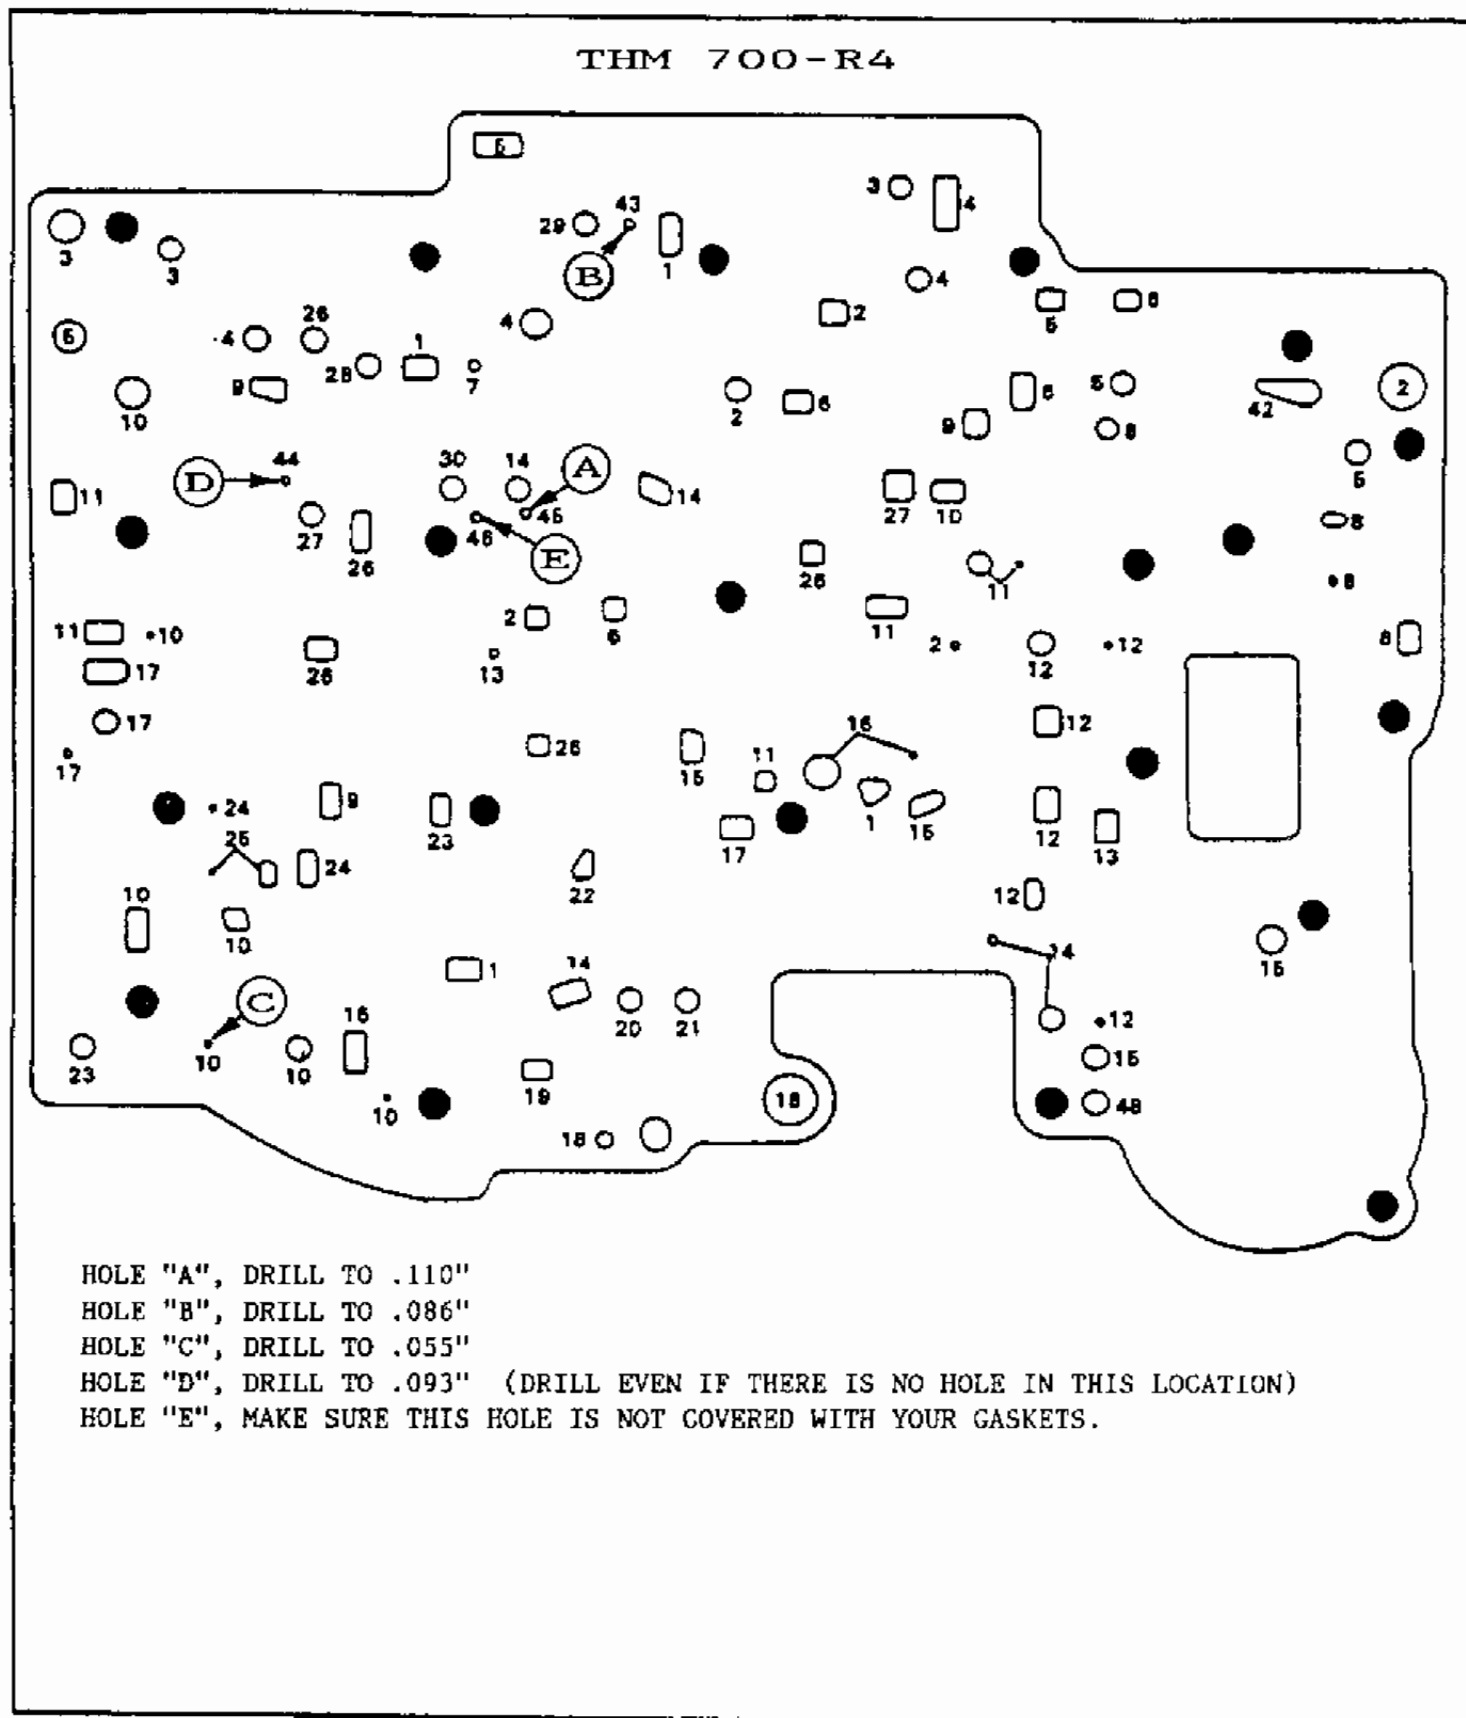
Figure 1
AUTOMATIC TRANSMISSION SERVICE GROUP

COMPLAINT: Soft and/or mushy upshifts regardless of throttle position.

CAUSE: Not enough feed oil to the 2-4 band, and the 3-4 clutch pack.

CORRECTION: Drill the holes in the spacer plate, as shown in Figure 1, as follows:

HOLE "A", DRILL TO .110".

This will improve the 1-2 shift.

HOLE "B", DRILL TO .086".

This will improve the 2-3 shift. DO NOT drill any larger than .086" as a larger hole will create a flare on the 2-3 shift on some models.

HOLE "C", DRILL TO .055".

This will prevent the T.V. valve from hydraulically locking.

HOLE "D", DRILL TO .093".

This will help prevent the 3-4 clutches from burning. This hole was eliminated on the 1988 and later 5.7L models. If your spacer plate does not have this hole, use the gasket as a template and drill it to .093".

HOLE "E", MAKE SURE THIS HOLE IS NOT COVERED WITH YOUR GASKETS.

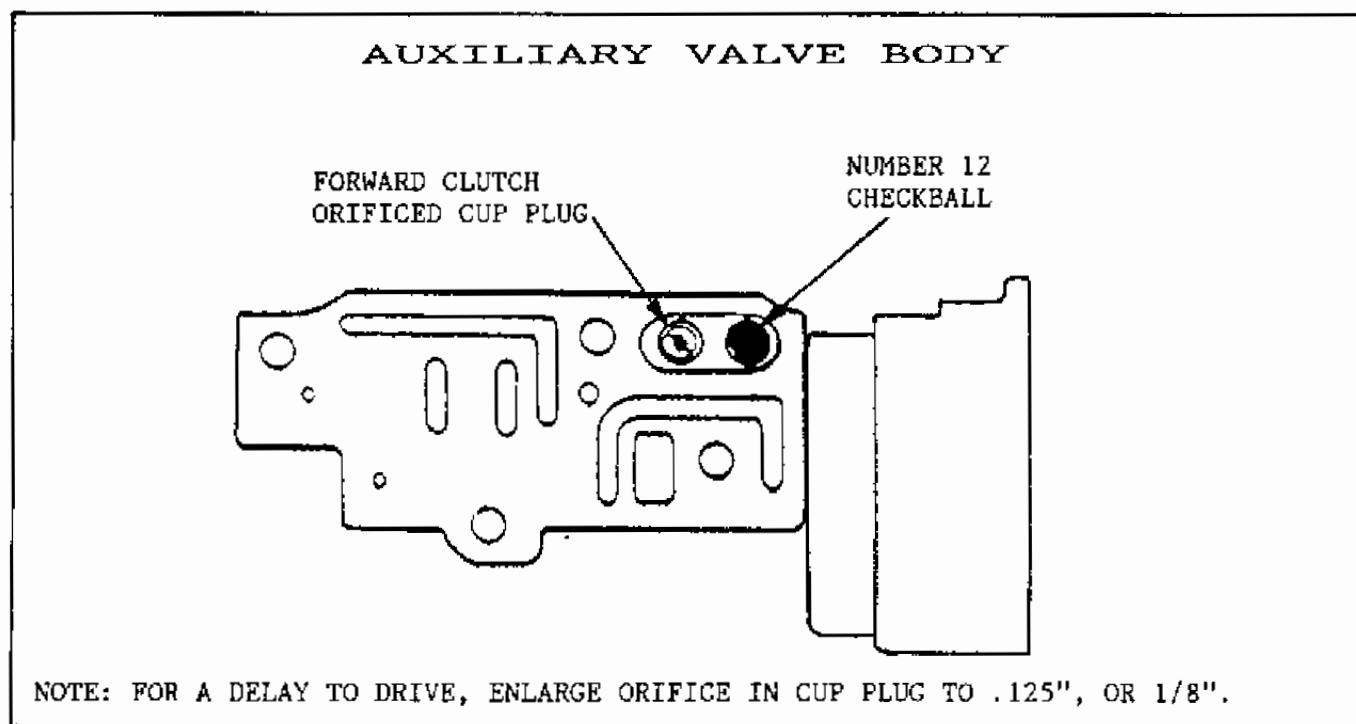
Figure 2

Do not install the number 12 checkball on top of the orifice cup plug in the auxiliary valve body. It goes next to the orifice cup plug as shown in Figure 2. If you install it improperly, the checkball falls through the spacer plate into the D4 passage, and is forced into the governor screen blocking all of governor feed oil, and creates "No Upshift". It may also be an intermittent problem, as the checkball sometimes falls away from the screen allowing D4 oil to the governor (See Figure 3).

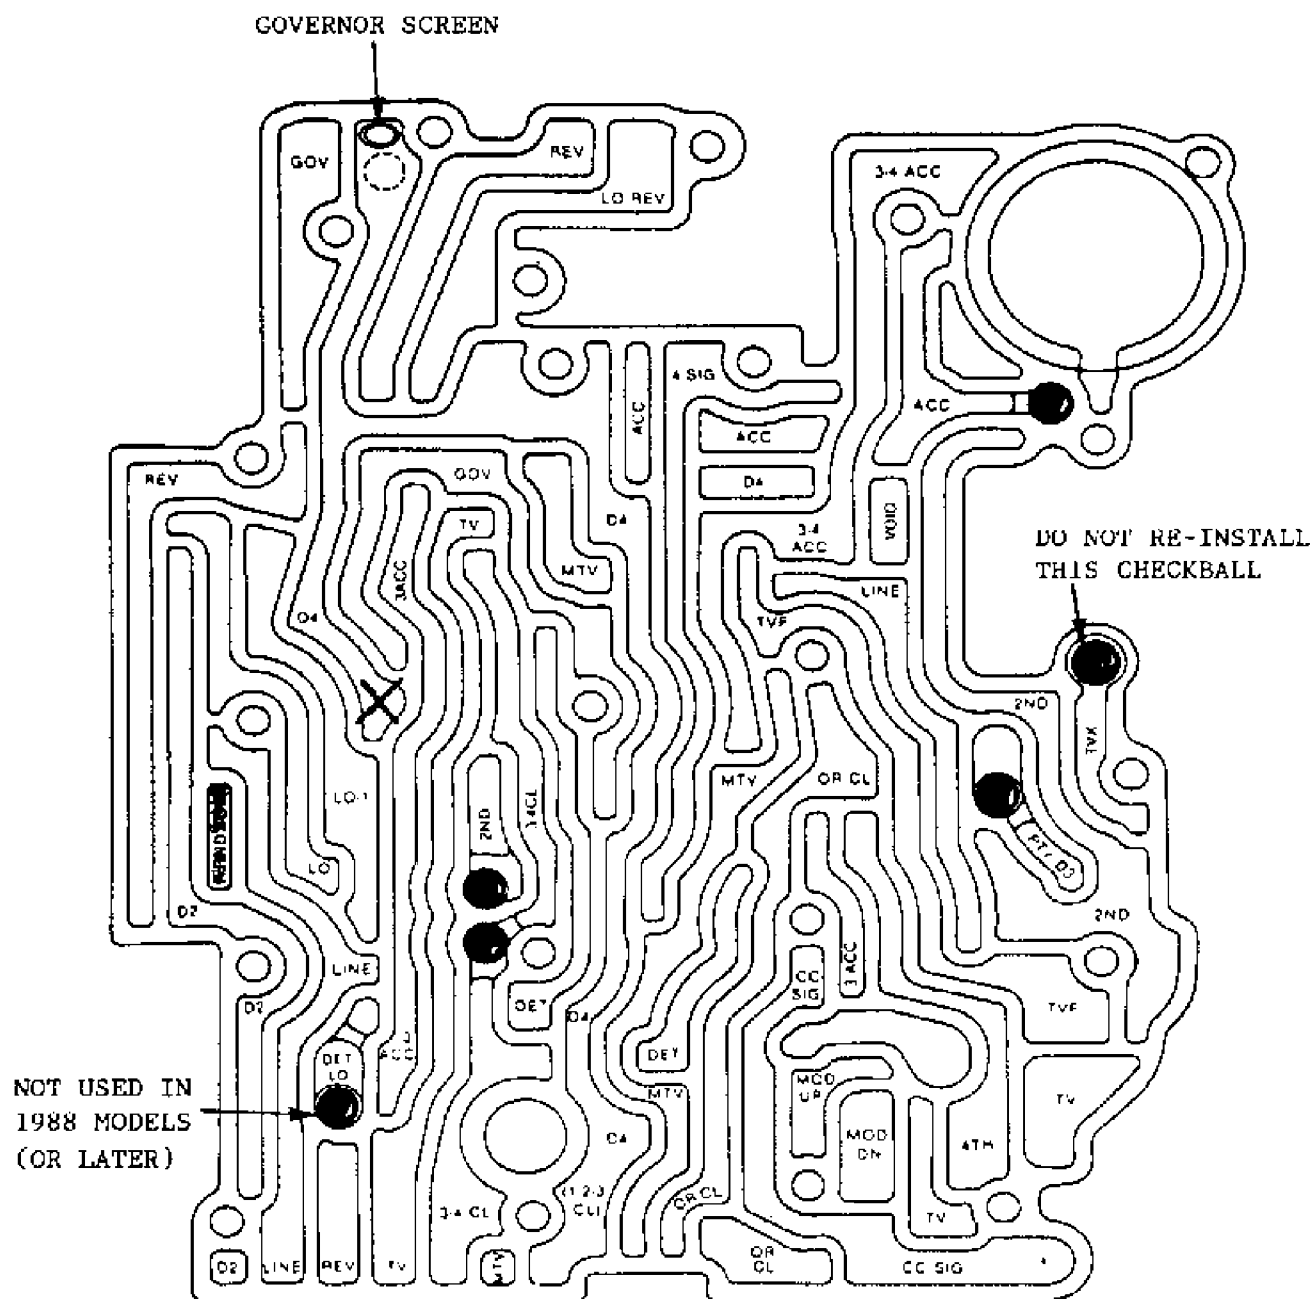
Figure 3

DO NOT INSTALL CHECKBALL IN LOCATION MARKED WITH AN "X" IN THE ILLUSTRATION ABOVE. IF YOU DO, THE RESULT WILL BE NO 2ND GEAR.

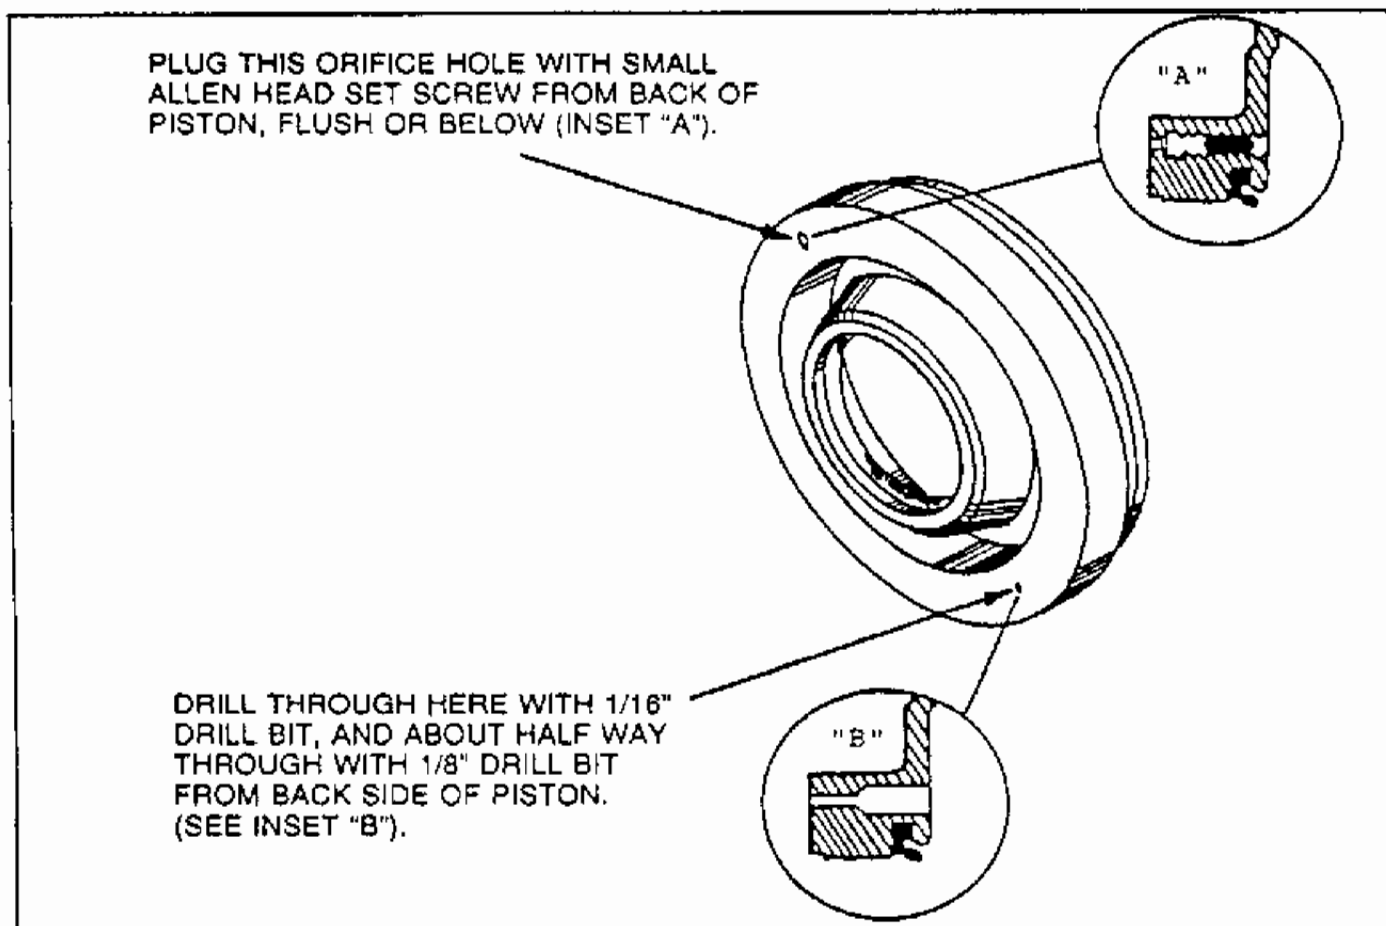
Figure 9

- COMPLAINT:** Premature failure of the reverse input clutches, on 1987 or later models only. These models have the new aluminum piston.
- CAUSE:** The cause may be the orifice hole in the new aluminum piston being larger than the feed hole in the reverse input housing. The original orifice hole was .116".

- CORRECTION:** This should be modified on ALL aluminum pistons to eliminate any repeat failures, and there are two methods.
- METHOD NO. 1.**
Plug the original hole from the back side of piston with an allen head set screw, flush or below. Retain the set screw with Loc-tite, (See Figure 9, Inset "A").
180 degrees from original hole you will find a hole started but not drilled through. Drill through here with a 1/16" drill bit, from the front side of piston. Turn the piston over and from the back side of piston, drill about half way through with a 1/8" drill bit (See Figure 9, Inset "B"). Please use a drill press for this operation to keep the holes straight.

- METHOD NO. 2.**
Install an orifice cup plug, OEM part number 8631146, into original hole from the back side of piston, and enlarge orifice to 1/16".

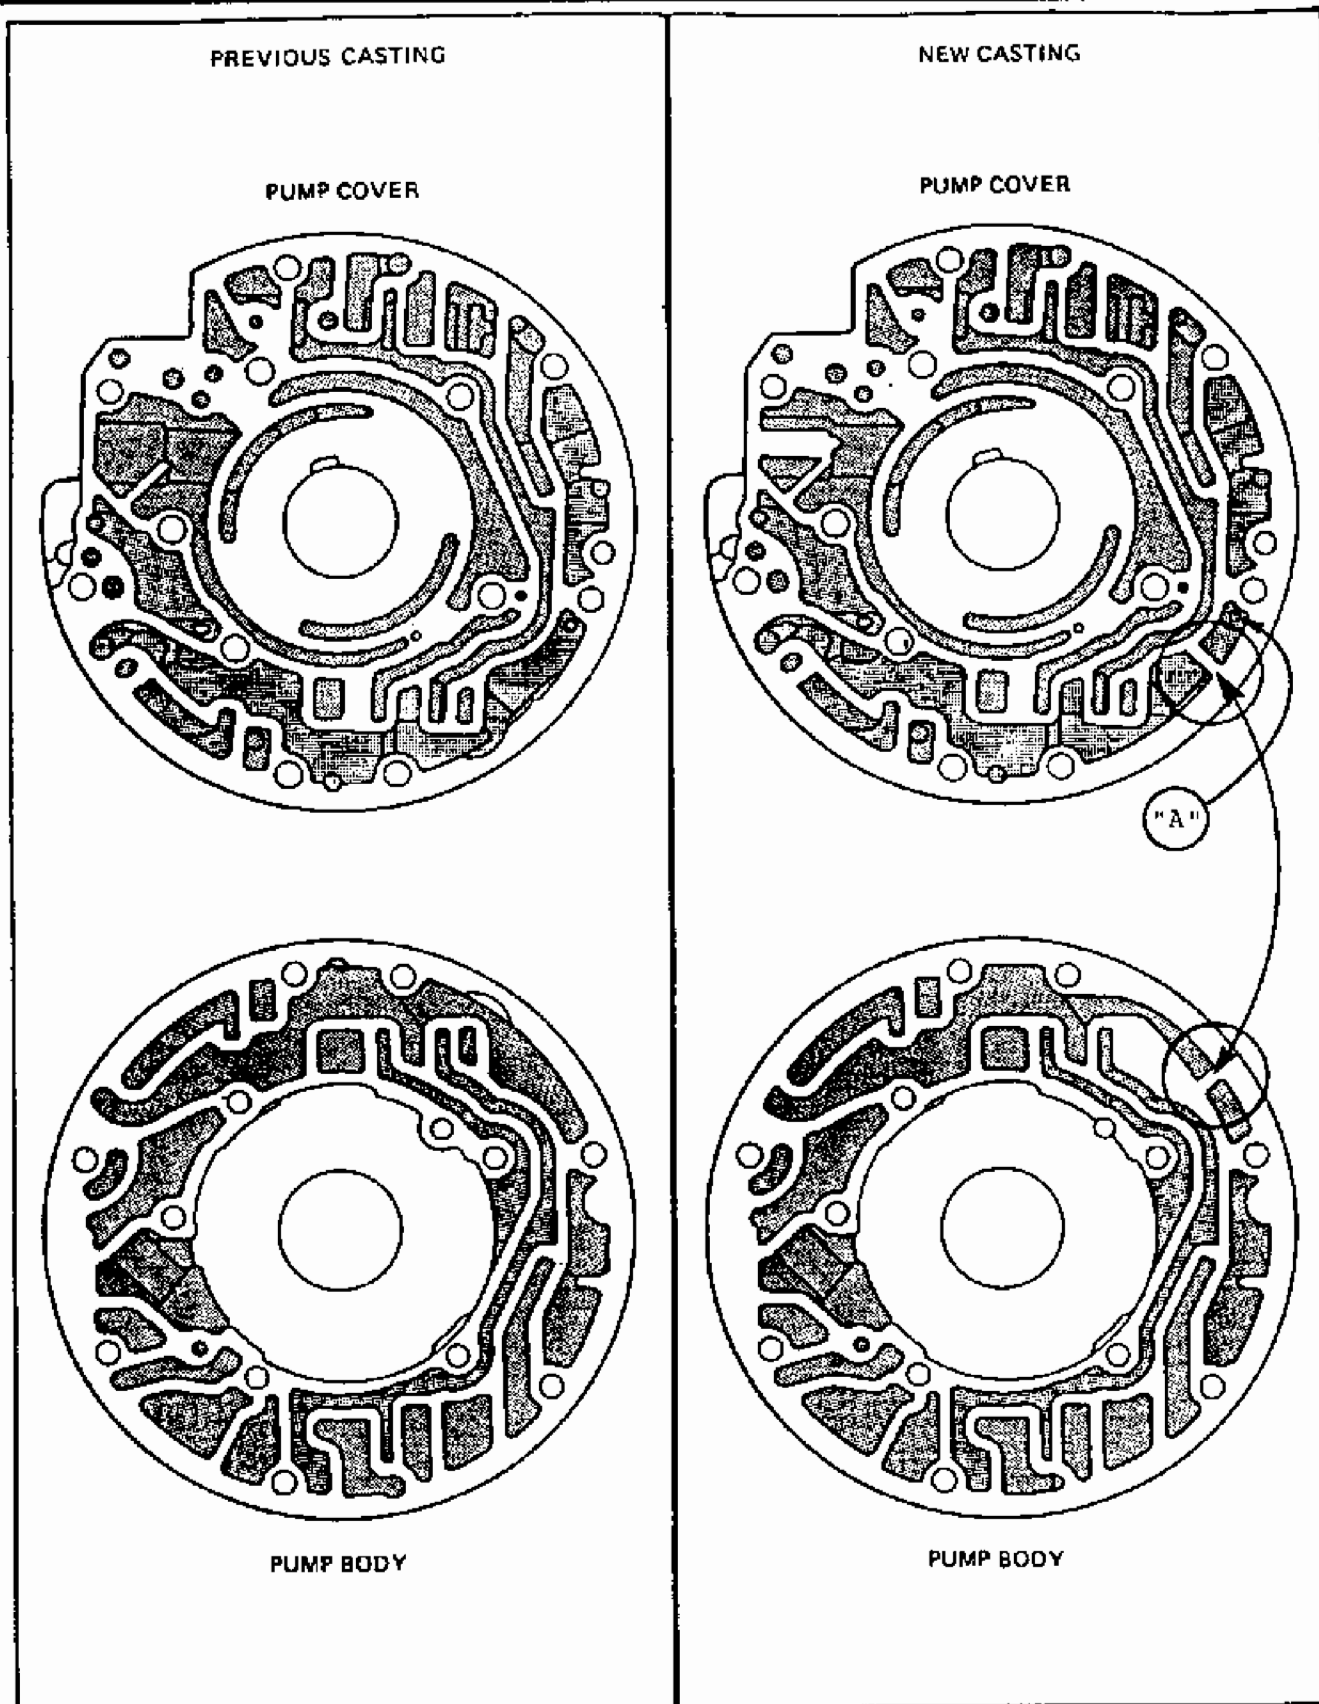
Figure 11

REASON: To reduce pump fluid leaks.

To use the new design pump cover (With Oil Dam), You must plug the hole marked "A" in Figure 11, and then it will be compatible with the previous design pump body. However if you are experiencing pump leakage between the pump halves you should use the "Dam Type" body and cover.

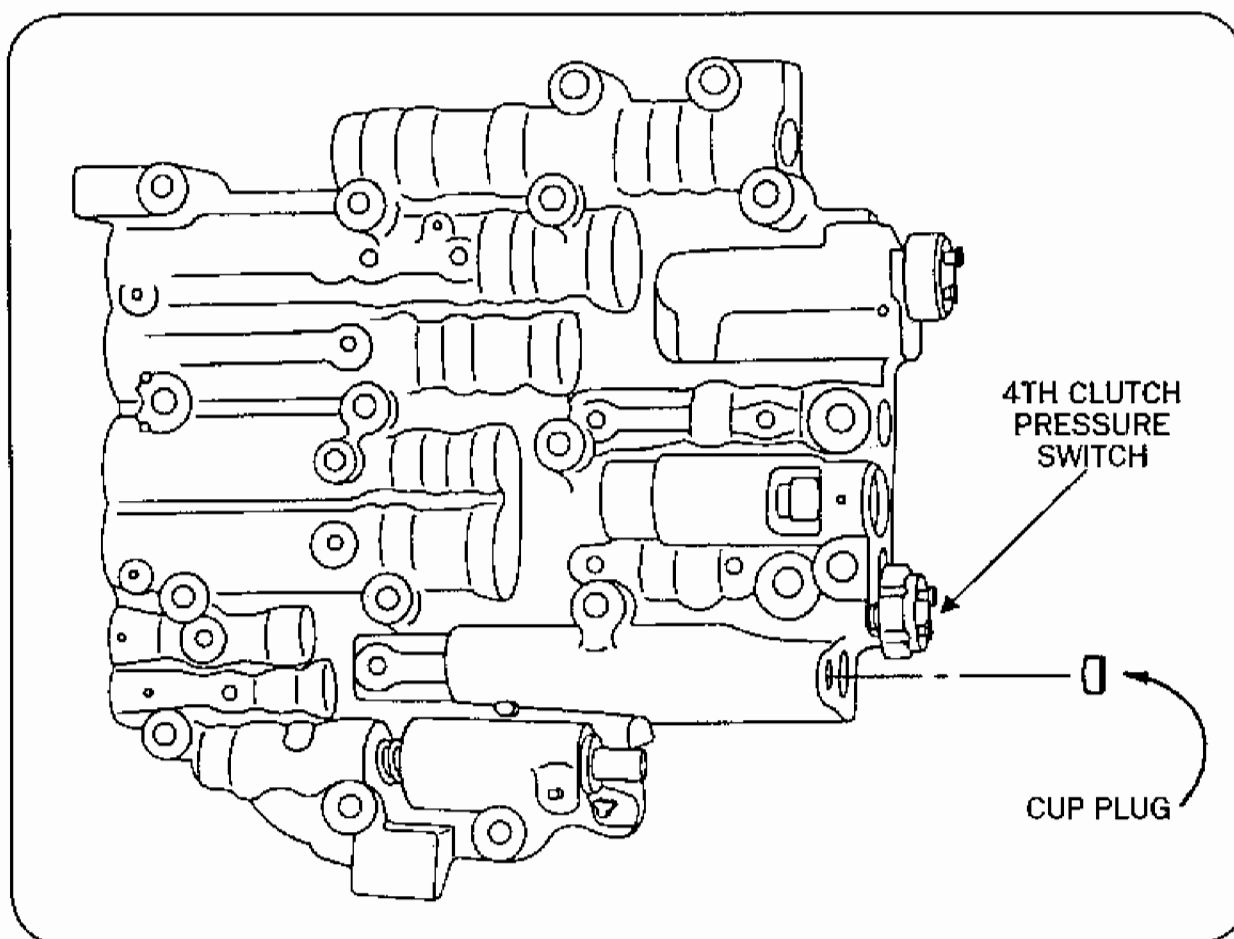
Figure 13

CAUSE #1: The cup plug missing from the servo feed passage in the valve body shown in figure 13.

CAUSE #2: The 4th clutch pressure switch is leaking causing a loss of 4th signal oil to the 3-4 relay valve (See Figure 13).

CORRECTION #2: Screw the 4th clutch pressure switch into the end of your blow gun and pressurize the switch. If air comes out of the front of the switch, replace the switch with one that does not leak (See Figure 13).

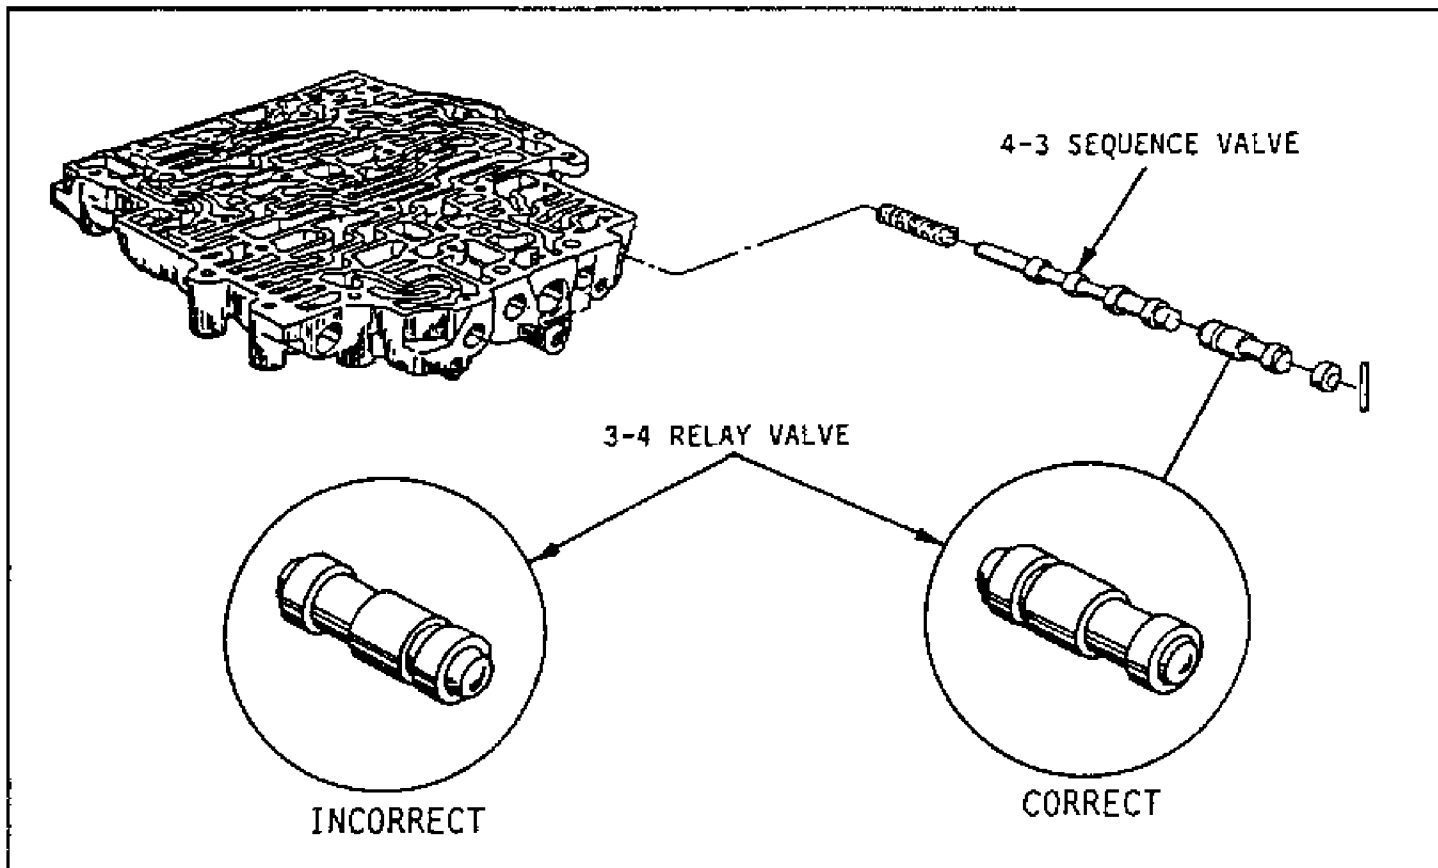
Figure 15

CAUSE #4: The 3-4 relay valve may be installed backwards (See Figure 15).

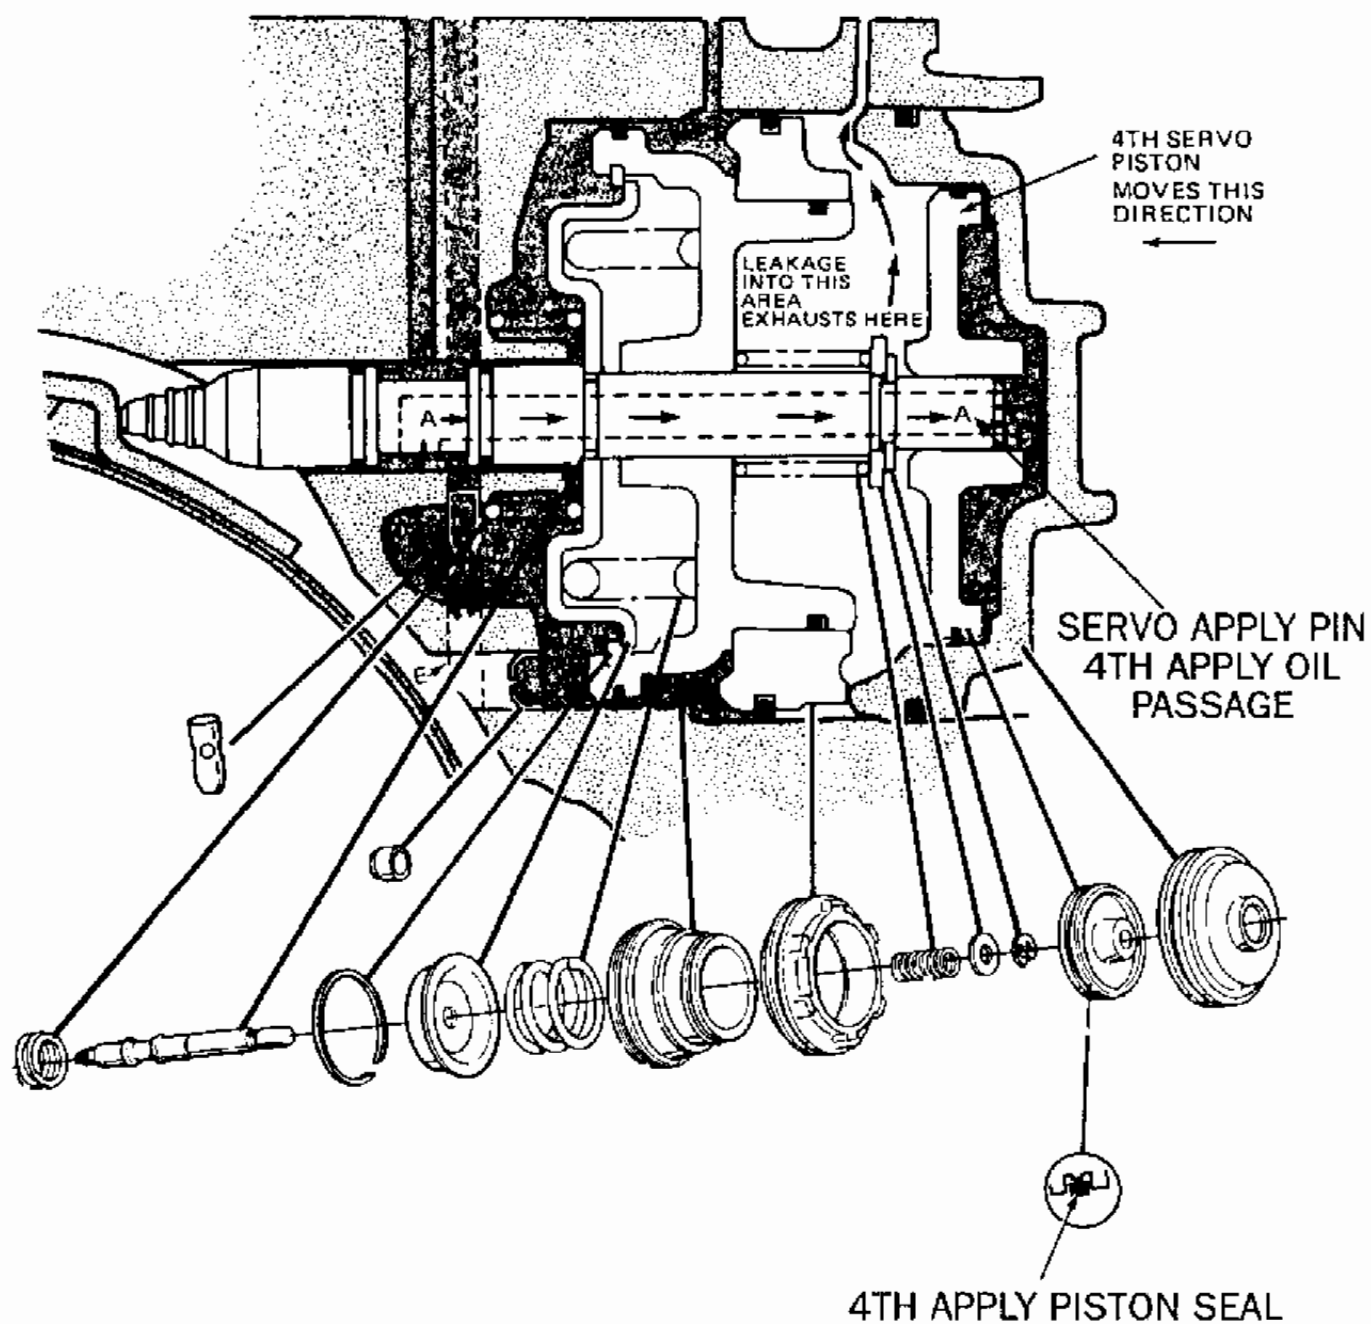
Figure 16

CAUSE #5: The 4th apply piston seal in the servo may be missing or torn causing 4th apply oil to leak into the exhaust (See Figure 16).

CAUSE #6: The 4th oil apply passage in the servo apply pin may be blocked with foreign material (See Figure 16).

CORRECTION #5: Repair or replace the sealing ring on the 4th apply piston in the servo (See Figure 16).

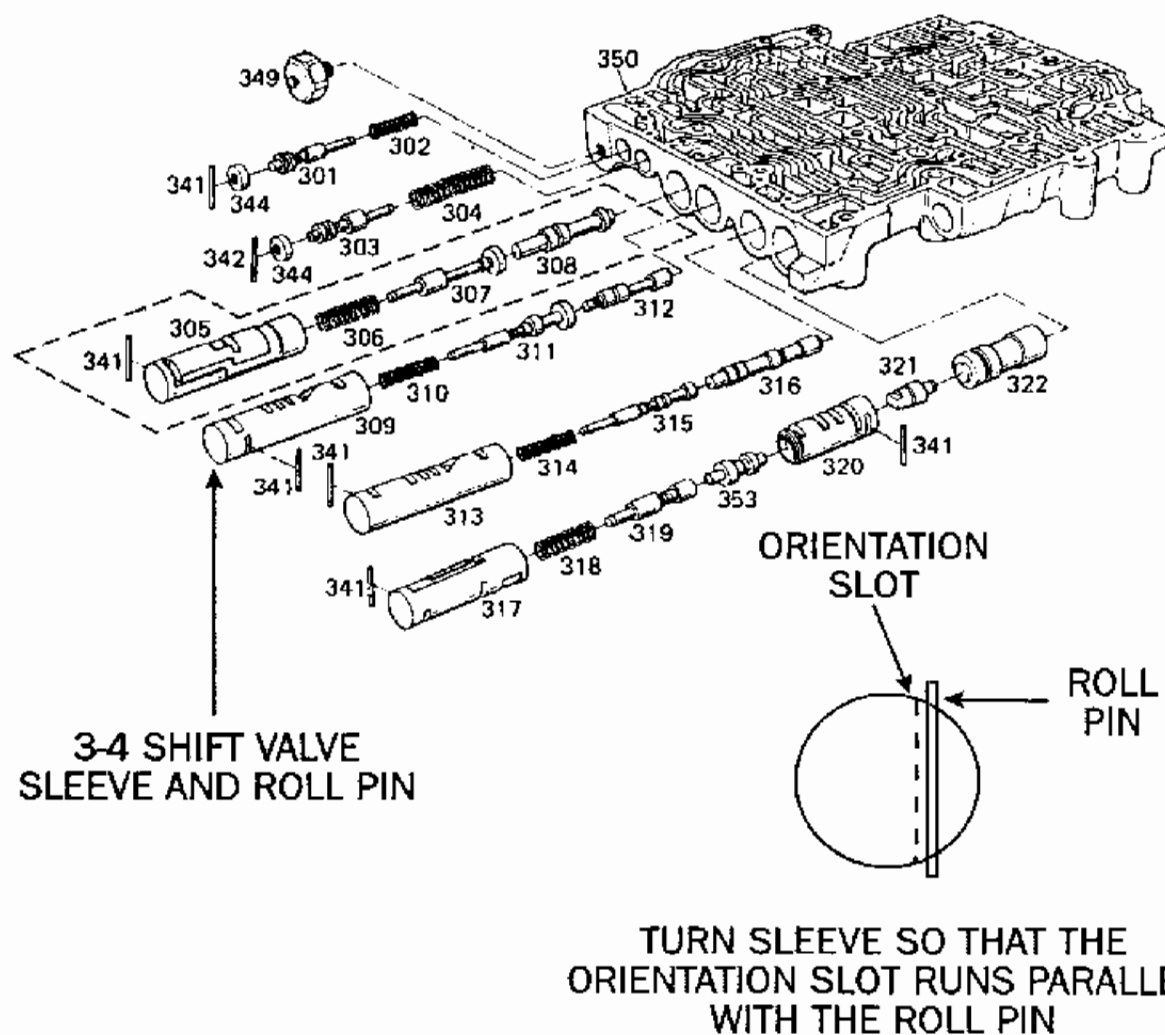
Figure 17

CAUSE #7: The 3-4 shift valve sleeve may be rotated to far against the roll pin (See Figure 17).

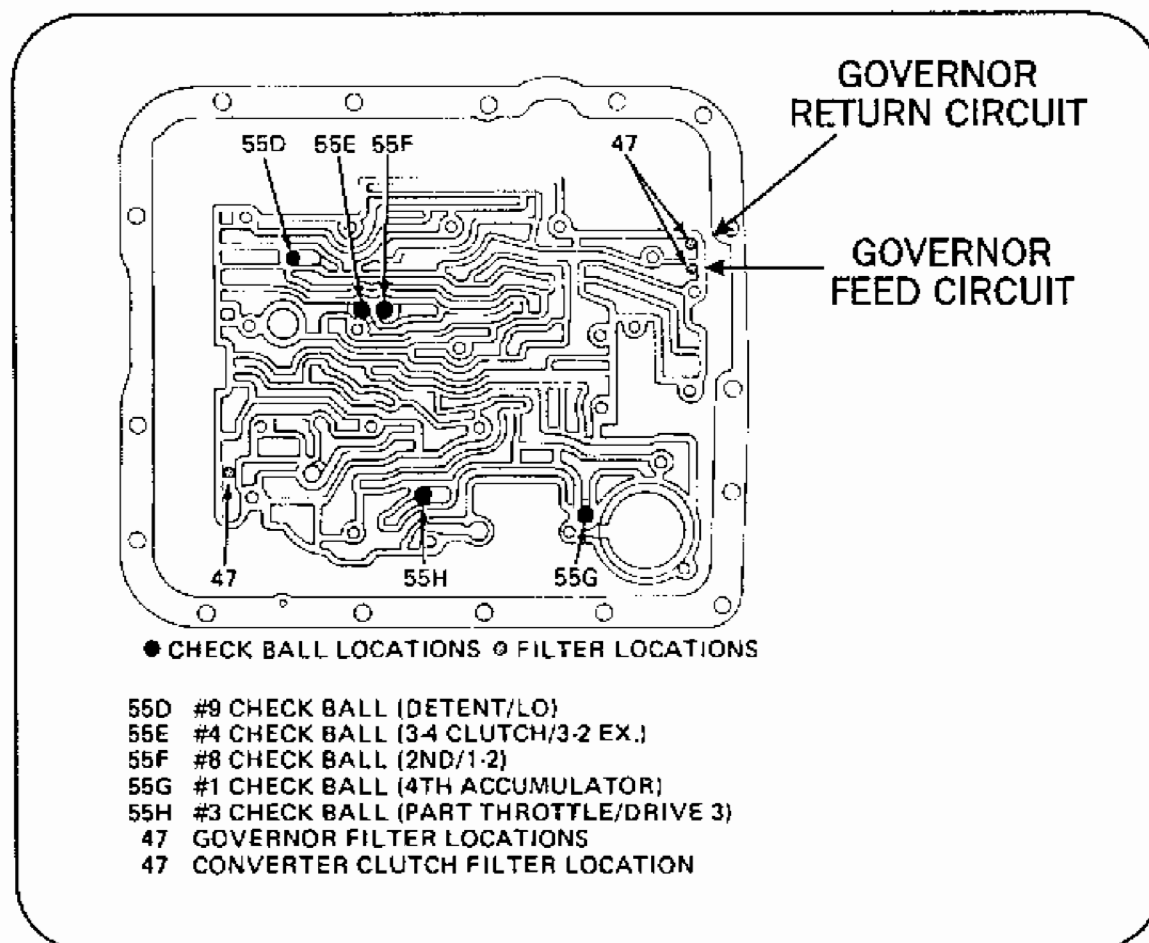
Figure 18

CAUSE #8: The governor may be defective, or the governor bore is worn, or the screen in the governor feed circuit may be restricted (See Figure 18).

CORRECTION #8: Replace the governor, resleeve the bore if necessary, and remove the filter from the feed circuit if it has been installed (See Figure 18).

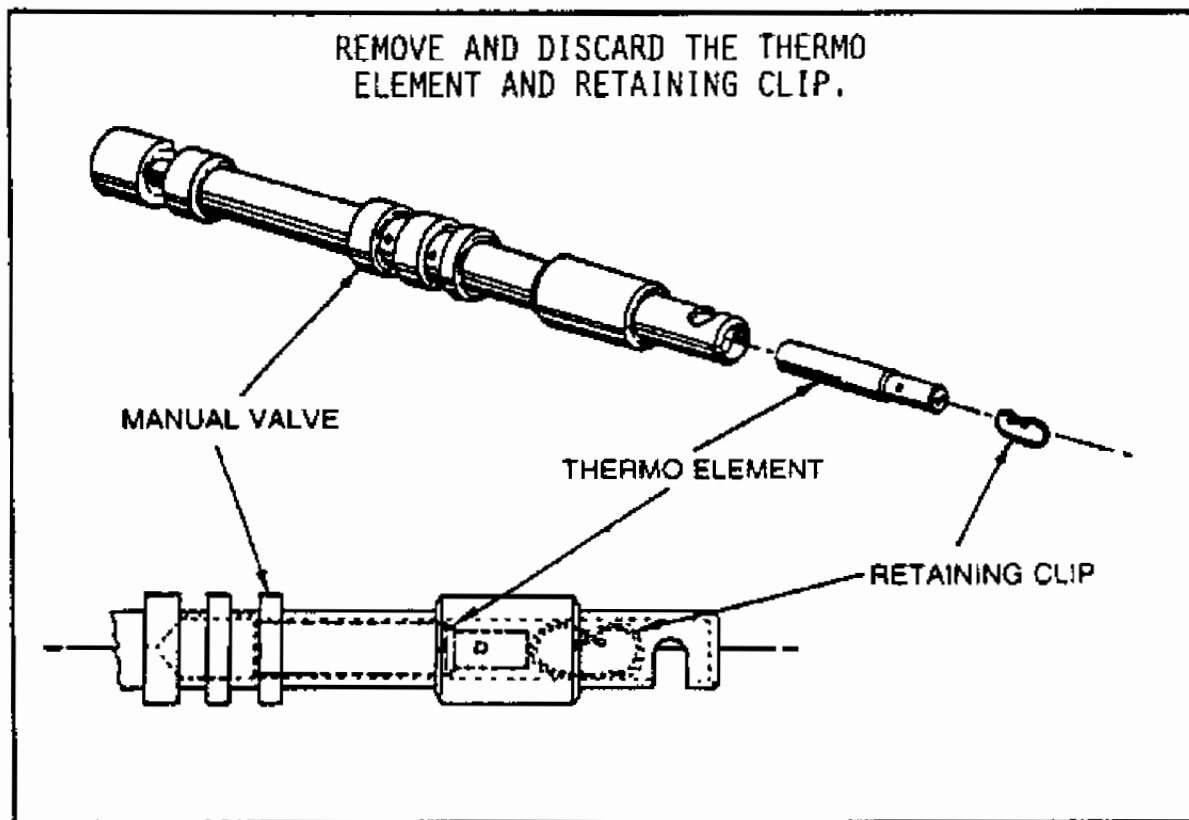
Figure 37

- COMPLAINT:** A no reverse condition and/or low/reverse clutches badly burnt at a very low mileage.
- CAUSE:** The cause may be the Low/Reverse fluid not completely exhausting, so that the Low/Reverse clutch remains partially applied while moving in all forward gears. All reverse fluid must exhaust through the thermo element, located in the manual valve, on a reverse to drive garage shift.
- CORRECTION:** Remove and discard the thermo-element and the retaining clip, located inside the manual valve, on all vehicles so equipped (See Figure 37). This should be done as standard procedure during ALL rebuilds.

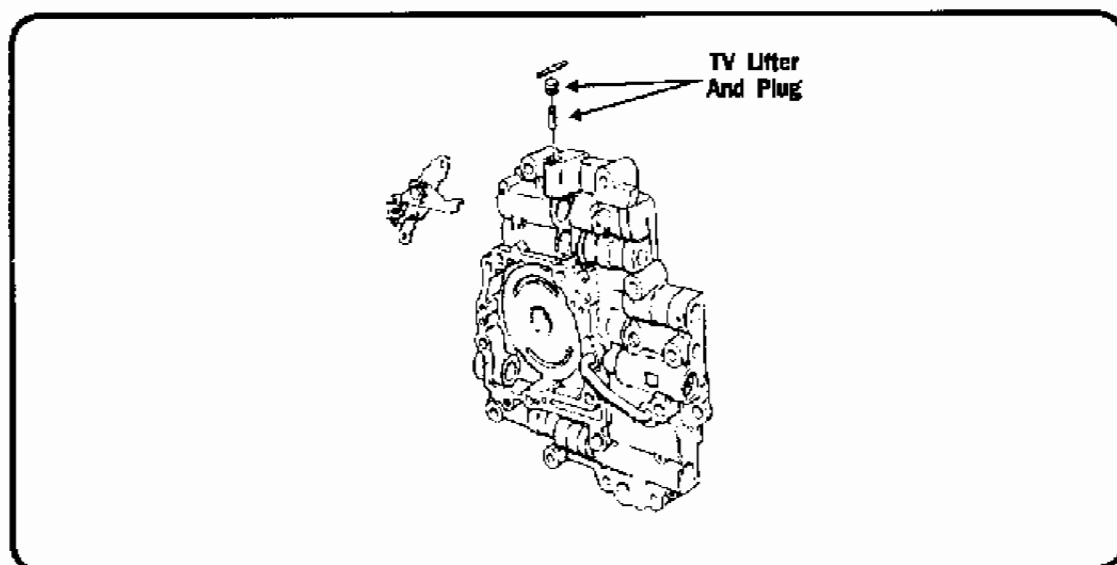
Figure 1.

CAUSE: The TV exhaust lifter on the top of the valve body may be partially seating (See Figure 1). If this occurs, orificed TV oil will not bleed off and the TV pressure will rise to maximum.

CORRECTION: Remove the valve body and drill down through "BOTH" the plug and the TV lifter (See Figure 2) with a 1/16 inch drill bit. This will relieve any pressure that is trapped by the lifter.

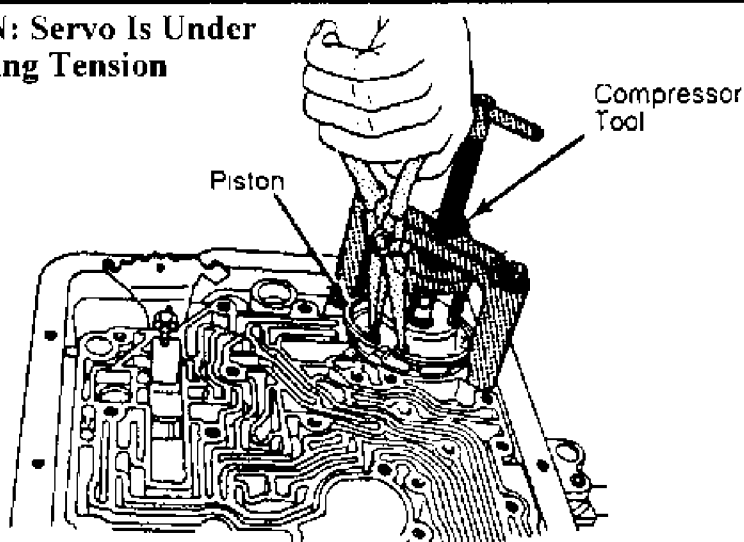
Figure 1.

CAUSE: If the fluid level is okay, the cause may be that the spring under the servo is so strong that the band cannot reapply at minimum pressure.

CORRECTION: Carefully remove the servo cover, piston, and spring. See **Figure 1**. Remove the strong servo release spring and replace it with a weaker one. See **Figure 2**. The overall length of the factory spring is about 2.48 inches, the outer spring diameter is about 1.87 inches, and the spring coil thickness is about .25 inches.

USE CAUTION: Servo Is Under High Spring Tension

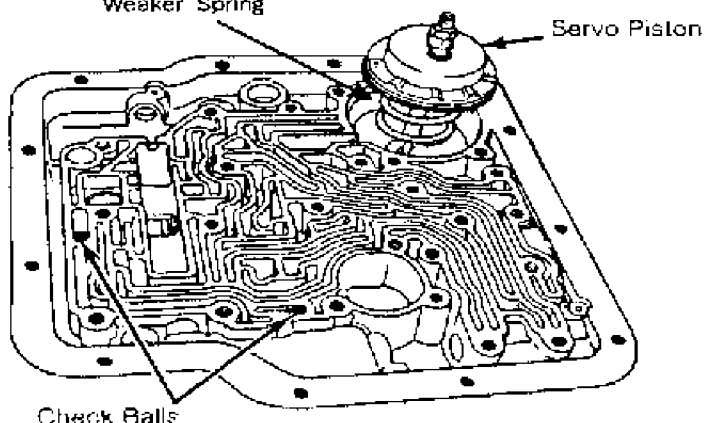
Figure 2.

Servo Piston Spring.
Replace With A
Weaker Spring

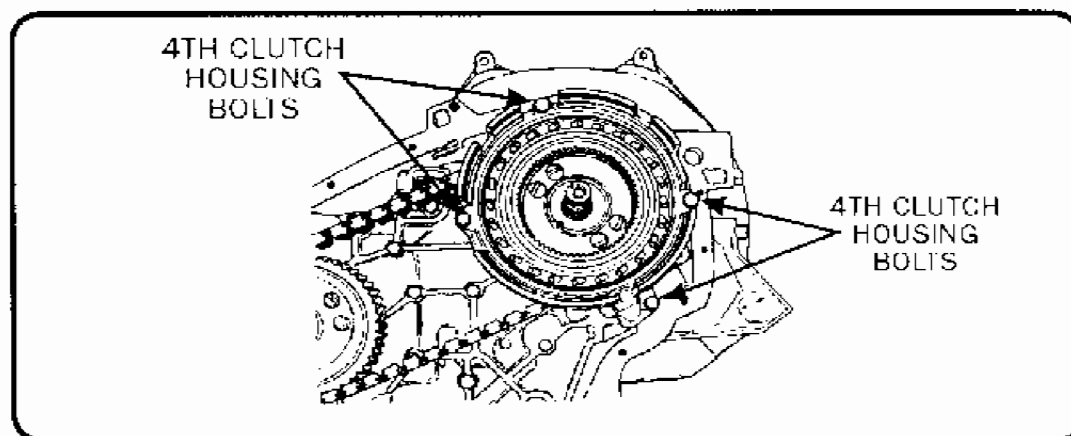
Figure 1.

COMPLAINT: After an overhaul, a 325-4L transmission returns with the overdrive ring gear broken. There may be no apparent cause as these parts may have checked out as good during the overhaul, and everything else looks okay.

CAUSE: The cause may be that the overdrive clutch housing is not centered on the case cover. When the overdrive clutch housing is not centered, excessive side force is applied to the drive sprocket by the overdrive carrier. This jams the carrier gear into the ring gear causing the explosion.

CORRECTION: During reassembly, DO NOT TIGHTEN the 4th clutch housing bolts (See Figure 1) before installing the overdrive carrier. Install the overdrive carrier, the thrust bearing, selective thrust washer, and snap ring first. (See Figure 2.) This will help center the 4th clutch housing on the case cover. After the carrier is installed, torque the 4th clutch bolts to 18Ft.-Lbs.

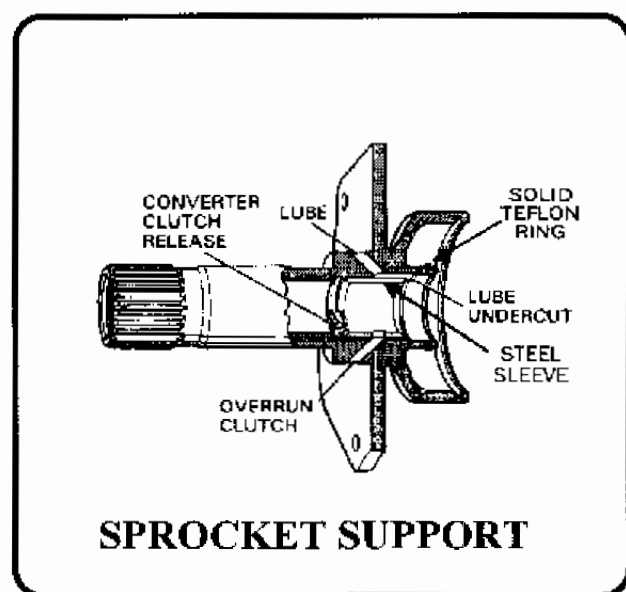
Figure 1.

COMPLAINT: Overdrive Carrier, sun gear, and roller clutch burnt up and/or broken into pieces.

CAUSE: Loss of lube oil to the overdrive carrier area. If the solid teflon sealing ring located on the rear of the sprocket support is damaged or missing, **See Figure 1.** lube oil will not be able to get to the overdrive carrier. Also if the steel sleeve in the drive sprocket support has moved toward the overdrive carrier, lube oil will be blocked to the overdrive carrier resulting in destroyed gears. If the turbine shaft teflon rings are damaged or have worn grooves in the sprocket support, lube oil will be lost. **See Figure 2.**

CORRECTION: Check the seal on the turbine shaft to make sure that it fits properly into sprocket support sleeve, and that the sleeve is not grooved. Carefully check the sprocket support where the steel sleeve is pressed in at the rear. If there is evidence that the sleeve may have moved, then the sprocket support should be replaced. Next, check the solid teflon ring on the rear of the sprocket support for wear or damage. Replace as necessary. It is a good idea to blow air through all of the passages shown in **Figure 1** to assure that there are no restrictions.

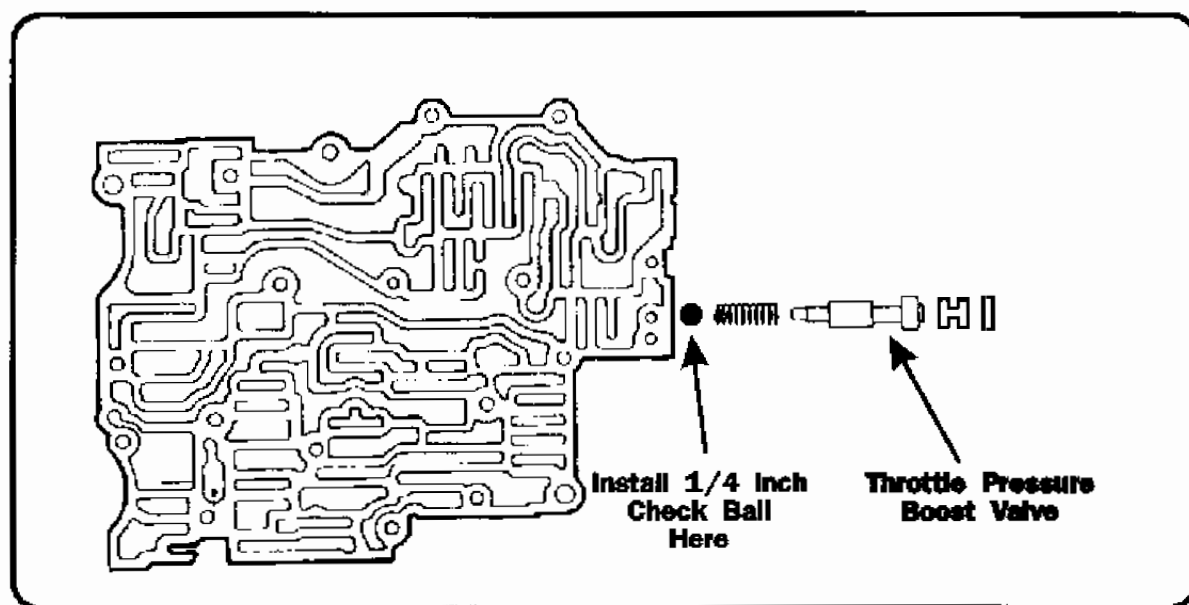
Figure 1.

CAUSE: If the modulator and pin are correct, and the kickdown linkage properly adjusted, the problem may be that the throttle pressure boost valve is overreacting to throttle changes.

CORRECTION: Remove the throttle pressure boost valve and spring and install a 1/4 inch check ball into the bore before reinstalling the spring and valve. **See Figure 1.** This will eliminate part throttle 3-2 downshifts, but will not affect normal upshifts or full detent downshifts.

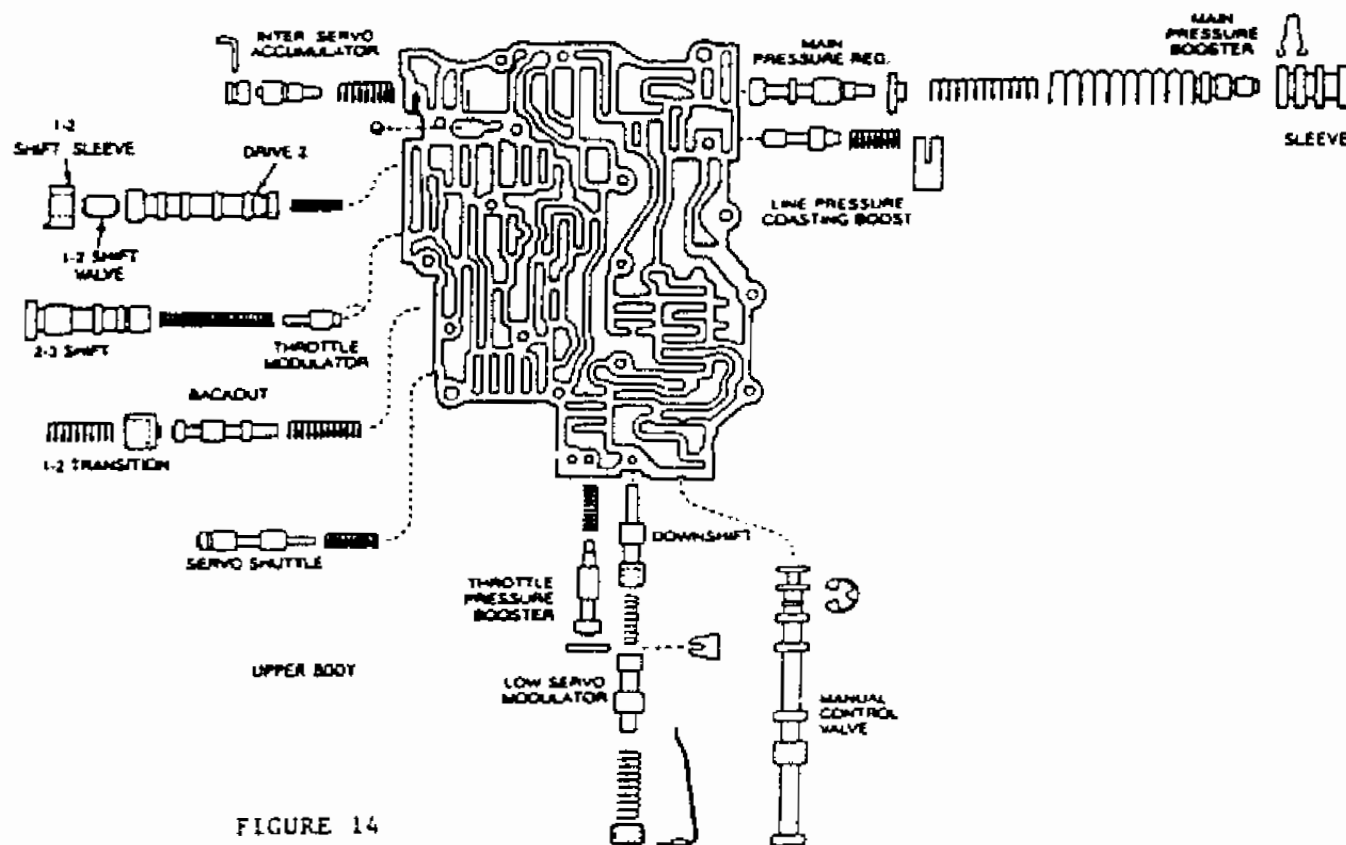
FIGURE 14

Some C-5 automatic transmissions, built prior to September 10, 1981 (transmission build date code -J10) may exhibit shift concerns caused by irregularities in the D2 valve. (Figure 14). This condition results in a 1-3 shift or second gear starts, at all throttle openings, the condition may go away as the transmission warms up to normal operating temperatures and may return as the transmission cools down.
