TIME OUT

INTRODUCTION

THM 4L60 (700-R4) SOFT UPSHIFTS AND OTHER THINGS

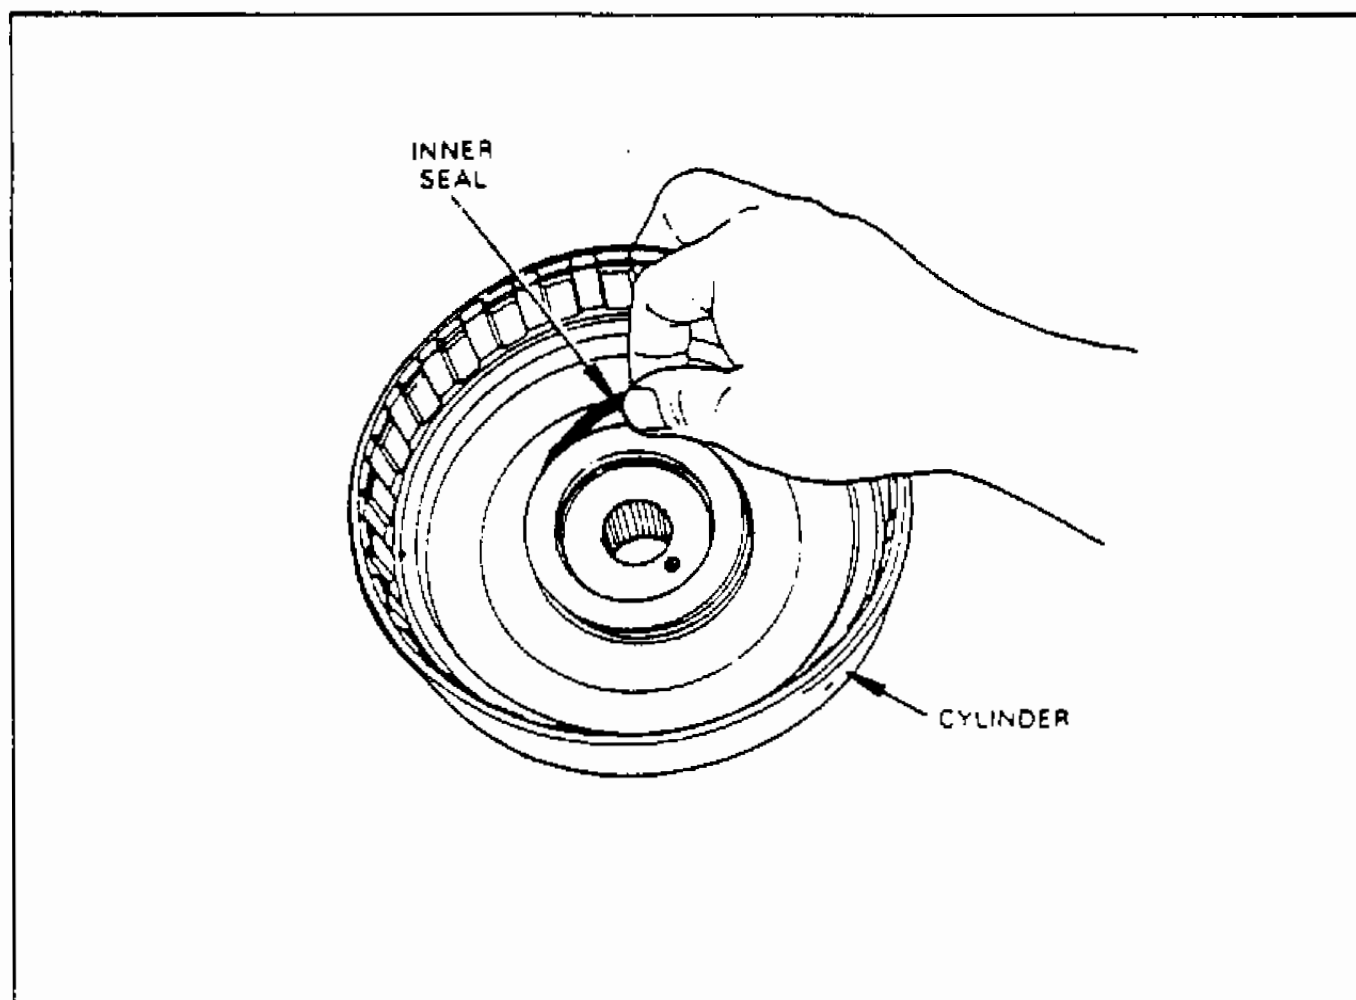
Figure 1

COMPLAINT: Abnormal delay when the selector lever is placed into the drive position, and reverse is normal, or premature failure of the forward clutch pack.

CAUSE: The cause may be the forward clutch piston inner "O" ring seal, that has become hard or cracked from heat. The OEM "O" ring seal for this location is made of a "Nitrile" material.

CORRECTION: Install a THM 440-T4 servo cover "O" ring seal in the forward clutch housing as it is exactly the same deminsion. This "O" ring seal is made of a "Viton" material and will withstand much more heat without becoming brittle or breaking down (See Figure 1).

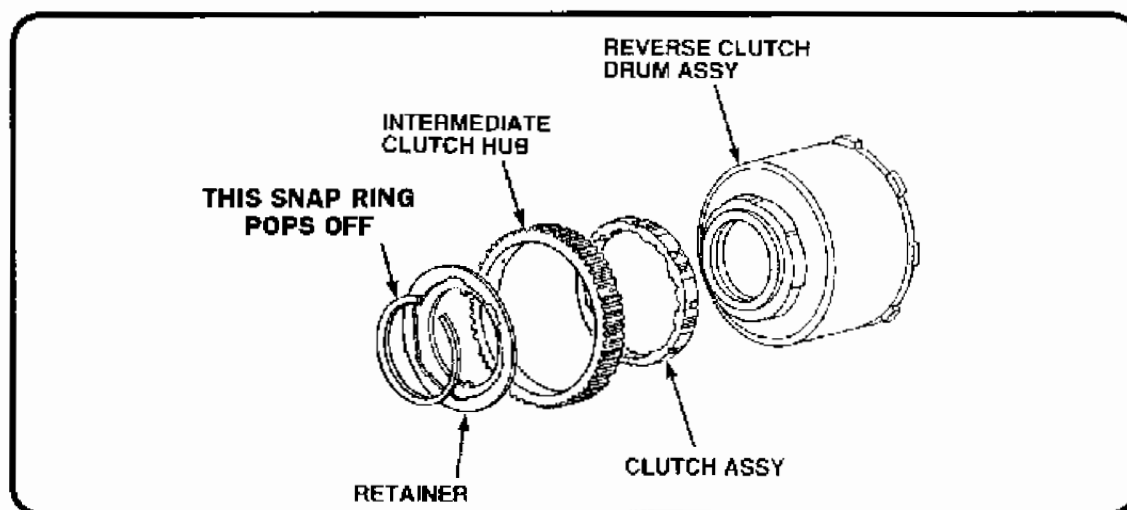
Figure 1.

COMPLAINT: The intermediate roller clutch outer race retainer snap ring pops off and the roller clutch fails. **See Figure 1.**

CAUSE: During a forced 4-2 downshift, the forward clutch may not reapply fast enough. An overspeed condition of the reverse drum will occur causing the snap ring and retainer to blow off of the drum.

CORRECTION: Replace the roller clutch and install an "acquired" spiral snap ring. The spiral snap ring from a 125 or 440-T4 final drive (See Figure 2), will usually work fine. On some reverse drums it may be necessary to file the snap ring groove slightly.

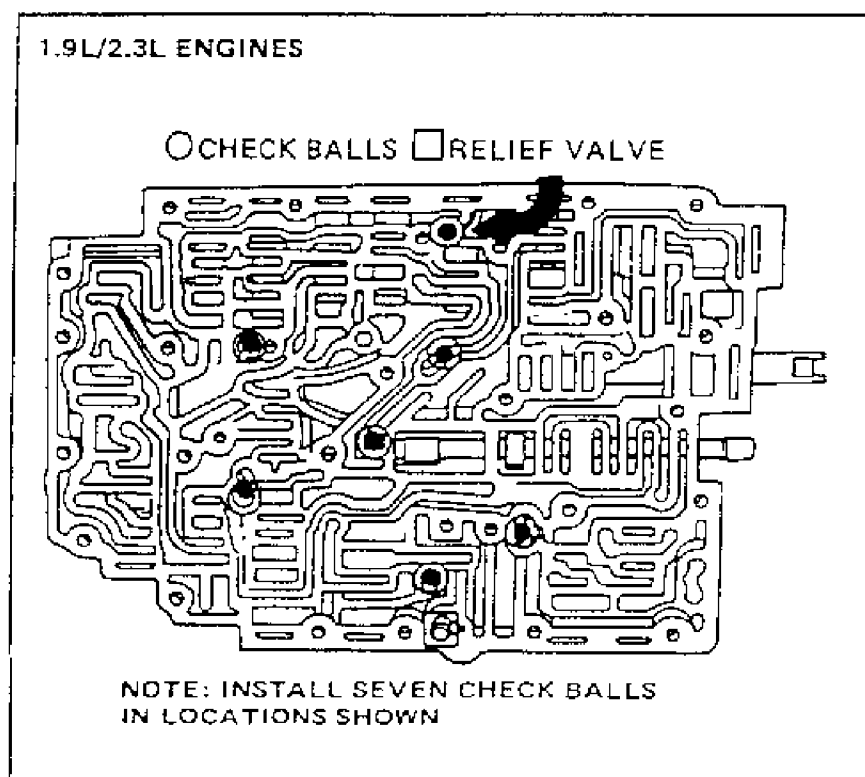
The number of main control check balls and their locations for the ATX transaxle as published in the 1989 Tempo/Topaz-Escort Car Shop Manual, Section 17-25-82 is incorrect. The correct number of main control check balls for the 1.9L ATX transaxle is seven (7) not six (6). Failure to install the seventh check ball will cause a harsh 2-3 upshift.

ACTION: When servicing the ATX transaxle main control make sure that all seven (7) check balls are installed. Refer to Figure 1 for the correct location of the main control check balls.

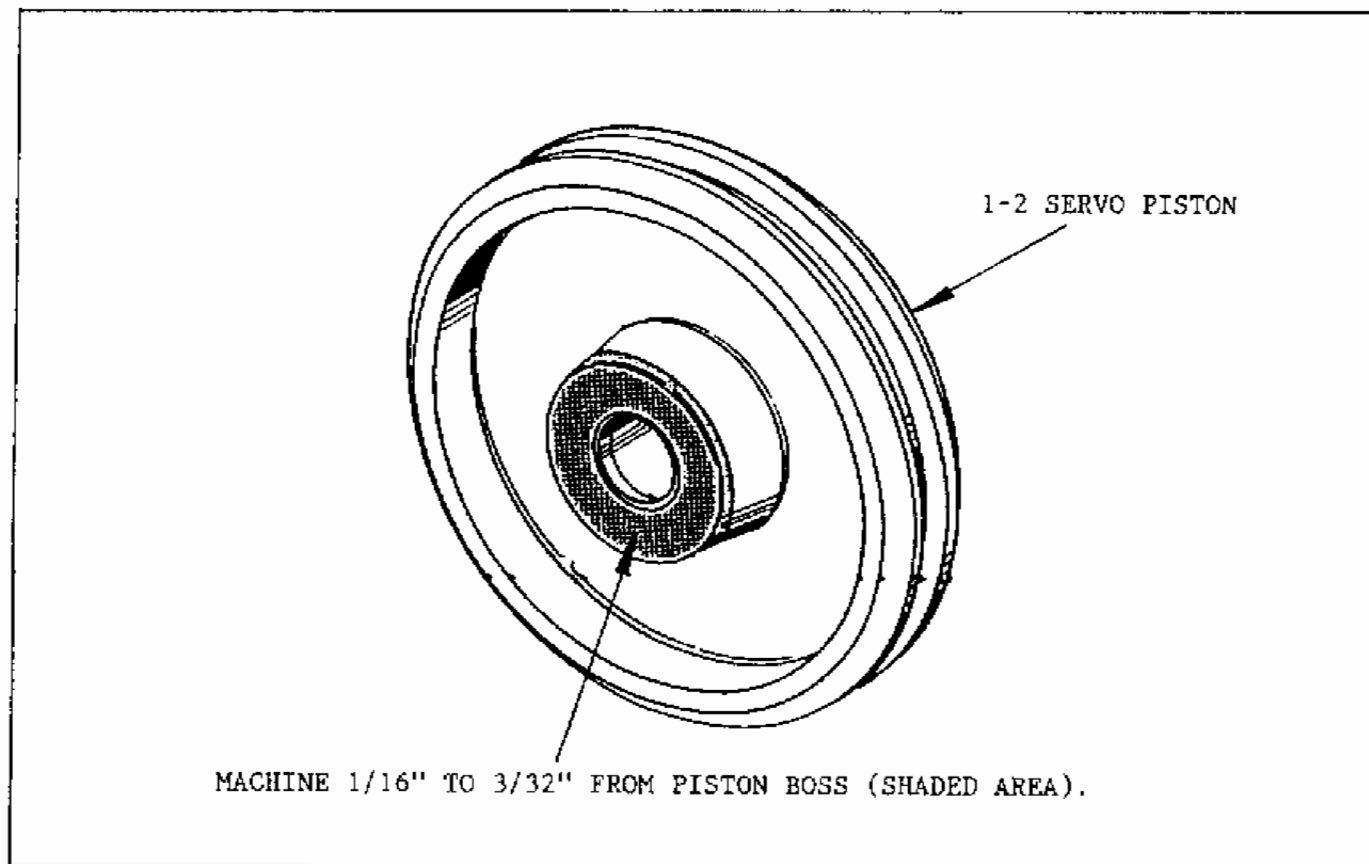
Figure 1

- COMPLAINT: Harsh downshift when coasting to a stop at closed throttle.
- CAUSE: Insufficient travel of the 1-2 piston against the cushion spring.
- CORRECTION: Remove $1/16"$ to $3/32"$ from the boss on the inside of the 1-2 servo piston as shown in Figure 1. We have shaded the area to be machined.

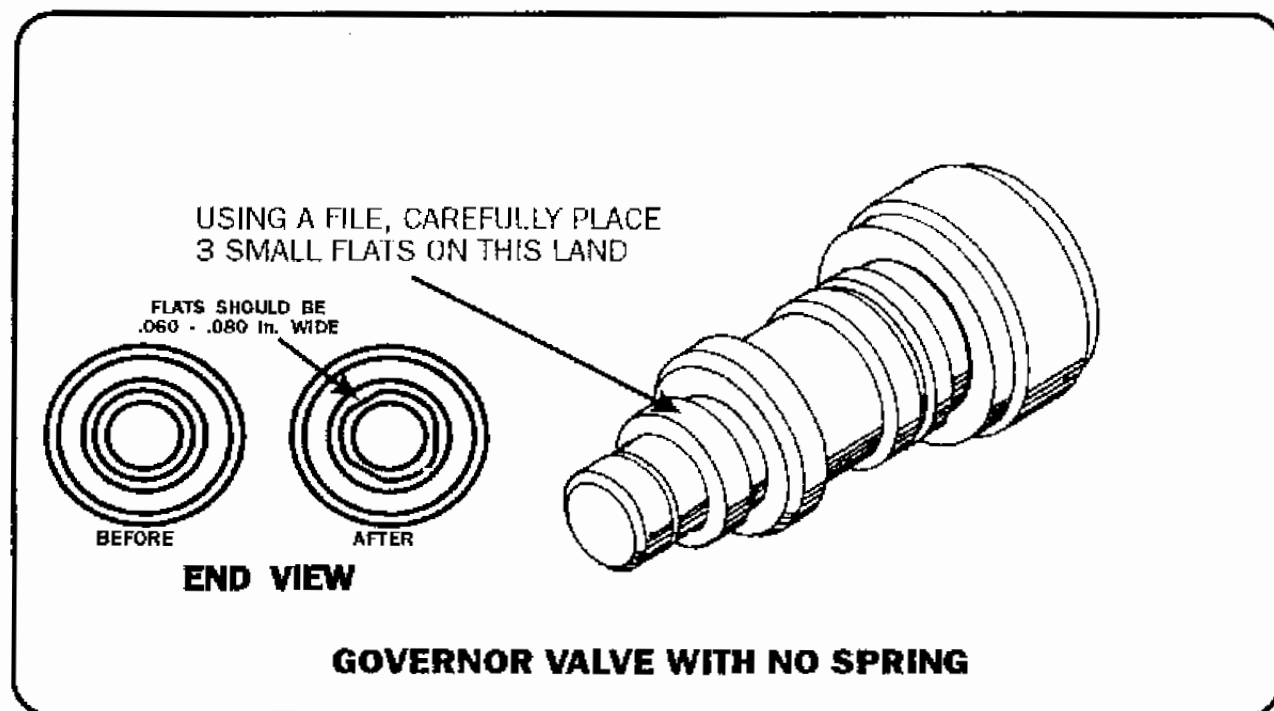
FIGURE 1

- COMPLAINT: 2nd GEAR STARTS AFTER OVERHAUL.
- CAUSE: IF ALL OTHER POSSIBILITIES HAVE BEEN ELIMINATED, THE CAUSE MAY BE CROSS LEAKS CAUSING GOVERNOR PRESSURE AT A STAND STILL.
- CORRECTION: CAREFULLY GRIND 3 SMALL FLATS ON THE SECOND LAND OF THE FREE FLOATING GOVERNOR VALVE (WITHOUT SPRING) TO PROVIDE AN EXHAUST. SEE FIGURE 1.
