**THM 4L80-E/4L80-EHD  
NEW DESIGN FOURTH AND  
OVERRUN CLUTCH STEEL PLATES**

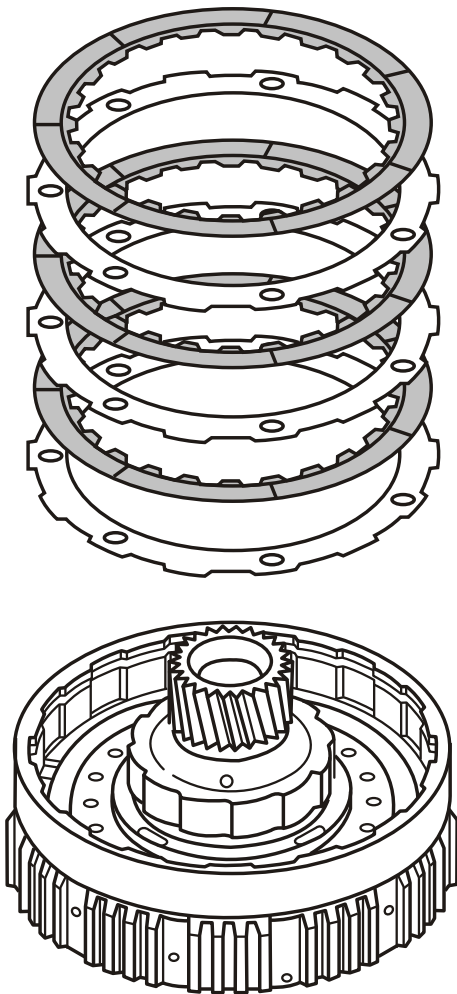
## 1997 MODEL OVERRUN CLUTCH ASSEMBLY

**CHANGE:** Beginning at the start of production for all 1997 model THM 4L80-E transmissions were built with new design steel plates for both the fourth clutch and the overrun clutch, which now include "Turbulator" holes in the plates (See Figure 1).

**REASON:** The holes interrupt fluid surface pressure to improve efficiency.

- (1) OVERRUN STEEL PLATES - New design has seven holes in the steel plates (See Figure 1).
- (2) 4TH CLUTCH STEEL PLATES - New design has four holes in steel plates (See Figure 1).

The new design steel plates are not recommended for previous models because of calibration considerations and changes.

Fourth Clutch Steel Plates (With Holes) .....	24204283
Overrun Clutch Steel Plates (With Holes) .....	24204287
