Technical Service Information

FORD AODE/4R70W FALLS OUT OF 4TH INTO NEUTRAL, REPEAT INTERMEDIATE ROLLER CLUTCH FAILURE REPEAT OVERDRIVE BAND FAILURE FORWARD DRUM AND /OR STATOR FAILURE

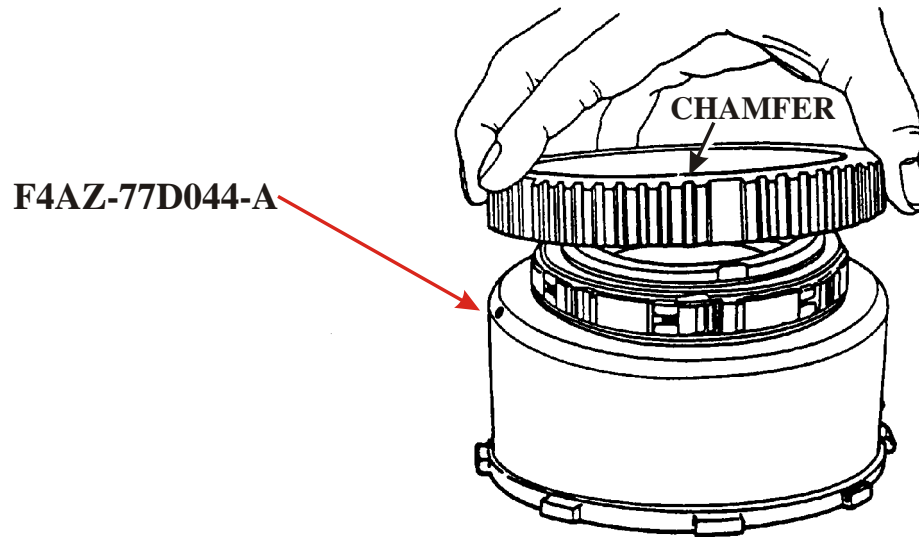
Figure 3

1. Improved spring design for the rollers.
2. Revised cam to improve oil distribution.
3. Grooved outer race to reduce vibration.
4. Elimination of the gap between the outer race and reverse drum for improved roller clutch cage support.
5. Reverse drum assembly now balanced in production.
6. Machining tolerances reduced on reverse drum.

ALWAYS replace the Reverse Drum and Intermediate Roller Clutch Asm, with the new design, OEM part number F4AZ-7D044-A, as shown in Figure 3. ATSG recommends installing the spiral snap ring from a TBM 125 or 440-T4 final drive, OEM part number 11501326, in place of the original snap ring for the intermediate roller clutch.

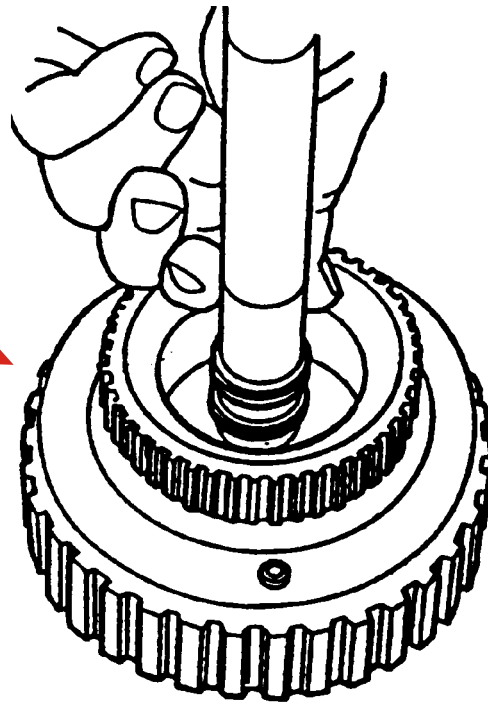
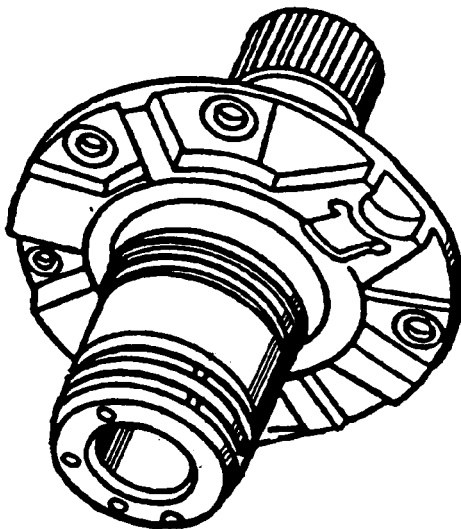
Figure 5

NUMBER (5) - Some early models were built with a Forward Clutch Drum and/or Pump Support (Stator), with a "Rough" micro-finish where the sealing rings ride in the Pump Support. Simply replacing these parts with the updated OEM parts will eliminate these concerns. The New Design Forward Clutch Drum is available under OEM part number F3LY-7F207-A, and the New Design Pump Support available under OEM part number F4AZ-7A108-A (See Figure 5).

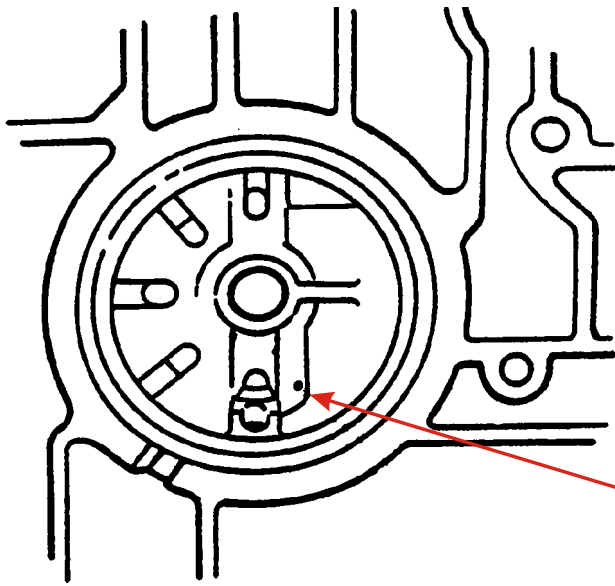
Figure 6

THIS .020" BLEED ORIFICE MUST BE FREE FROM CONTAMINATION

NUMBER (6) - Inspect the .020" bleed orifice located in the overdrive servo bore, in the location shown in Figure 6. This bleed orifice is difficult to see, but MUST be there, and MUST BE OPEN, for the over-drive band to apply properly. ALWAYS inspect this bleed orifice to ensure that it is free of all contamination, and open to the inside of the case (See Figure 6).

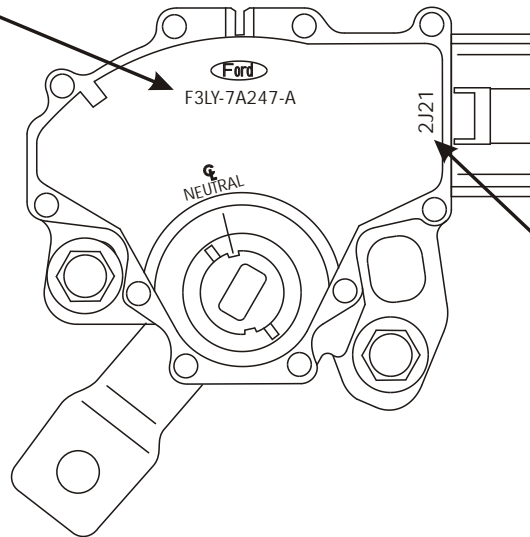
Figure 7

NUMBER (7) - The Manual Lever Position Switch is very susceptible to contamination from road water, snow, mud, and interference with the insulation material on the floor pan above it. Simply cut away enough of the insulation to provide sufficient clearance between the top of the MLPS and the floor pan. Inspect for bent pins in the connector. ALWAYS replace the MLPS with a revised service level MLPS that is more resistant to internal contamination, with the following part numbers;

DO NOT USE MLPS WITH DATE CODES OF 2521 THRU 2LO6.

The date code is stamped on the outer cover of the Manual Lever Position Switch, as shown in Figure 7.
