Technical Service Information

THM 3T40 (125C) HARSH 1-2 SHIFT

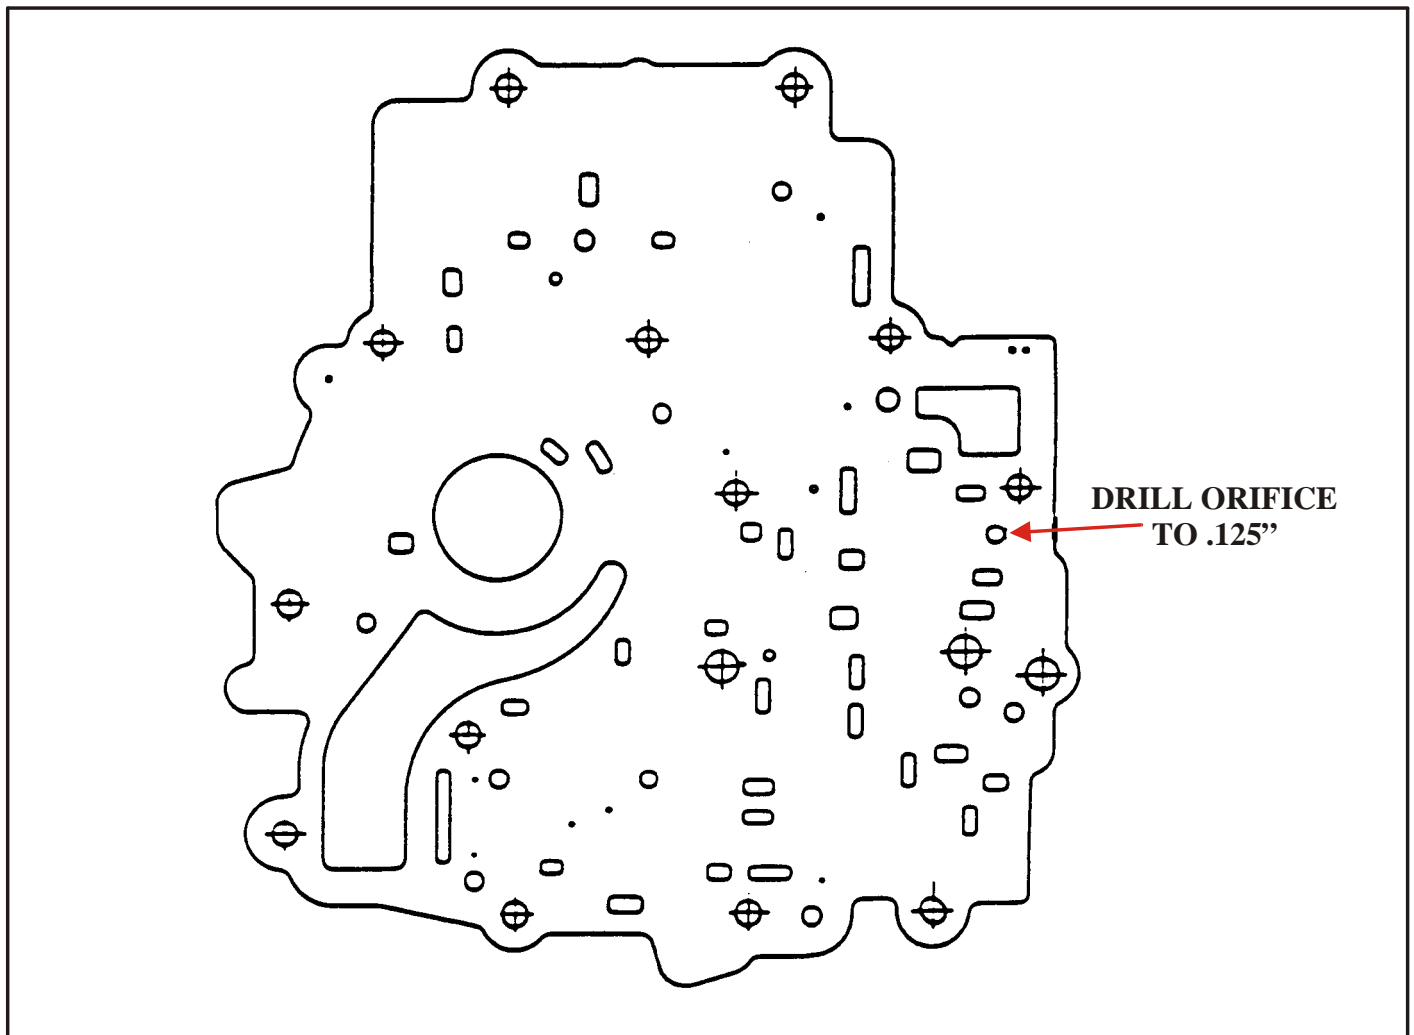
Figure 1

COMPLAINT: Harsh 1-2 shift encountered on 1985-86 Thm 125C transmissions.

CAUSE: Too small an orifice in separator plate (.040) 1-2 ACCUMULATOR FEED BACK ORIFICE.

CORRECTION Drill orifice to (.125) or replace with part number 8660581
