Technical Service Information

THM 4L60-E BIND-UP IN MANUAL LOW AND REVERSE 2ND GEAR START AND BIND ON 2-3 UPSHIFT

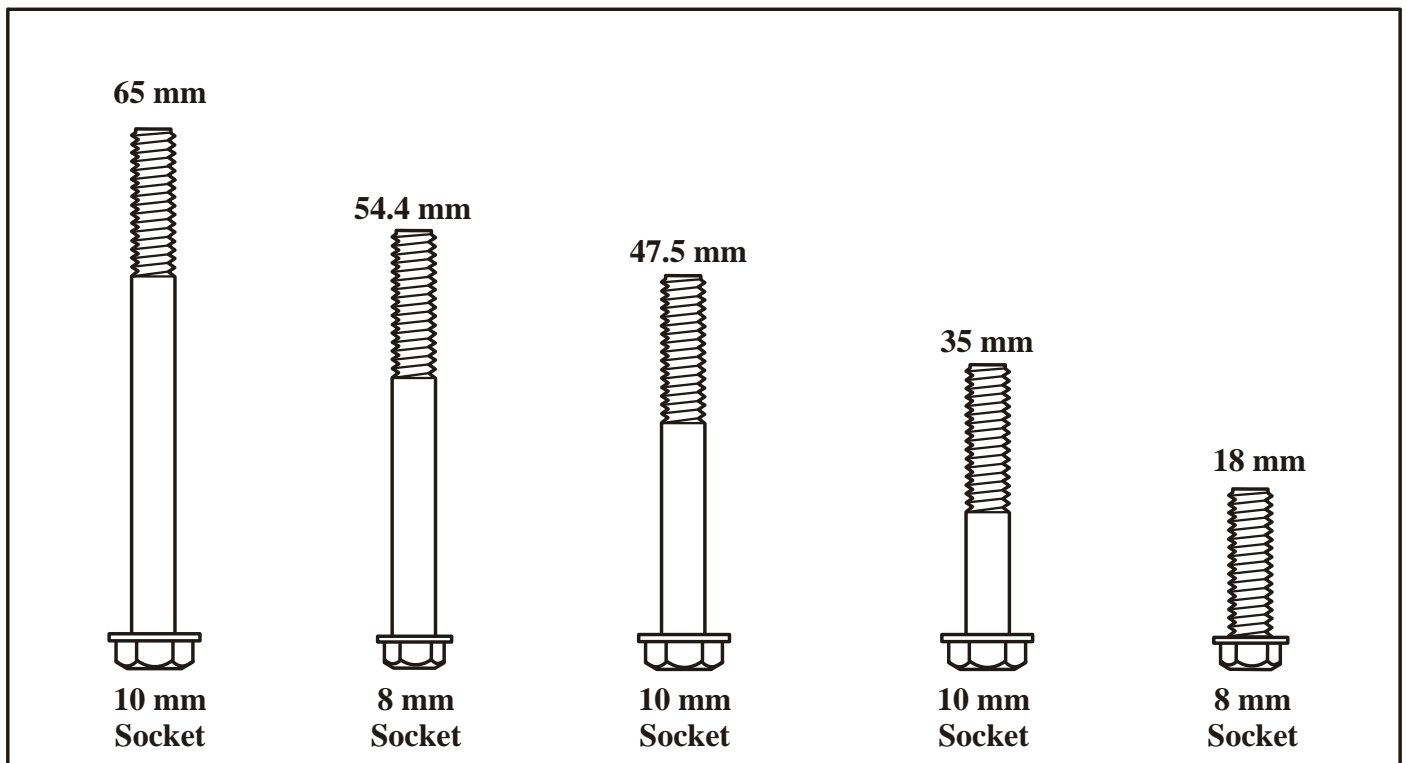
Figure 1

CAUSE: There are different length valve body bolts which can be easily mis-positioned (See Figure 1). A **common** error is placing a 54.4 millimeter length bolt into a location designed for a 47.5 millimeter length bolt (See Figure 2). The mis-located bolt will extend into the barrel of the case and into the sun shell. The bolt now being screwed into the sun shell inhibits the rotation of the shell creating the above complaint.
