Technical Service Information

THM 440-T4 VACUUM LINES PINCHED

Pinched or Kinked Modulator Vacuum Lines and the Deletion of the Aspirator/Solenoid system.

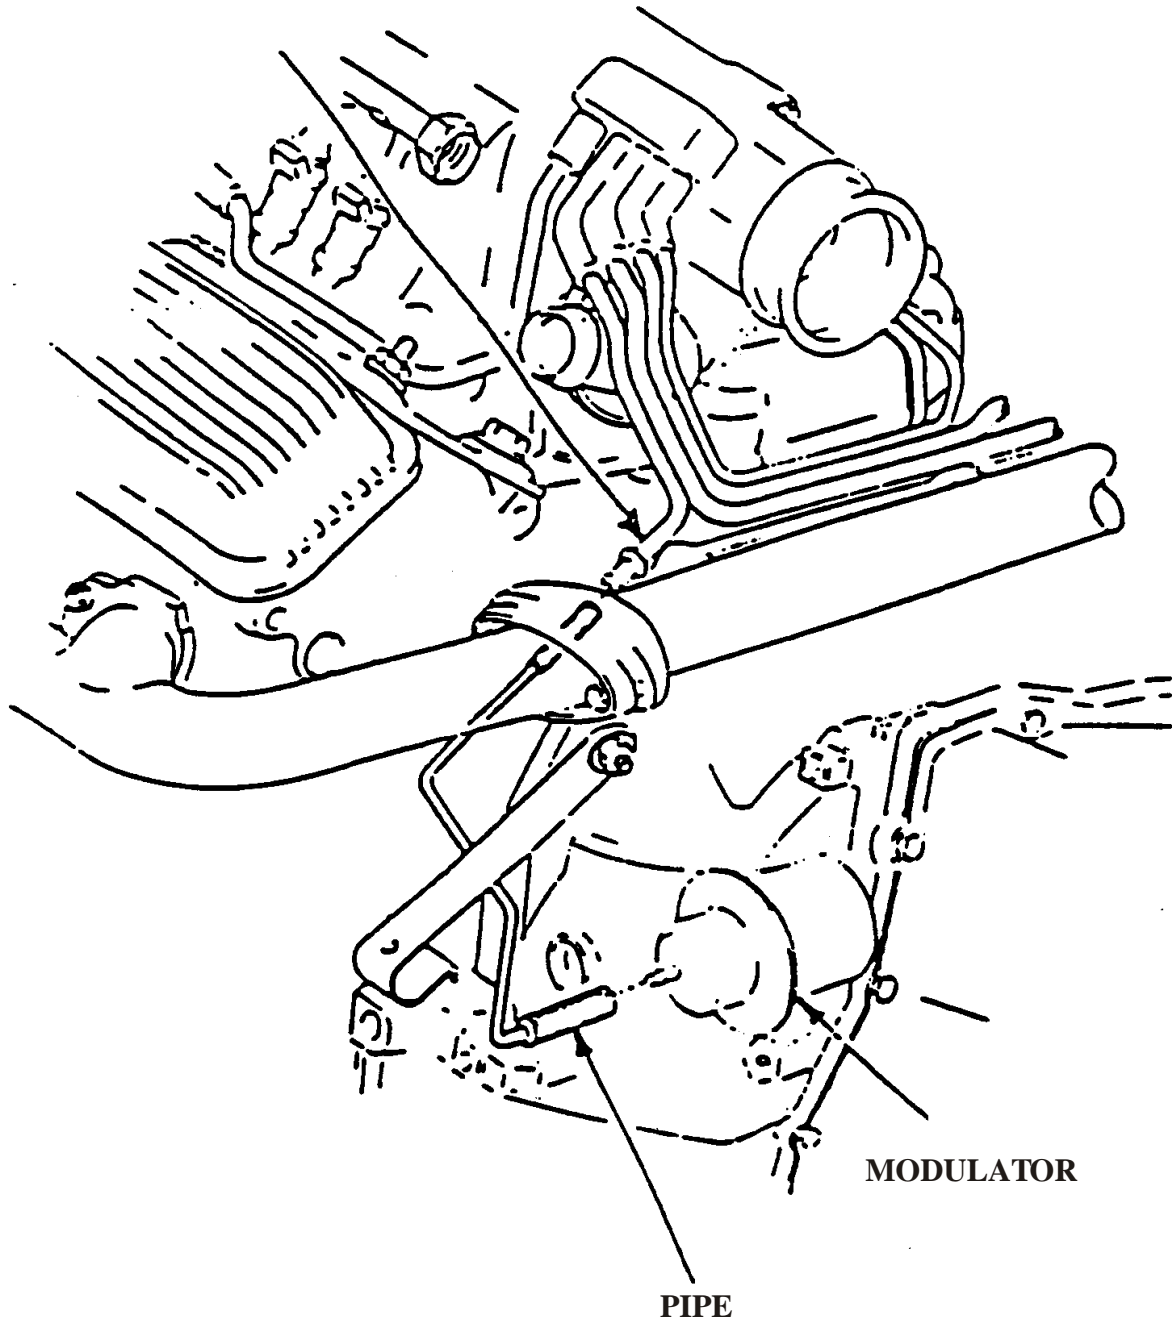
VACUUM HARNESS ASSEMBLY

A repeat THM 440T4 transaxle failure may be due to pinched or kinked vacuum lines causing low oil pressure. Visual inspection of lines is inadequate to detect this condition. Connect a vacuum gauge at the modulator by use of a tee with adequate hose length to observe gauge. With the engine running and the throttle closed, the vacuum reading at the modulator should be 13-17 inches. When the throttle is opened, vacuum drop should be IMMEDIATE. A slow vacuum drop when the throttle is opened would indicate a kinked or pinched vacuum line. Vacuum retained in the modulator will reduce line pressure and result in a second clutch failure.

A mid year production change eliminated the aspirator/solenoid. This replace with a solid steel line applying vacuum directly to the modulator. If an inadequate supply of vacuum to the modulator exists or if the aspirator/solenoid should fail giving the vehicle SECOND GEAR STARTS, we recommend that the solid steel line to the modulator be installed. See FIGURE 1.

NOTE: The electrical connector to the aspirator system solenoid should be taped back out of the way.

Two pieces of 7/32" vacuum hose and a steel line part numbers 25527722 3.8L engine and others 25527723.
