EAGLE 4HP-18 DELAYED OR NO REVERSE

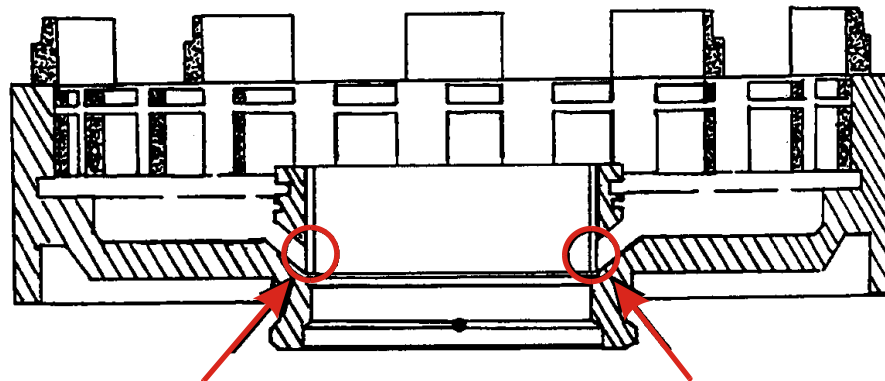
Figure 1

CAUSE: One cause may be that the bushing in the reverse input drum has moved forward blocking the two oil feed holes (See Figure 16). The normal position of the bushing is about .060" above the drum surface and covers 50% of the feed holes (See Figure 17).

**OIL FEED HOLES BLOCKED BY BUSHING
INCORRECT BUSHING PLACEMENT**

CORRECTION: Currently, this bushing is not serviced separately so the entire drum will need to be replaced to correct this condition.
