## MITSUBISHI F4A40/50 SERIES HARSH OR FLARED 3RD GEAR UPSHIFT

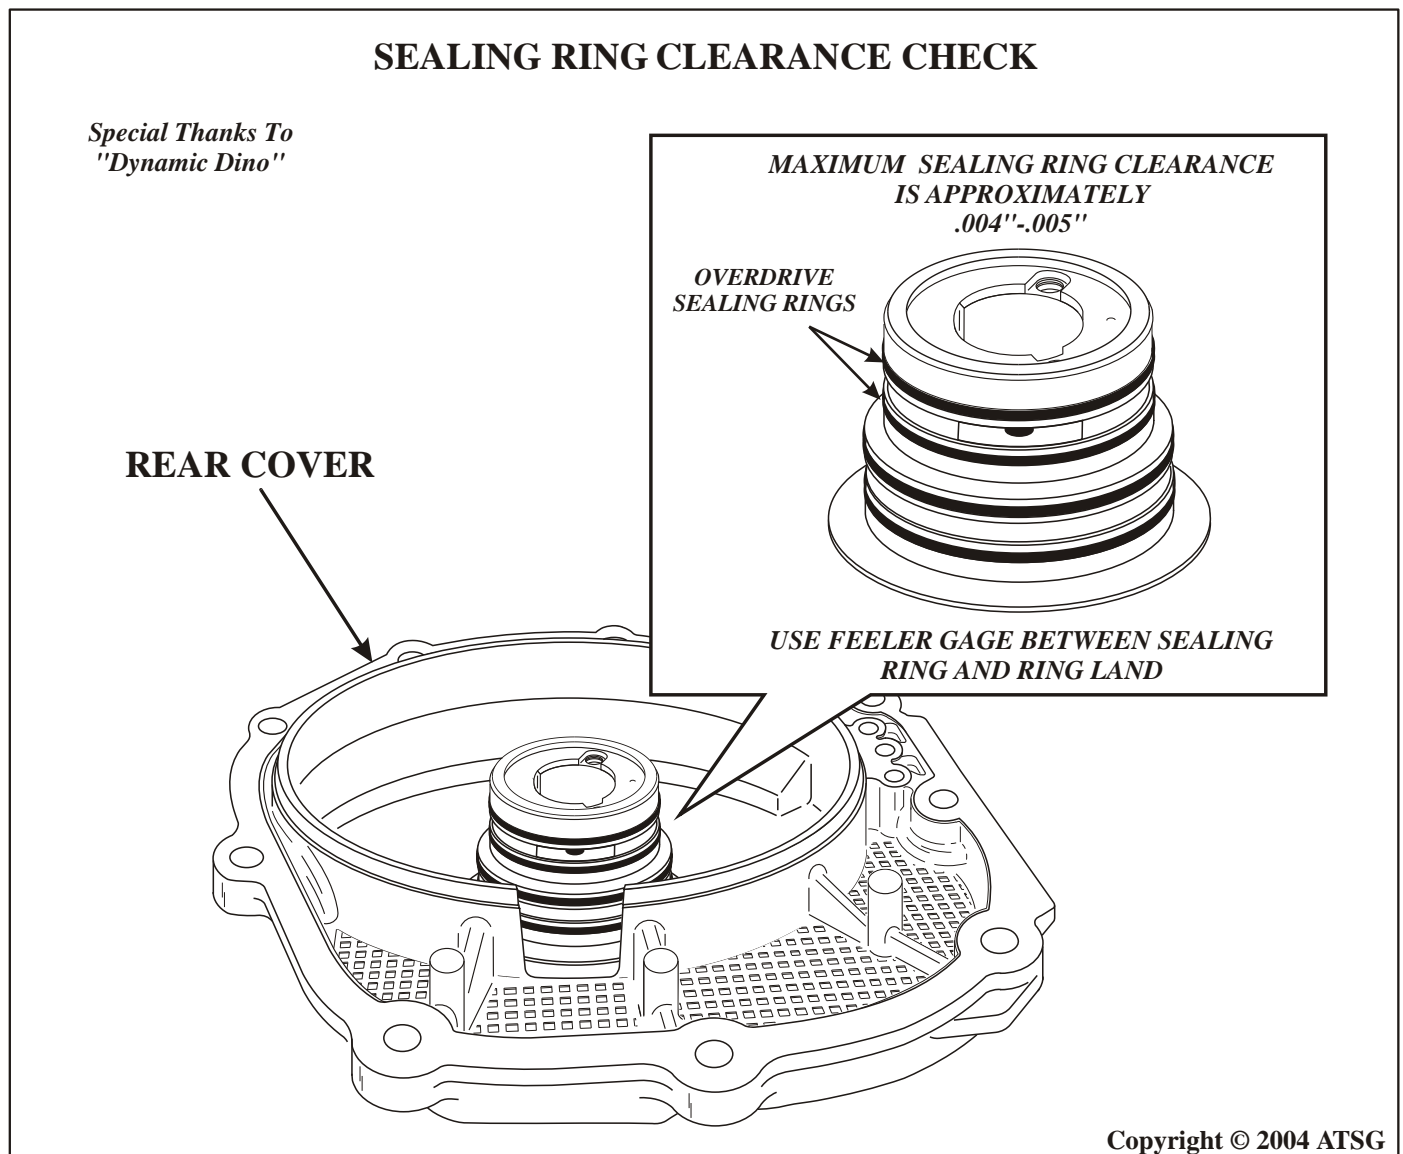
**COMPLAINT:** Before or after overhaul, vehicles equipped with the F4A40 or F4A50 series transaxles may exhibit a Flared or Harsh upshift into 3rd gear.

**CAUSE:** The cause may be, worn sealing ring lands where the Overdrive Clutch sealing rings ride, creating leakage in the Overdrive Clutch circuit.

**CORRECTION:** Refer to Figure 1 to identify the Overdrive Clutch Sealing Rings. Using a feeler gage ensure that there is no more than .005" clearance between the sealing ring and the sealing ring groove. Replace Rear Cover as necessary.
