FORD AXOD

NO 3-4 SHIFT

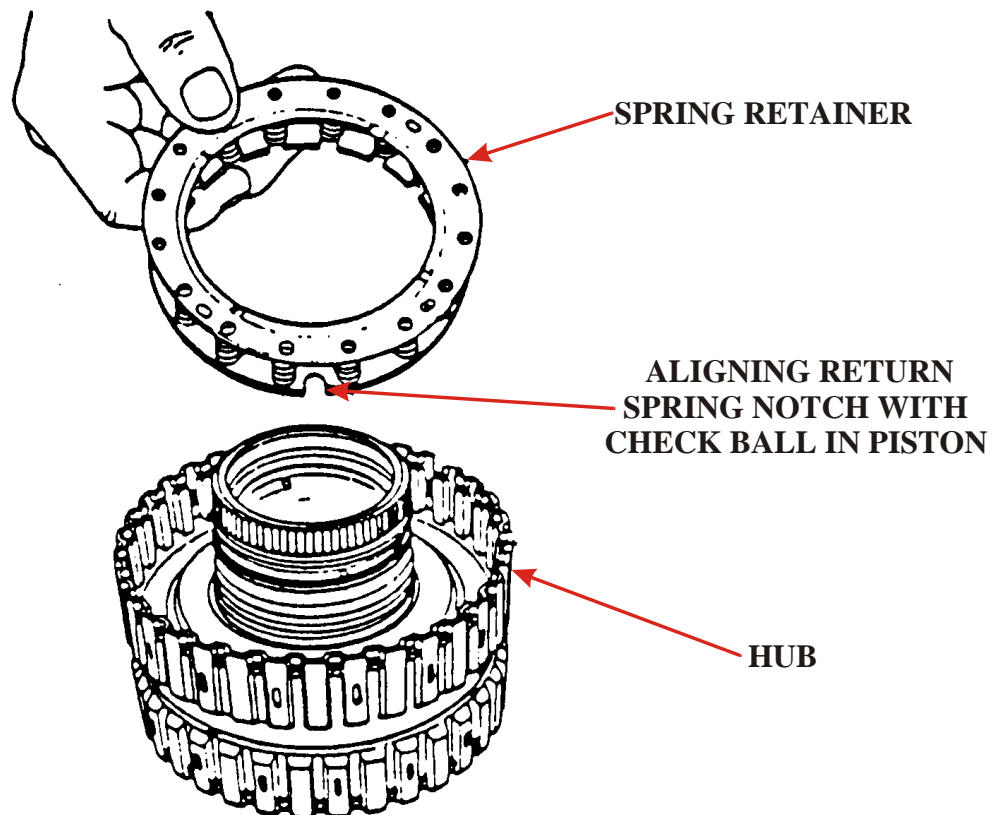
COMPLAINT: An extended 3-4 shift with possible direct clutch failure or a NO 3-4 shift condition.

CAUSE: This condition may be caused by a partially or fully blocked oil flow of the direct clutch piston check ball.

INSTALL RETURN SPRING IN DRUM ALIGNING RETURN SPRING NOTCH WITH CHECK BALL IN PISTON

CORRECTION: Special care must be taken during the overhaul operation when re-assembling the direct clutch return spring over the direct clutch piston. Make sure that the notch in the spring bottom retainer (See Figure 1) is positioned properly over the check ball so it will not block or restrict oil flow of the piston check ball assembly. Refer to Figure 1.
