Technical Service Information

CHRYSLER A604

SLIPS IN REVERSE AND/OR NO REVERSE

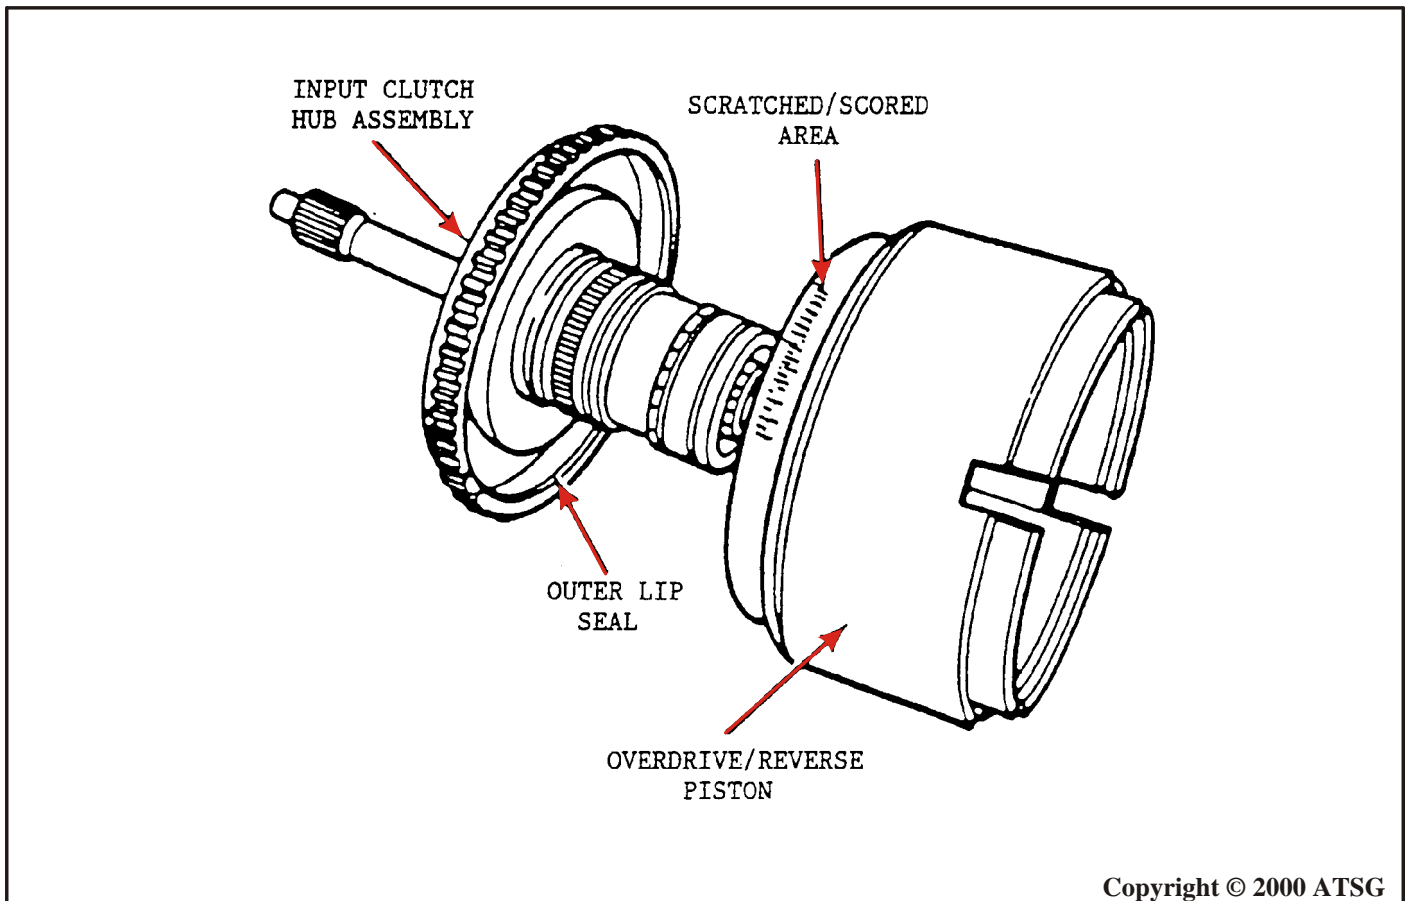
Figure 1

CAUSE: The cause may be an undersized input clutch hub, in the area of the hub outer seal. This undersize condition will result in the Overdrive/ Reverse piston contacting the input clutch hub. This contact results in a scratching/scoring of the Overdrive/Reverse piston in the seal area (See Figure 1).

CORRECTION: Replace the Input Clutch Hub and the Overdrive/Reverse piston. The Overdrive/Reverse piston may be the 8 slot design, or the 4 slot design (See Figure 2).
