Technical Service Information

THM 4T65-E

RATTLING NOISE WITH ENGINE RUNNING

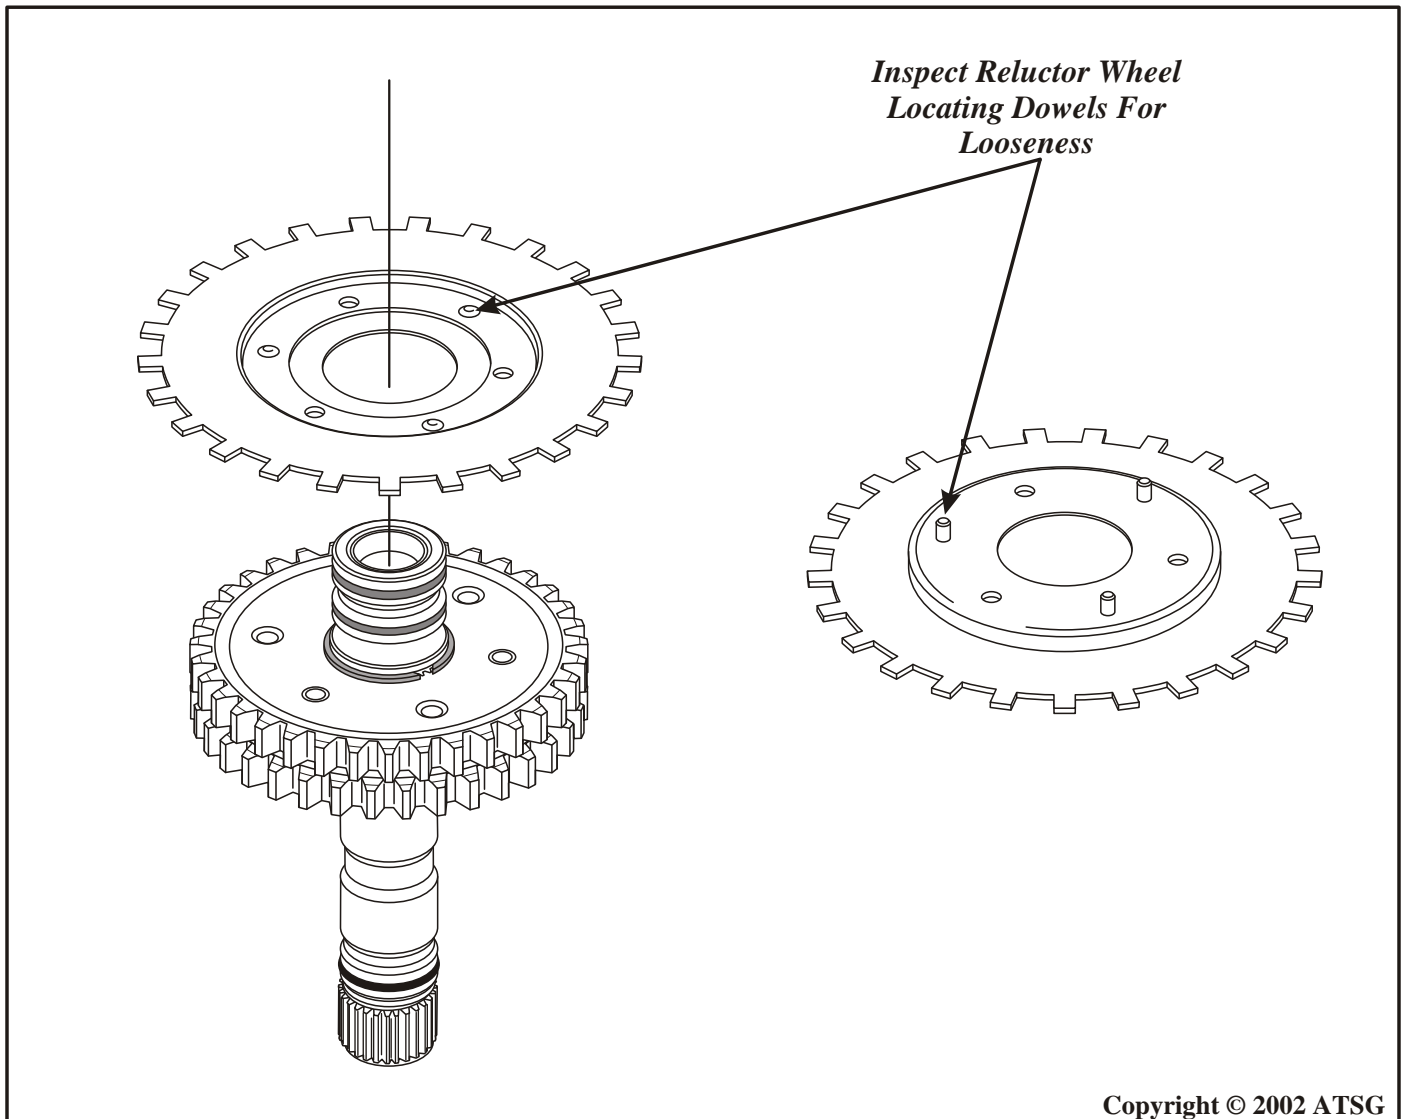
COMPLAINT: Some vehicles equipped with the THM 4T65-E transaxle may exhibit a rattling noise coming from the area of the side cover, and may occur in any gear.

CAUSE: The cause may be, the locating dowels (rivets) being loose in the input speed sensor reluctor wheel. Refer to Figure 1.

CORRECTION: Replace the input speed sensor reluctor wheel with updated OEM part number 24212217.
