# Technical Service Information

## FORD/MAZDA 4F27E/FN4A-EL

### DTC P0741, TCC STUCK "OFF"

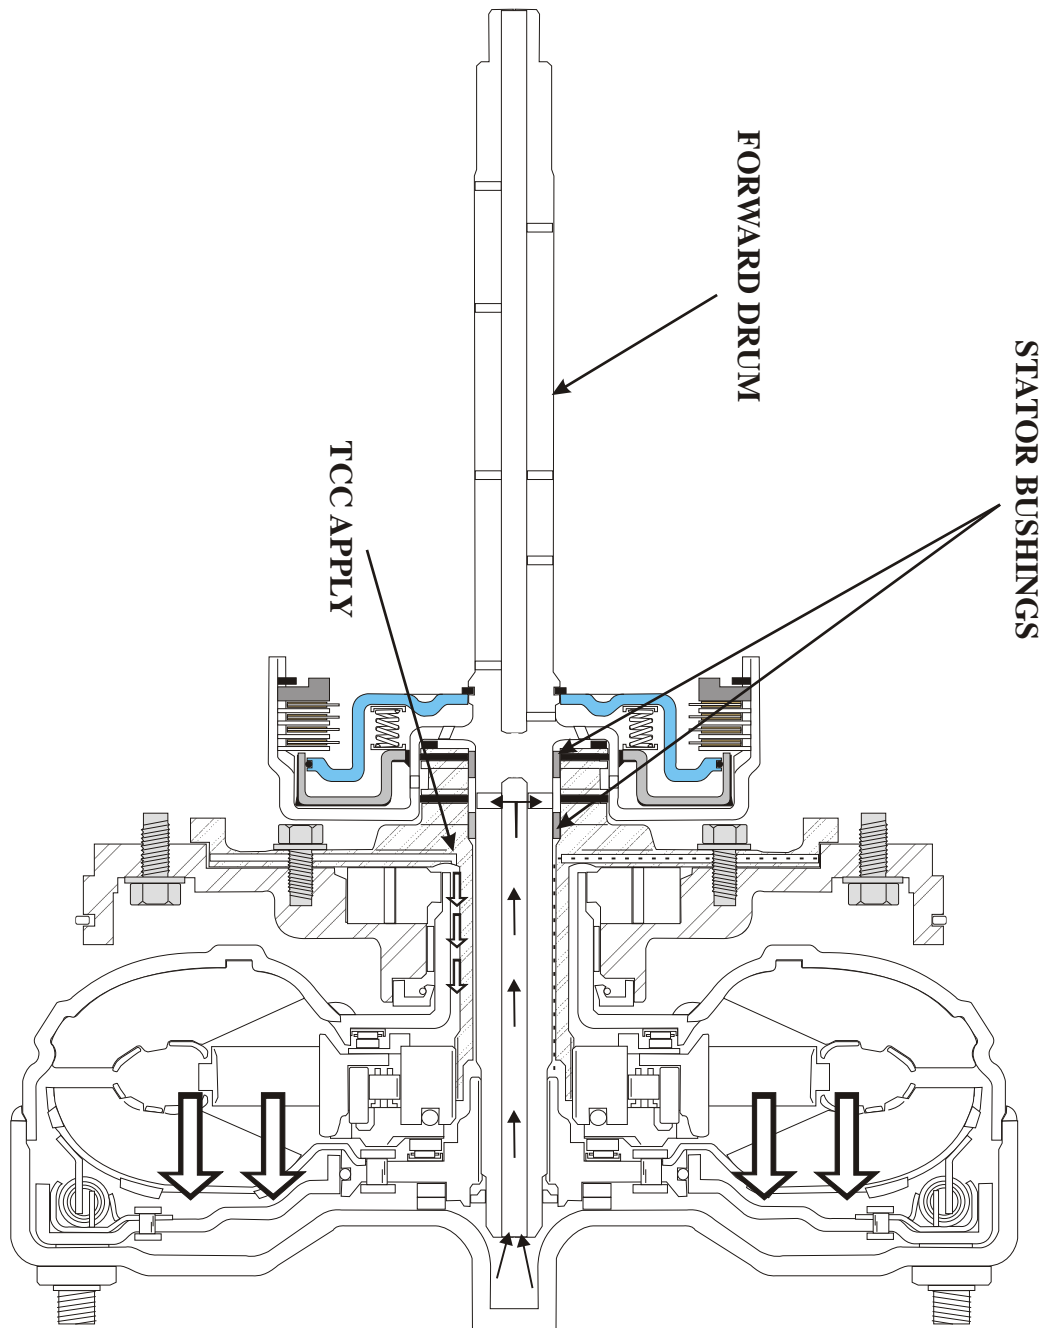
Figure 1

**CAUSE:** The cause may be, the bushings in the rear of the Pump Stator are worn causing a loss of Converter apply oil, when the TCC is applied, as shown in the cut-away in Figure 1. **NOTE:** *When the stator bushings wear, Torque Converter Clutch Apply pressure will be exhausted thru the already exhausting Torque Converter Release pressure.*

## TORQUE CONVERTER APPLIED

**NOTE:** Wear in the Stator bushings may cause a loss of TCC Apply Pressure to the already exhausting TCC Release Pressure, creating TCC slip.

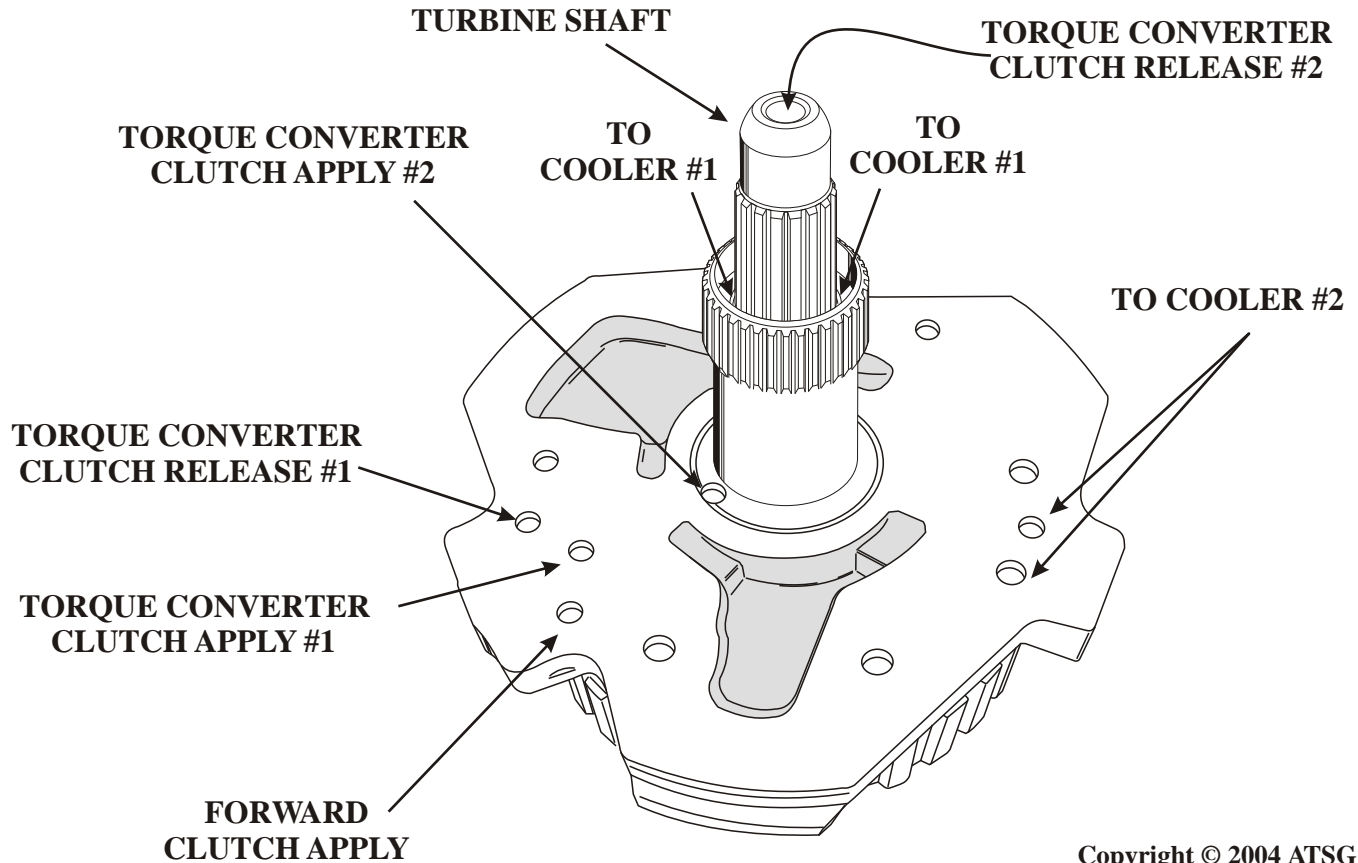
Figure 2

## STATOR PASSAGE IDENTIFICATION

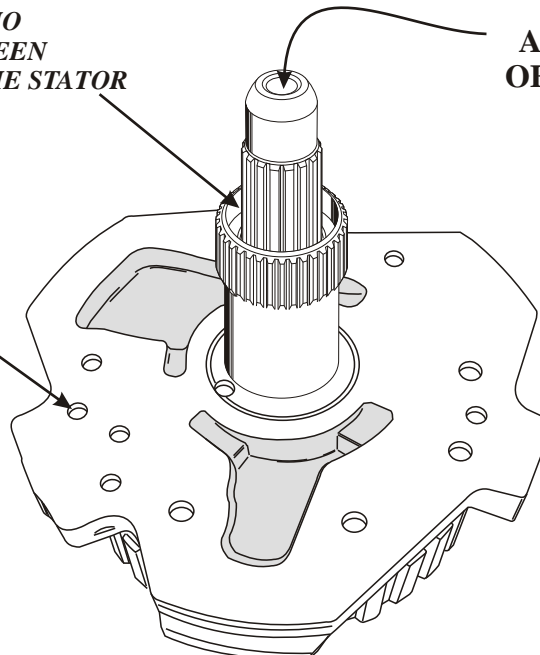
## AIR CHECKING THE STATOR BUSHINGS

*THERE SHOULD BE NO  
AIR LEAKING IN BETWEEN  
THE TURBINE SHAFT AND THE STATOR*

**CORRECTION:** Refer to Figure 2 for the identification of the Turbine shaft and Stator passages. Refer to Figure 3 to air check the Turbine Shaft to ensure that the bushings are worn. Refer to Figure 4 for the location of the Stator bushings. If stator does not pass the air check as shown in Figure 3, the stator bushings must be replaced.

**APPLY 80-100 psi.  
OF AIR PRESSURE  
HERE**

**BLOCK THIS  
HOLE**

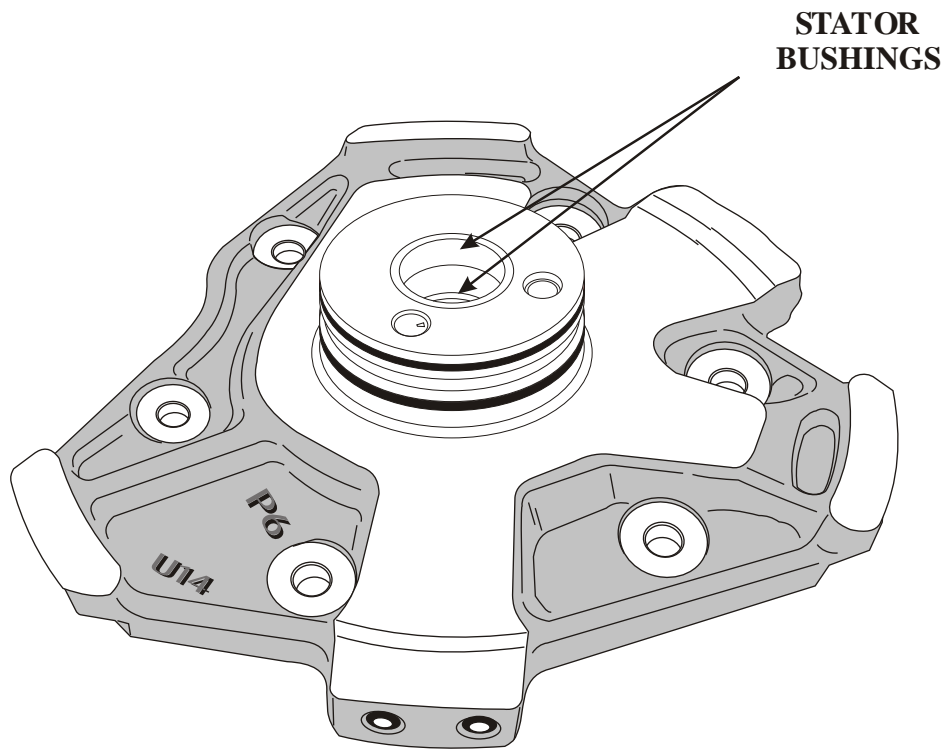
Figure 4

## STATOR BUSHING LOCATIONS

**NOTE:** *At the time of this printing the only bushings available are in the stator of a complete pump assembly.*

PUMP ASSEMBLY (Ford Part number).....3S4Z-7A103-AA  
PUMP ASSEMBLY (Mazda Part number).....FN111-970XB
