"2006" SEMINAR INFORMATION

AUTOMATIC TRANSMISSION SERVICE GROUP

"Top Tech Tricks for 2006"

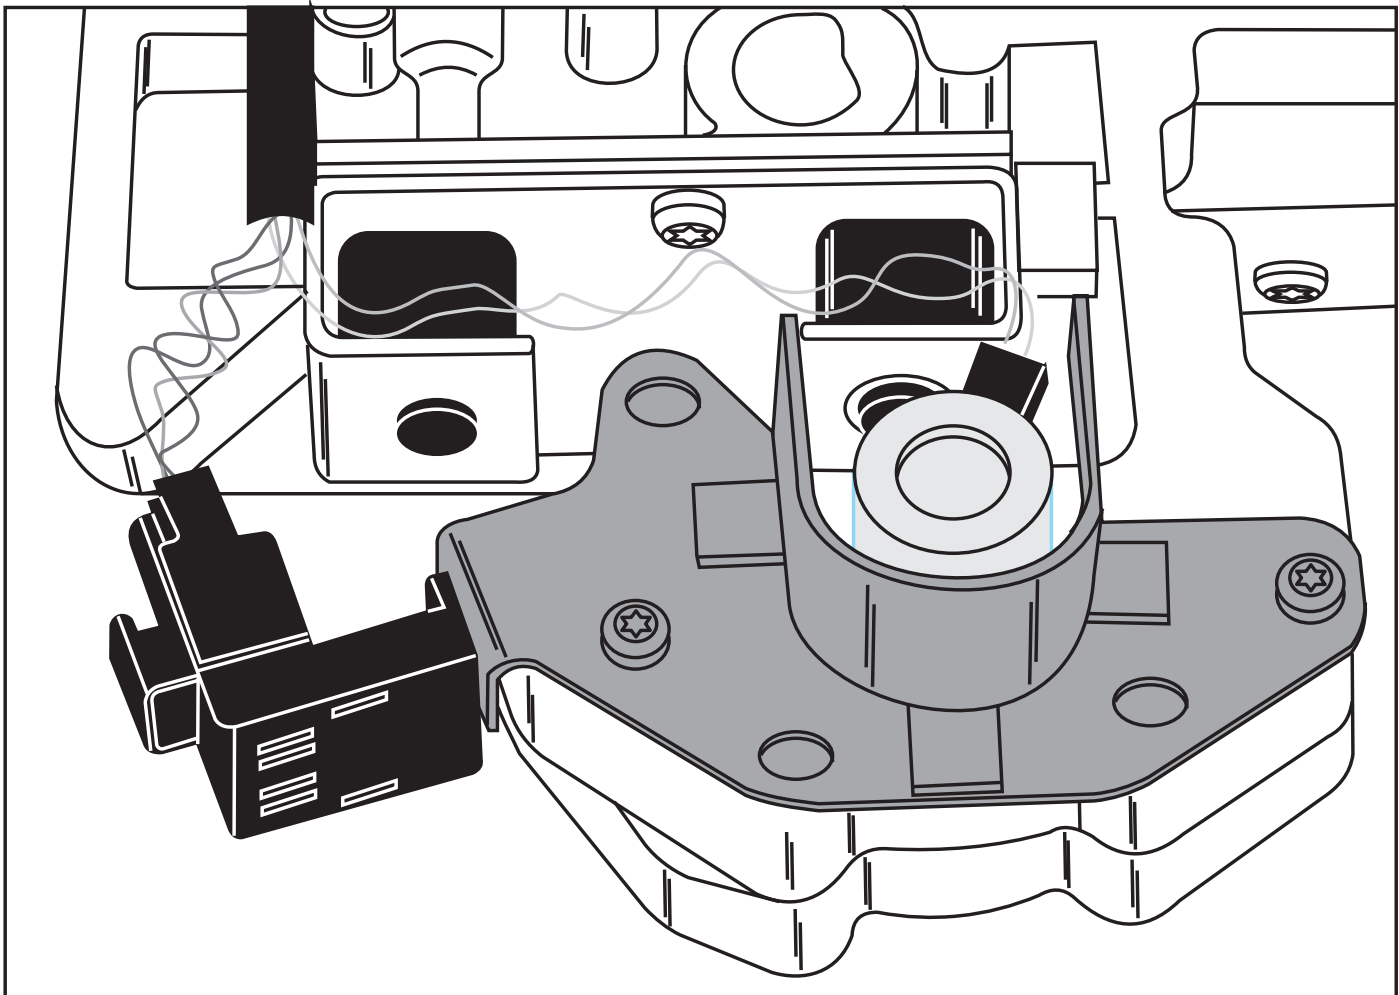
Figure 1

CAUSE: The area of the valve body where the governor pressure control solenoid and the governor pressure sensor are located is warped (Refer to Figure 1). When this area is warped governor pressure from the solenoid to the sensor is leaking causing erratic governor pressure which causes the erratic sensor signal voltage (See Figure 2). This results in oil at the tip of the sensor to vary which causes the sensor to vary the signal voltage. The PCM will react by varying the solenoid operation which will result in erratic governor pressure.

CORRECTION: Check the crush on the solenoid/sensor gasket which might reveal warpage in this area. Flat sand the solenoid/sensor mounting block as well as that area of the transfer plate section of the valve body (Refer to Figure 3).

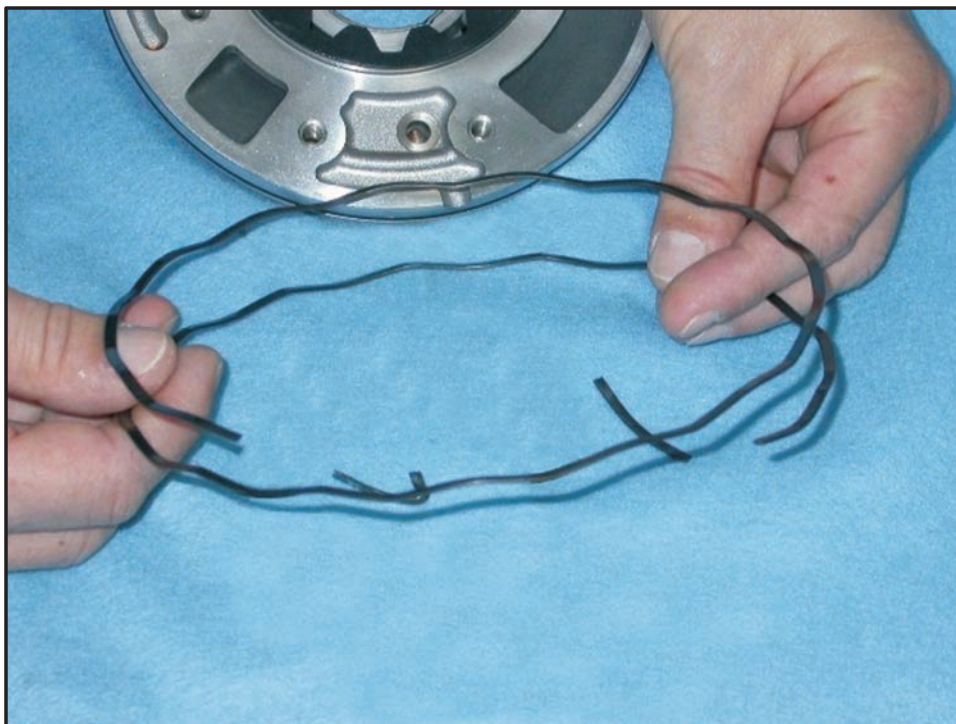
Figure 1

CAUSE: The cause may be broken pump gears and or severely damaged pump assembly. Pieces of Low/Reverse spiral cushion wave spring (Figure 1) located on top of the Low/Reverse clutch assembly (Figure 2) may be found lodged between the pump gears (Figure 3). When the filter is cut open, there is a 3 to 4 inch section of filter media that is not crimped along edge of filter halves during assembly. This allows the broken wave spring to enter the pump assembly (Figure 4).

CORRECTION: Replace pump and filter. Some after market filters have been found to have no problems with the filter media assembly.

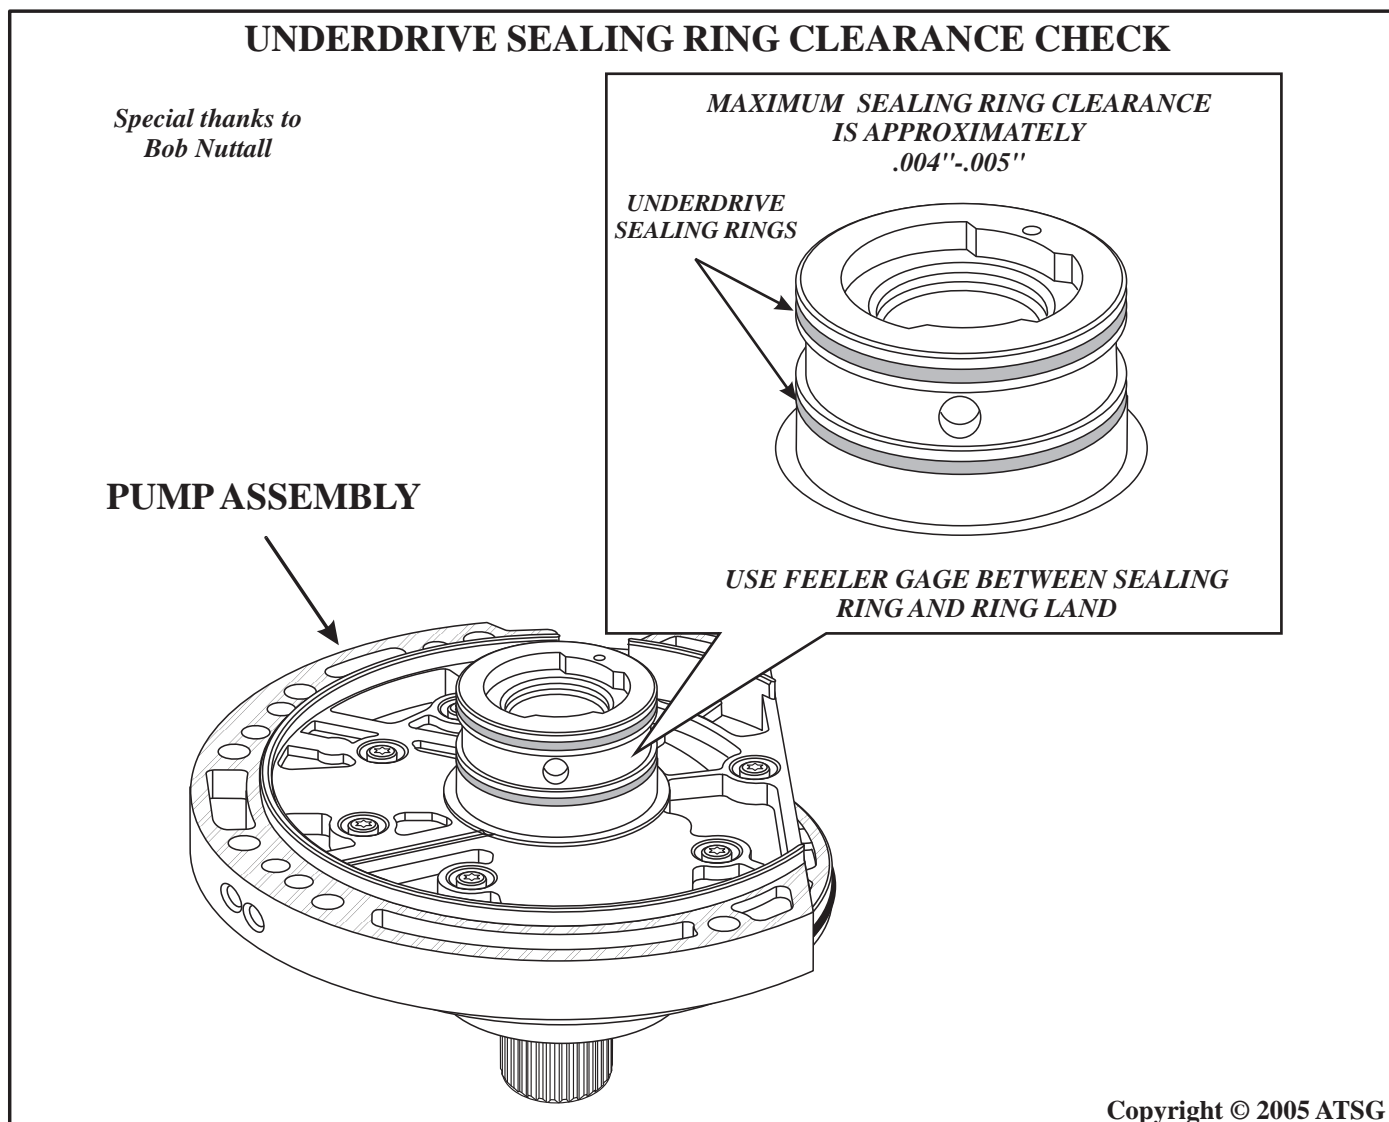
CAUSE: The cause may be, worn sealing ring lands where the Underdrive and or Overdrive Clutch sealing rings ride, creating leakage in the Underdrive or Overdrive Clutch circuit.

CORRECTION: Refer to Figure 1 to identify the Underdrive Clutch Sealing Rings. Using a feeler gage ensure that there is no more than .005" clearance between the sealing ring and the sealing ring lands. Repeat the same process for the Overdrive Clutch Sealing rings as shown in Figure 2. Replace the Pump stator or Rear Cover as necessary. **NOTE: Refer to Figure 3 and notice the "R-14" that is cast into the Pump Cover/Stator Support and Rear cover. This identify's a new design part which is made out of stronger material reducing ring land wear.**

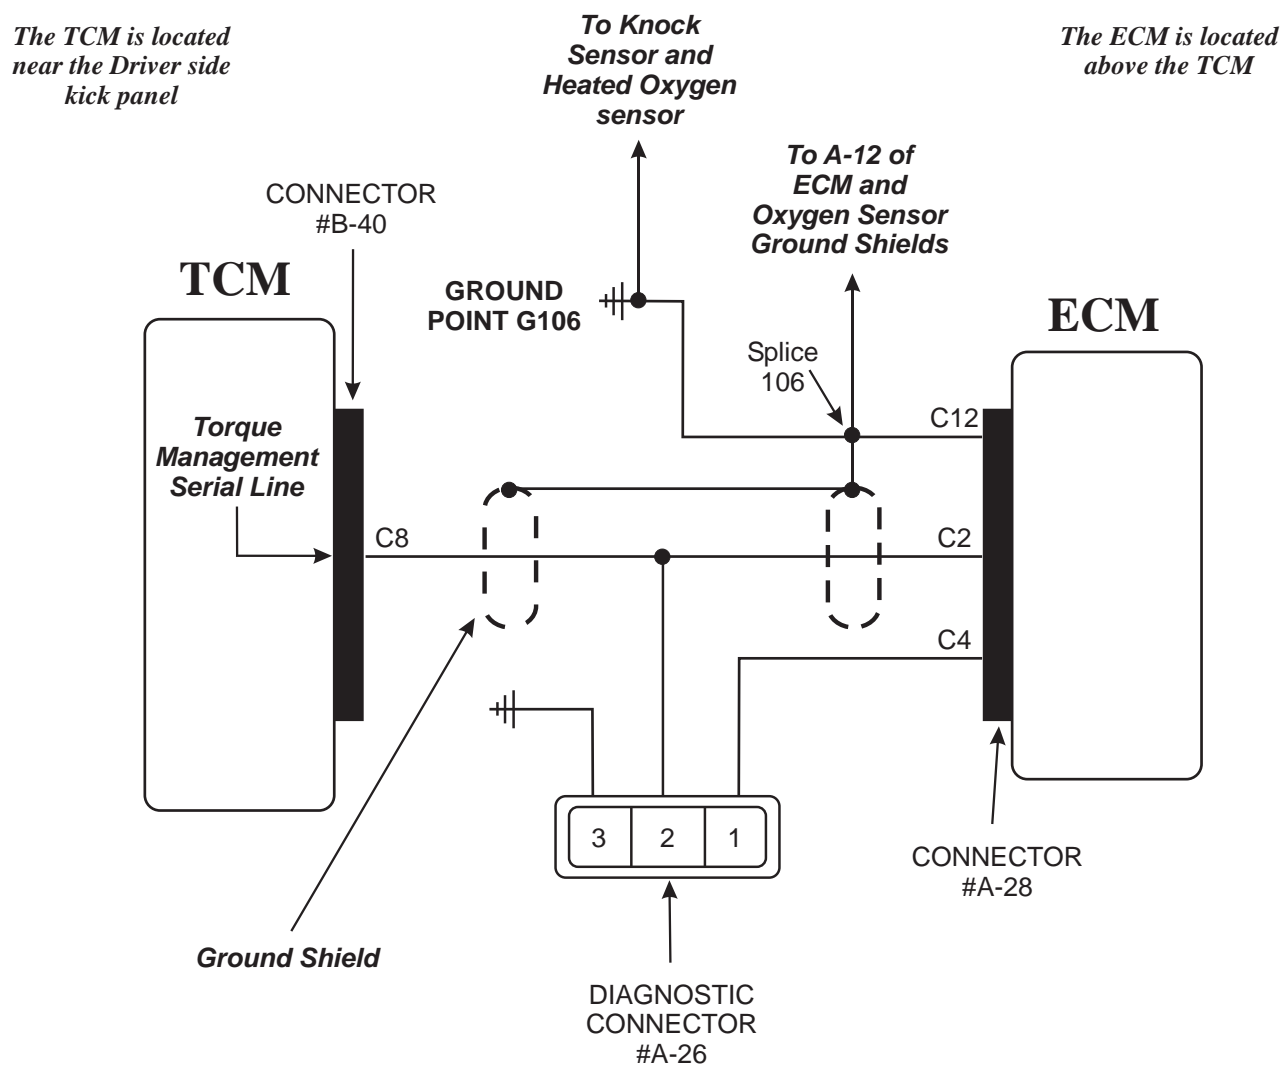
CAUSE: The cause may be, a wiring or connection problem in between terminal C8 of the B-40 connector at the Transmission Control Module and the C2 terminal of the A28 connector at the Engine Control Module. See Figure 1 for a partial wire schematic and notice that there are two oval dotted lines around the Torque Management Serial Line. These are an indication of ground shields. These ground shields are in place to prevent induced voltage from getting into the Serial Line. These ground shields are also connected to Oxygen Sensors and the Knock Sensor ground circuit, which is connected to Ground Point G106. A DTC 37 can set because of problems in the harness on the Serial Line, or a problem with the shielded wire, or a loose connection at Ground Point G106.

CORRECTION: Locate the ECM and the TCM as shown in Figure 1. Disconnect the connectors from the computers and verify the integrity of the wire between C8 of the TCM and C2 of the ECM. If the wire checks good, refer to Figure 2 and clean the connection at Ground Point G106.

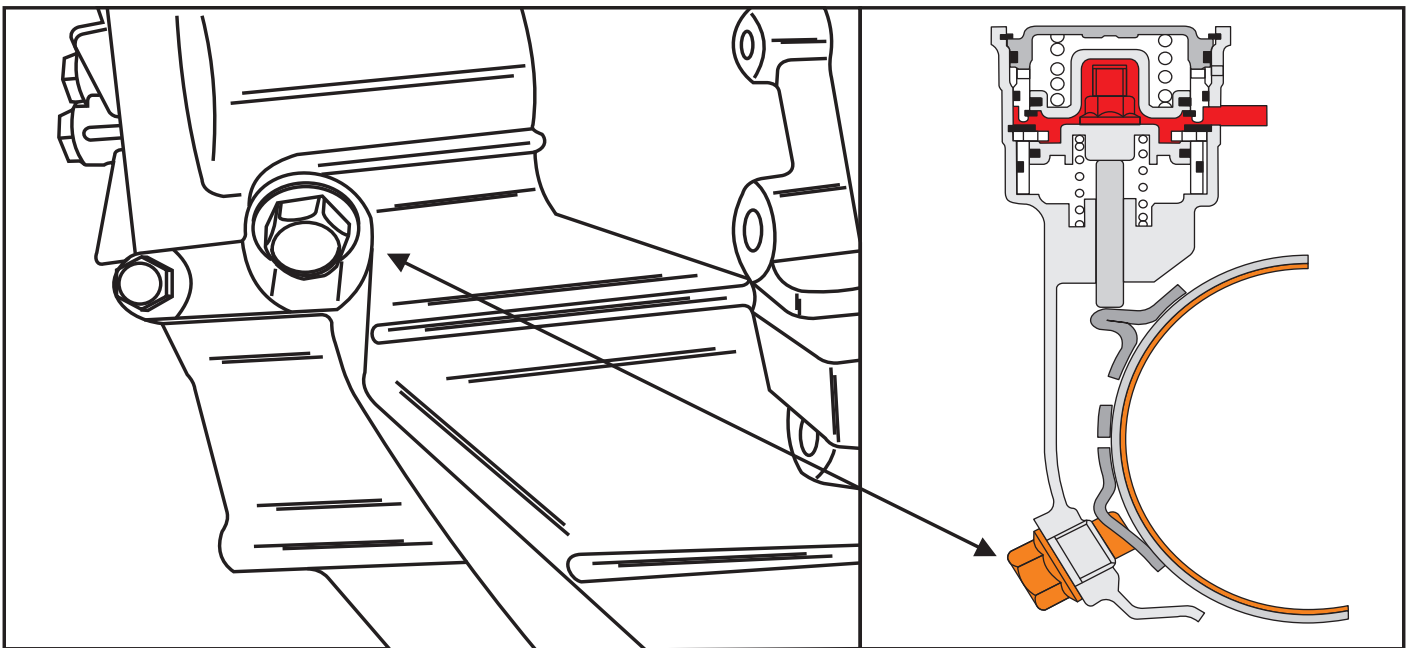
Figure 1

CAUSE: One cause may be that the Reduction band anchor bolt (Figure 1) was accidentally mistaken for the fill plug. When the bolt was removed the band dropped out of position.

CORRECTION: Some have said they were able to lift the band into position through the servo bore. If this can not be done, the transmission will need to be removed and disassembled to gain access to the band to place it back into it position.

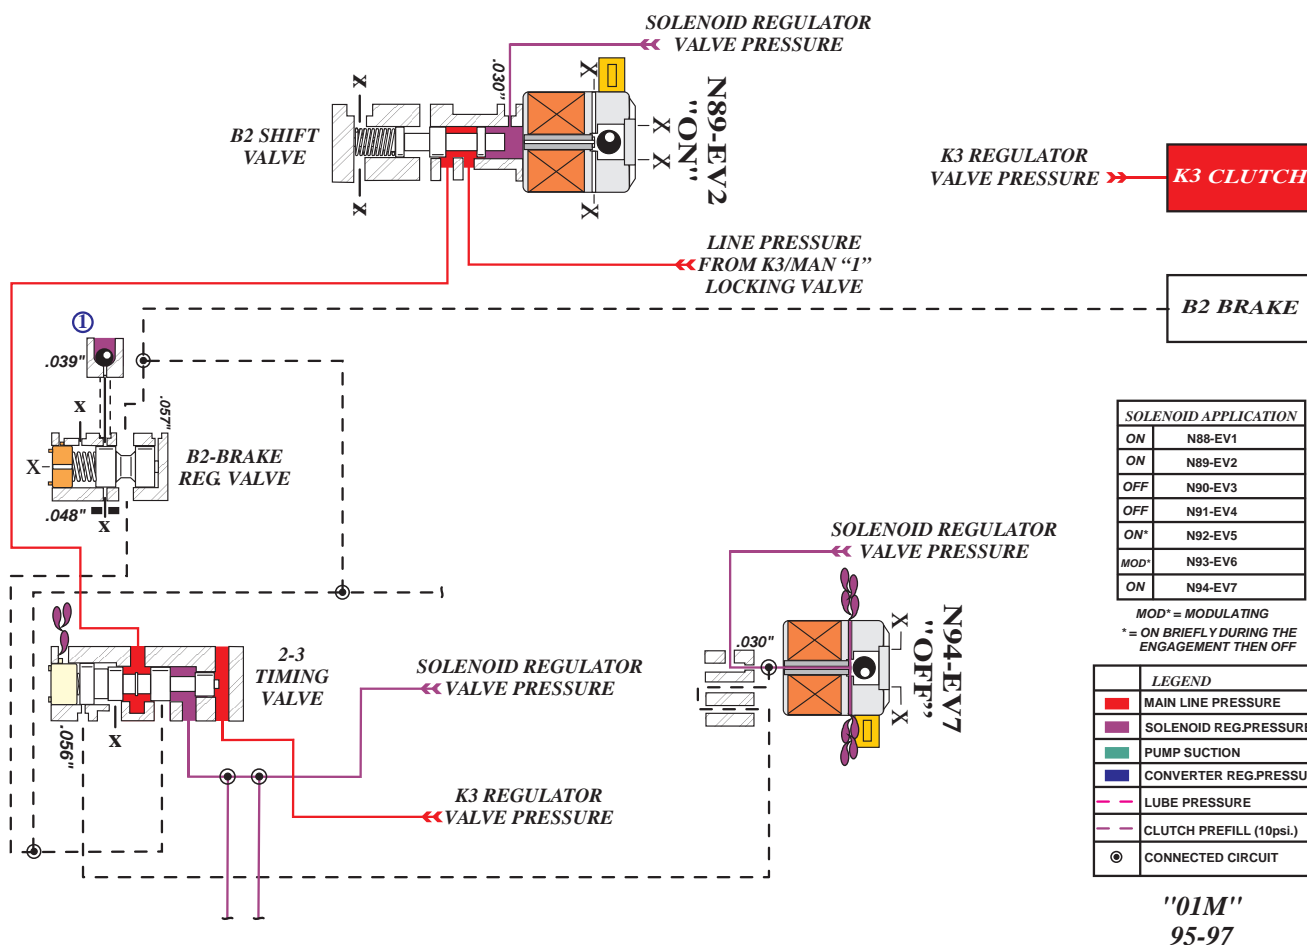
Figure 2

This partial hydraulic schematic depicts a hydraulic circuit that is leaking either at Solenoid Valve EV7, or the 2-3 Timing Valve bore plug. If the solenoid is open and can't close, or the bore plug is leaking, oil pressure at the spring side of the 2-3 timing valve won't build up and stop the valve from stroking. If this happens, line pressure from Solenoid valve EV2 won't be able to pass through the valve and apply the B2 Brake. The resulting condition will be a neutralizing effect because only the K3 clutch will be applied.

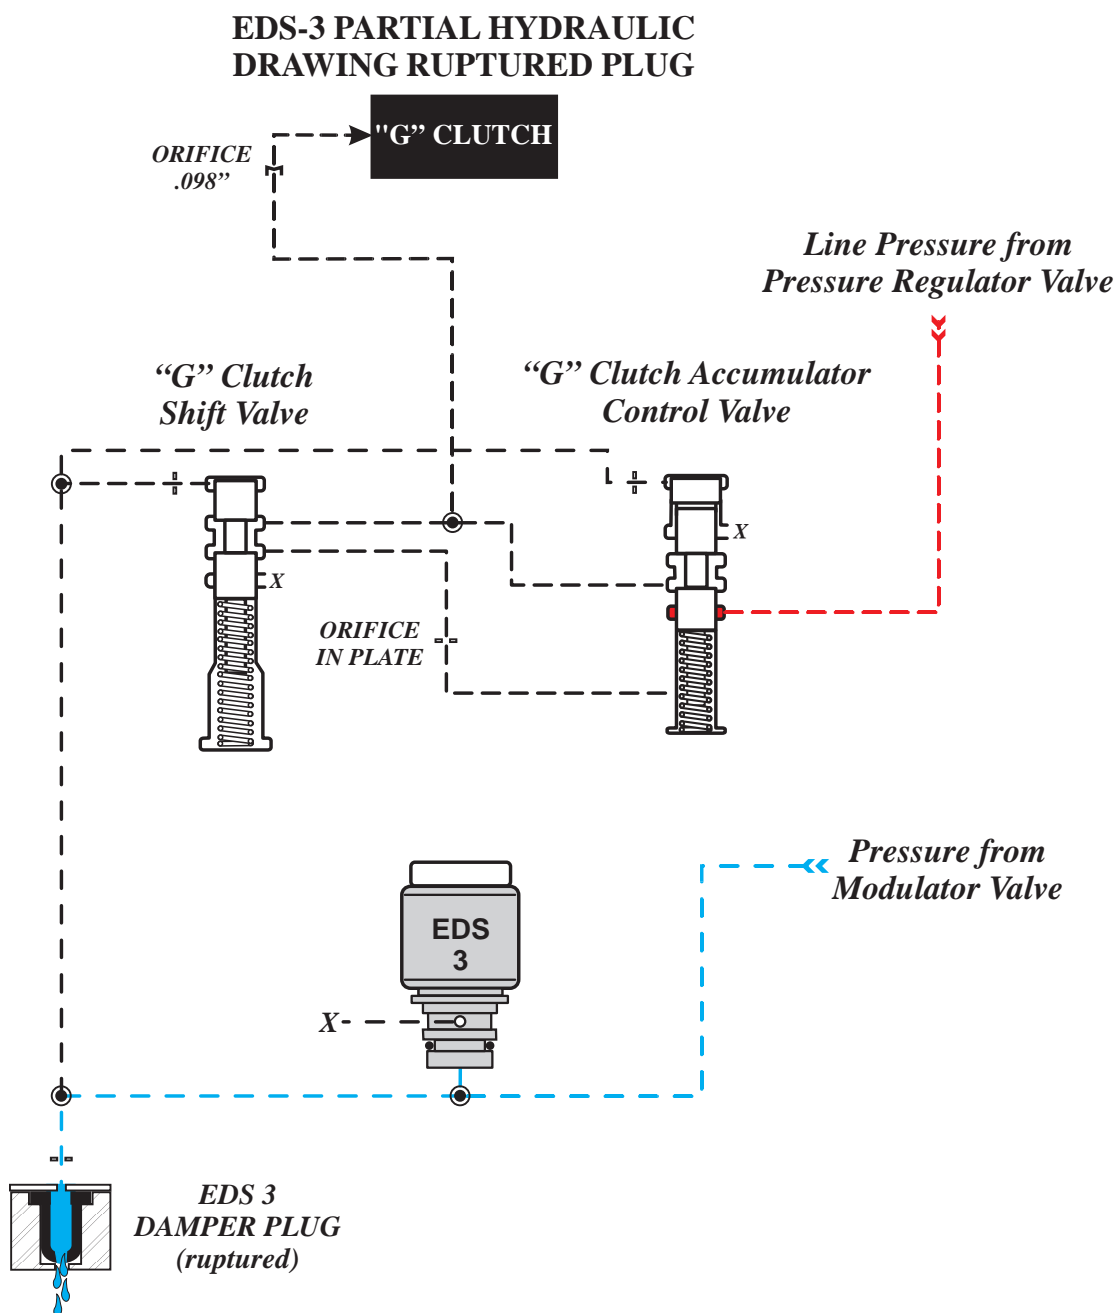
EDS 3 is used to control the engagement of the "G" clutch. This hydraulic circuit drawing shows oil flow with a ruptured EDS 3 Damper.

NOTE: With a ruptured EDS 3 Damper Plug, EDS 3 oil pressure exhausts through the hole in the bottom of the damper plug thereby not accumulating and passing to both Shift Valve "G" and Accumulator Control Valve "G".

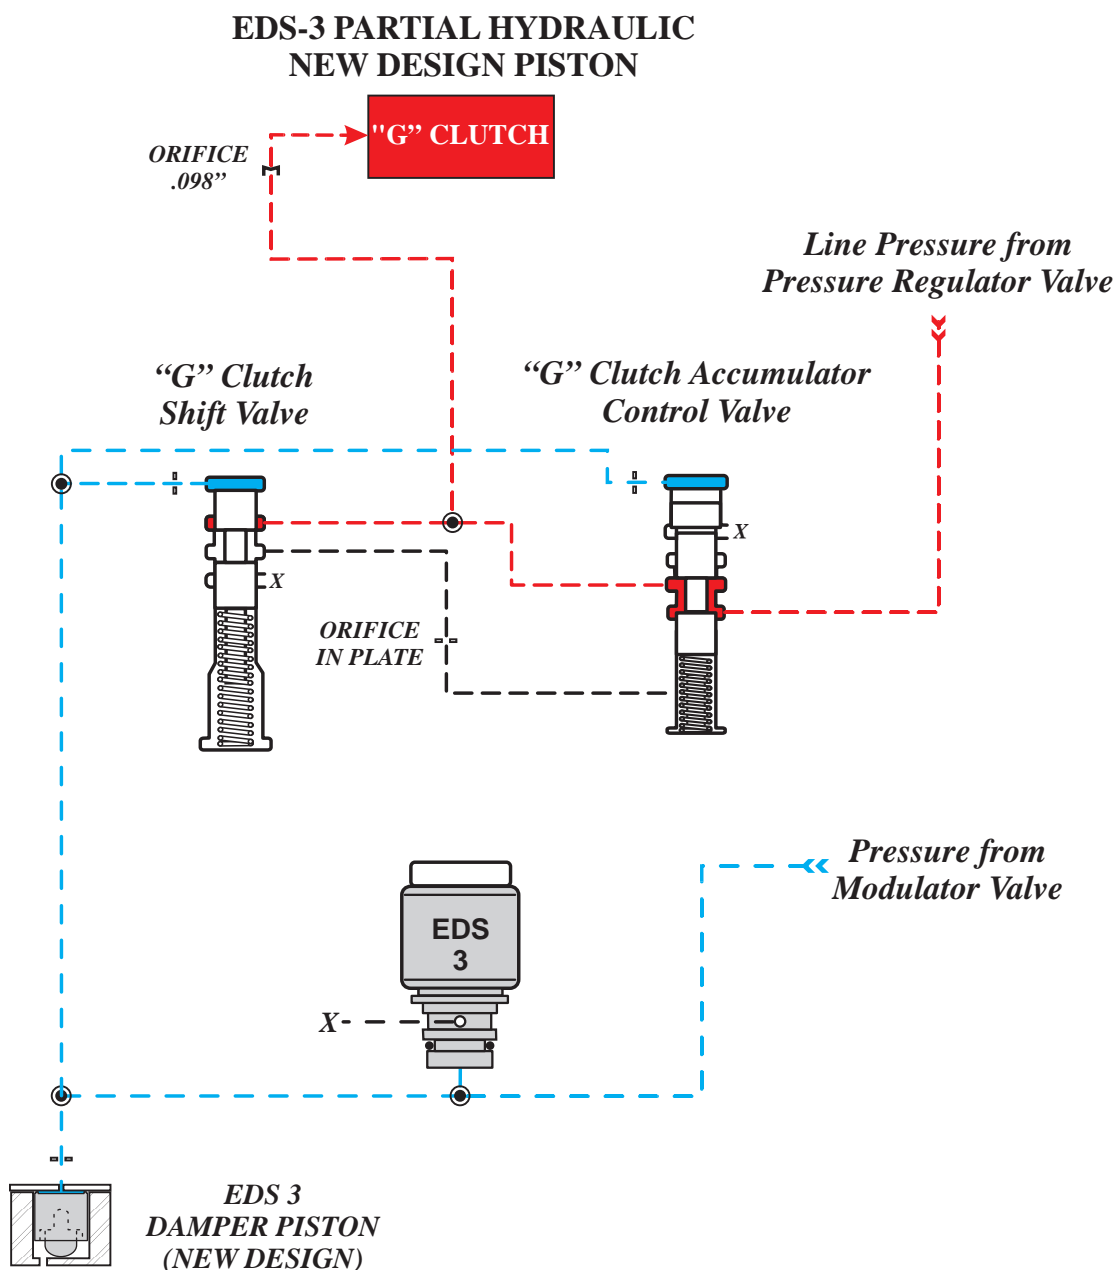
This hydraulic circuit drawing shows oil flow with New Design EDS 3 Damper Piston.

NOTE: *With a new design damper piston installed in the valve body, oil pressure only contacts the face of the plug. Since the hole is eliminated in the new plug, it reduces the possibility of the plug rupturing, and normal oil accumulation is achieved.*
