Technical Service Information

FORD 4R75E EXCESSIVE SLIP IN FORWARD

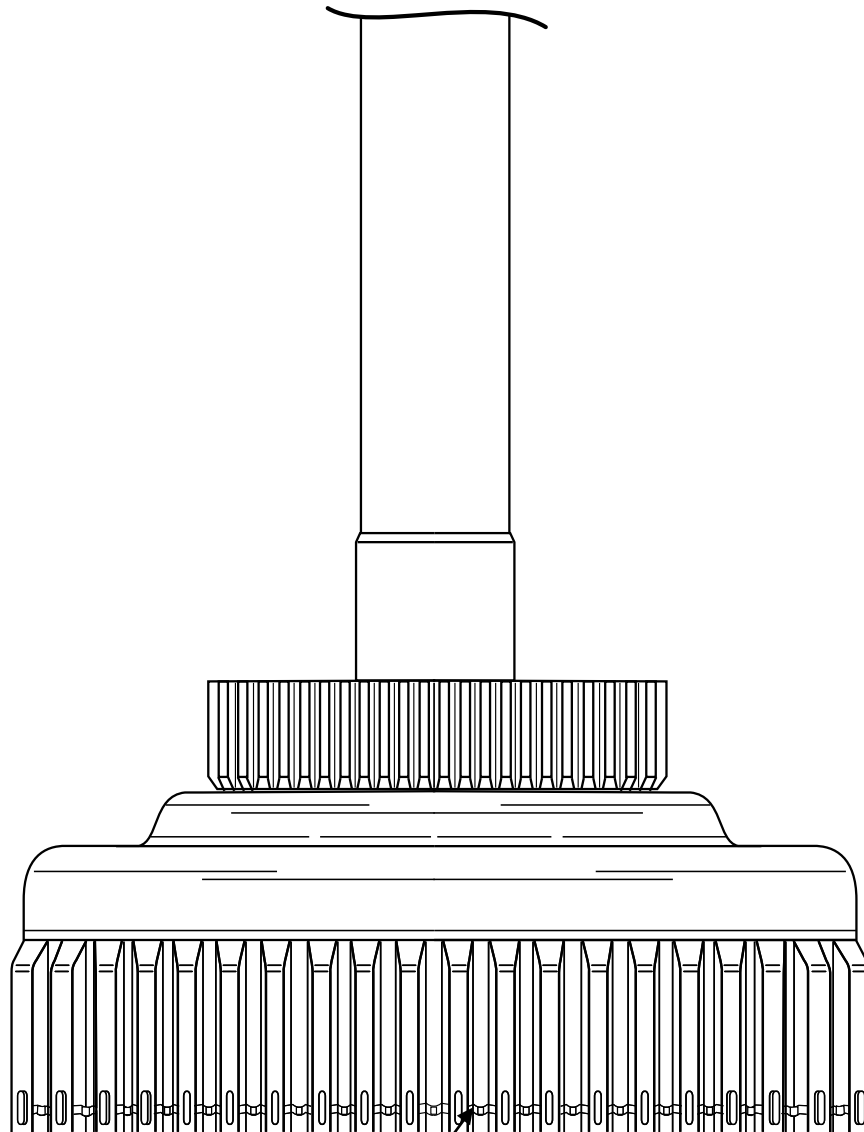
Figure 1

COMPLAINT: Excessive slip in all forward ranges, possible metal debris found in sump.

CAUSE: Cracked forward clutch drum, along the snap ring groove area as shown in figure 1. The metal debris found in the transmission sump is the result of the forward drum pressure plate hitting the inside area of the drive shell. Be aware that upon dis-assembly of a 4R75E if no debris is found in the sump, but the forward clutches are scorched. The crack along the snap ring groove may not be easily seen, check by placing a screw driver or scribe in the snap ring groove and slightly prying to reveal any failure in this area.

FORWARD CLUTCH DRUM

CRACKS ALONG SNAP RING GROOVE

CORRECTION: 1. Replace Forward drum. 2 Re-calibrate the PCM with program # 06B06.

- (1) FORWARD CLUTCH DRUM.....3L3Z-7F207-AA
- (2) In April 2006, Ford Motor Co. issued a news letter to vehicle owners with the Vehicle Identification Number listed in the letter. The letter states that this failure is caused by the Powertrain Control Module's shift timing strategy, during excessive 4-3 downshifts that may occur during certain driving conditions (city taxi driving). Ford Motor Company provided a Costumer Satisfaction Program #06B06. Which would re-calibrate the PCM with a revised transmission shift control strategy, free of charge that ended on **August 22, 2006** regardless of mileage. Once this update was completed, an Extended Coverage Program #06N06 for certain 2005 to 2006 Crown Victoria long wheel base vehicles, to replace the forward clutch cylinder also free of charge. The program extends coverage of the forward clutch cylinder to 3 years or 150,000 miles from the start date of the vehicle warranty, whichever occurs first. It is a one time replacement program. This program covers certain vehicles that were built at the St. Thomas Assembly Plant from Job #1 2005 through February 26, 2006. Coverage is also automatically transferred to second owners. If the vehicle owner already paid to have the forward clutch drum repaired before receiving the news letter, a refund would be provided under program #06N06 when a paid original receipt was presented to the local dealer **before May 22, 2006**. Even if the forward clutch drum was replaced the vehicle owner still needed to have program #06B06 performed to update the PCM transmission shift control strategy calibration.

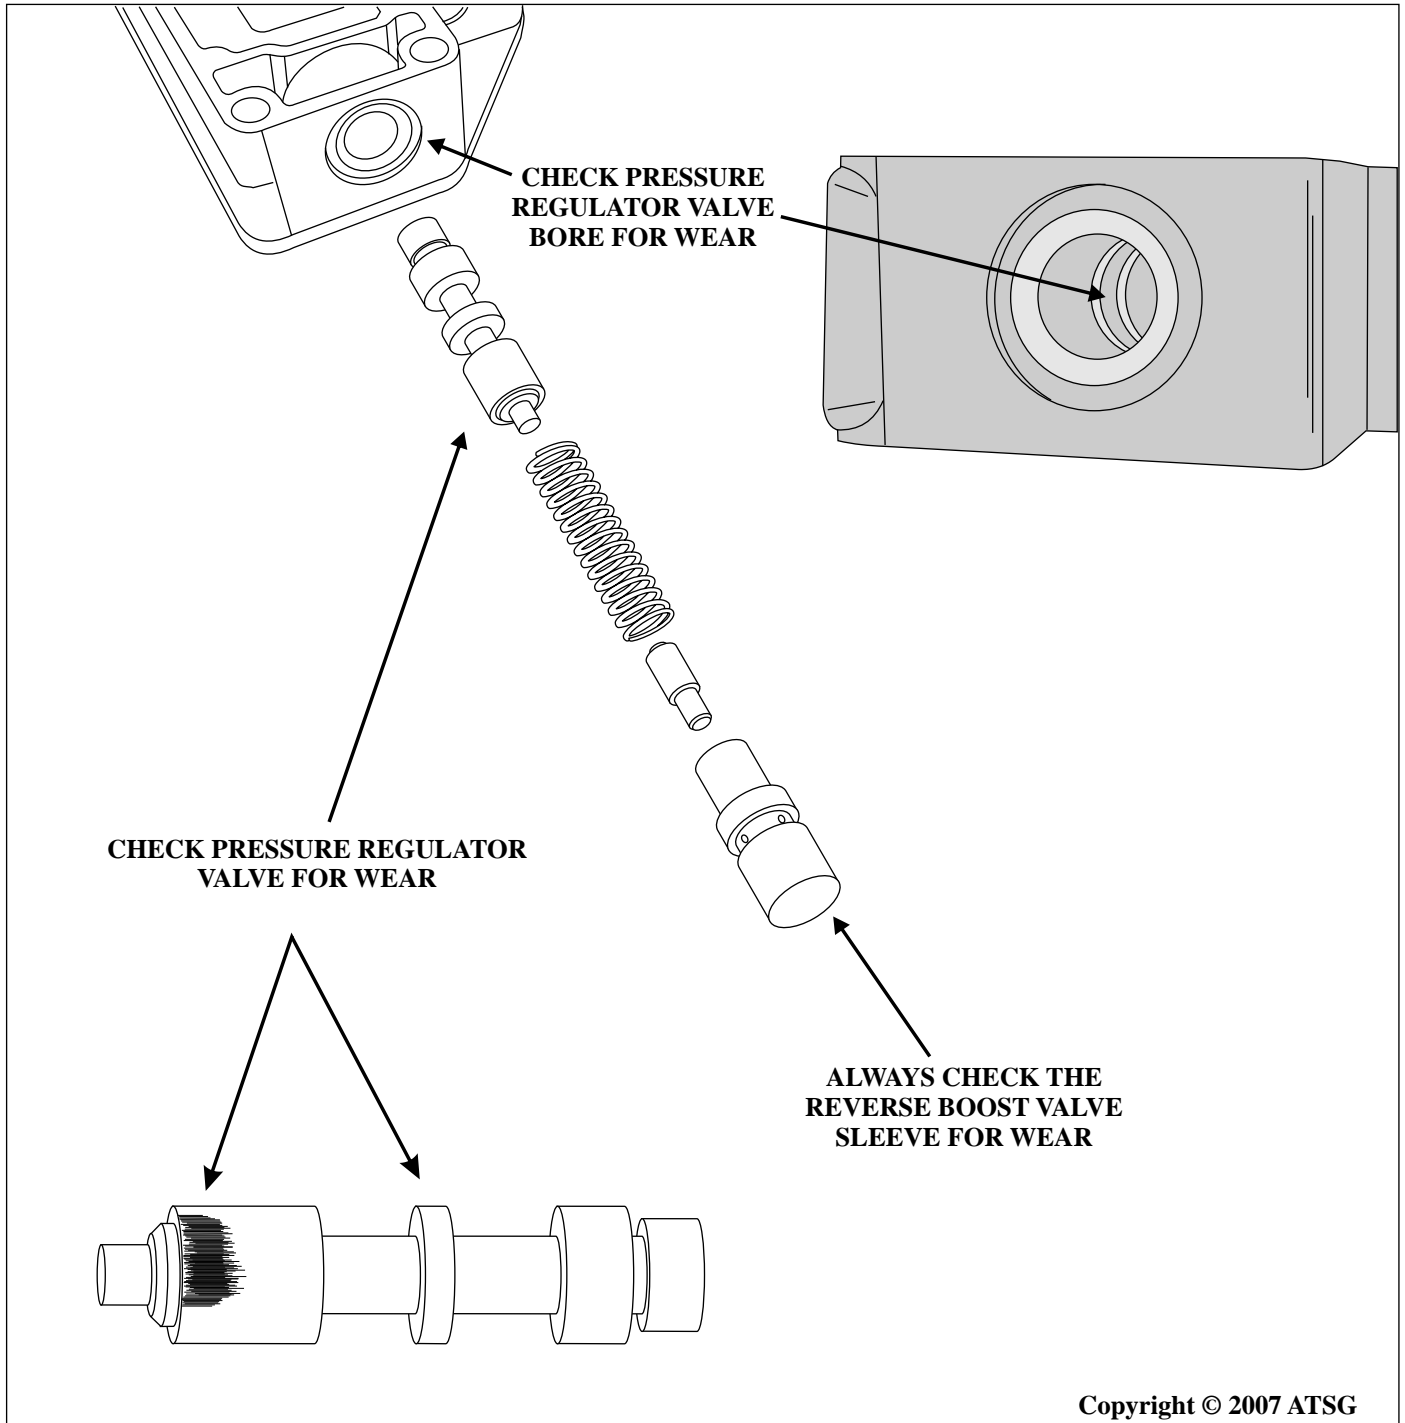
NOTE: ATSG has received several tech calls on vehicles that are not listed or covered under this Costumer Satisfaction Program showing up in shops with the same failure of the forward clutch drum. We have also found on some of these vehicles with as little as 35,000 miles, the valve body would have severe wear in the Pressure Regulator Valve bore. This may also cause Forward drum failure due to pressure spikes. See Figure 2 .
