Technical Service Information

CHRYSLER JEEP AW4 2-3 FLAIR/REVERSE DELAY

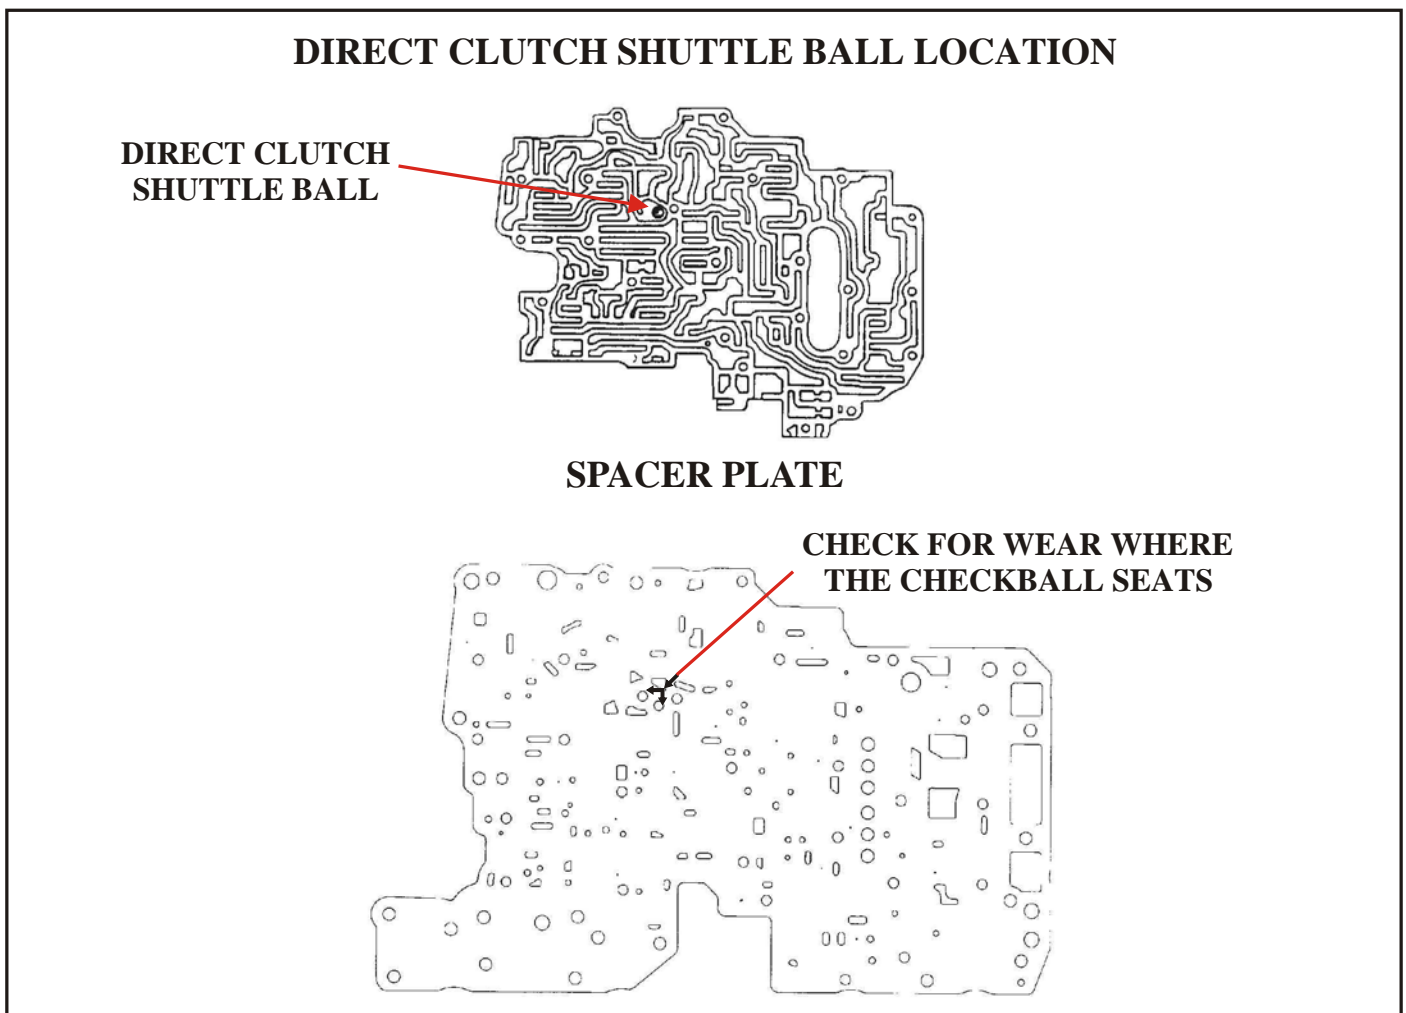
Figure 1

COMPLAINT: 1987-1989 Jeep vehicles equipped with AW4 transmissions may exhibit a flair on the 2-3 upshift or a delay on Reverse application.

CAUSE: The cause may be:
A worn spacer plate, where the direct clutch shuttle ball seats, causing a loss of direct clutch pressure. (See Figure 1)

CORRECTION: Replace the spacer plate.

SPACER PLATE PART NUMBER.....83503770
