Technical Service Information

MERCEDES 722.3 /.4 HARSH ENGAGEMENT INTO REVERSE ONLY

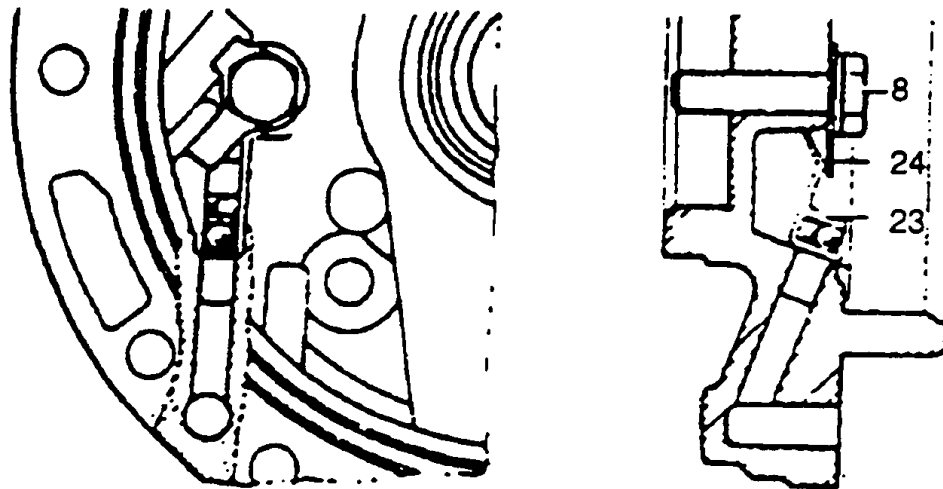
- 8 - Mounting screw, primary pump
23- Ball valve
24- Retaining washer

- COMPLAINT:** Harsh engagement in reverse only.
- CAUSE:** Ball valve in the front transmission cover is defective.
- CORRECTION:** Replace ball valve, part #201270 03 89, and install retaining washer (24), part number 000 463 008403 (Figure 1).
- Production Phase-in of retaining washer: As of trans end #316 257.
- NOTE** Take ball from package only shortly before installation, otherwise the plastic becomes brittle when it dries out and can break during installation.
