1997 SEMINAR INFORMATION

"THE RIGHT DIRECTION FOR '97"

INTRODUCTION

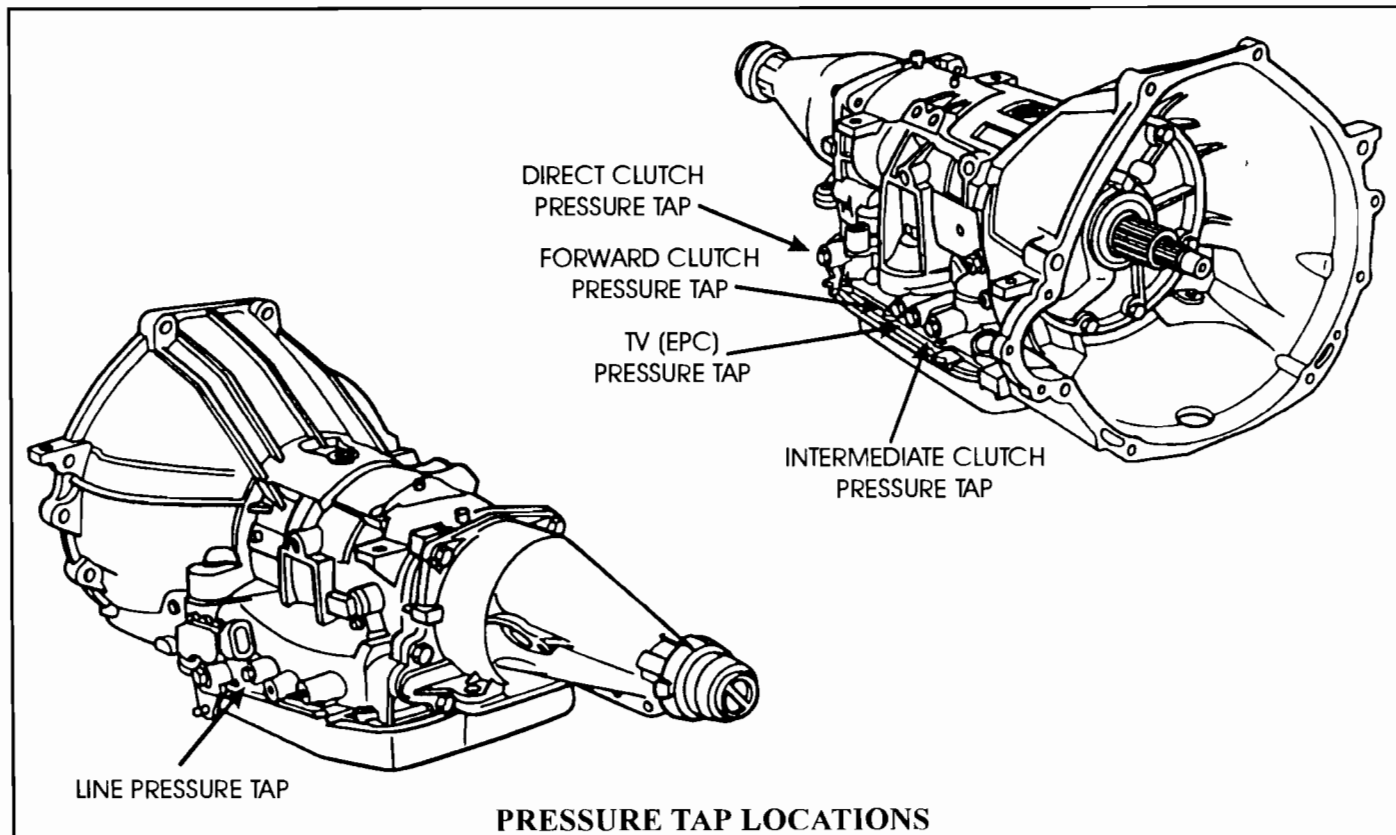
Figure 1

CAUSE: The cause may be, a partially clogged Shift Solenoid No. 2, which will stroke the 3-4 shift valve far enough to exhaust some of the forward clutch oil.

CORRECTION: Install two pressure gages to check line pressure and forward clutch pressure, as shown in Figure 1. With the transmission in Drive, both gages should read the same and should be approximately 55-75 PSI.
If the forward clutch gage reads lower than the line pressure gage, *and all internal parts are known to be good*, replace the Shift Solenoid Assembly with OEM part number F5AZ-7G484-A (See Figure 2).

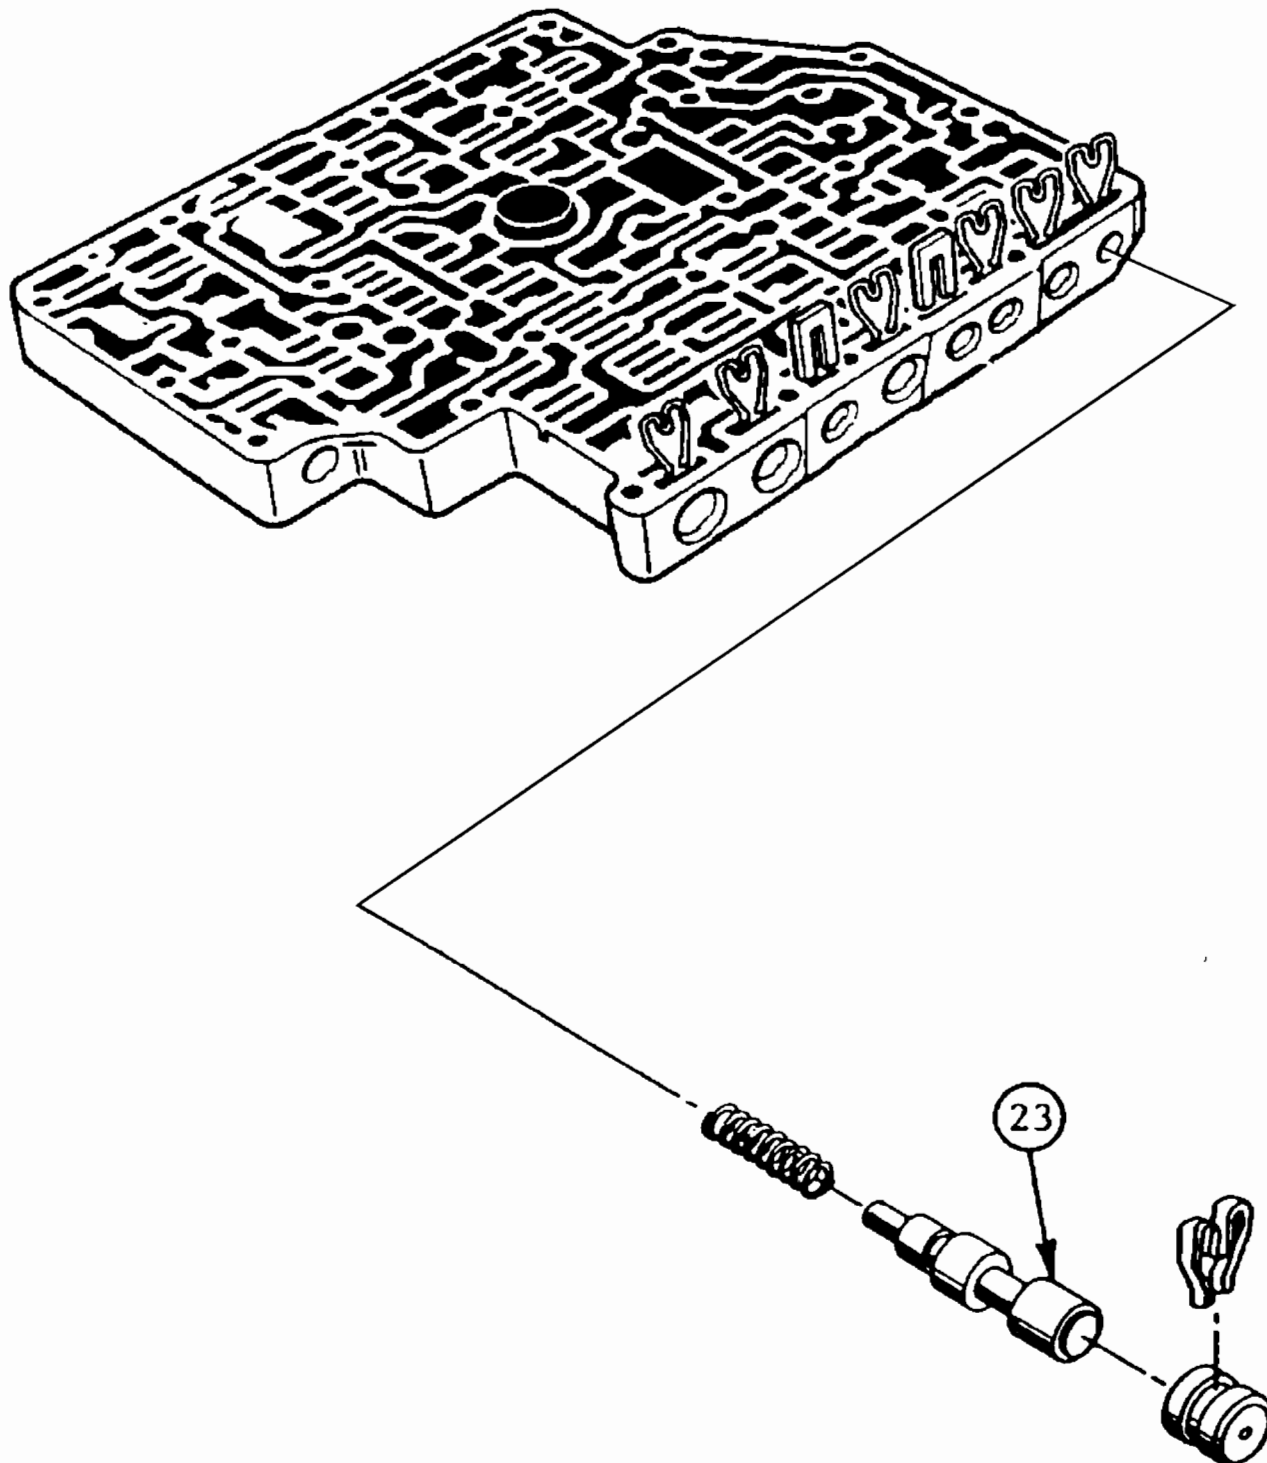
Figure 1

CAUSE: The cause may be, the 2-3 servo regulator valve in the valve body stuck, which will block servo apply oil to the 1-2 band (See Figure 1).

CORRECTION: Free the 2-3 servo regulator valve in the valve body from whatever contamination or debris that is keeping the valve stuck (See Figure 1).

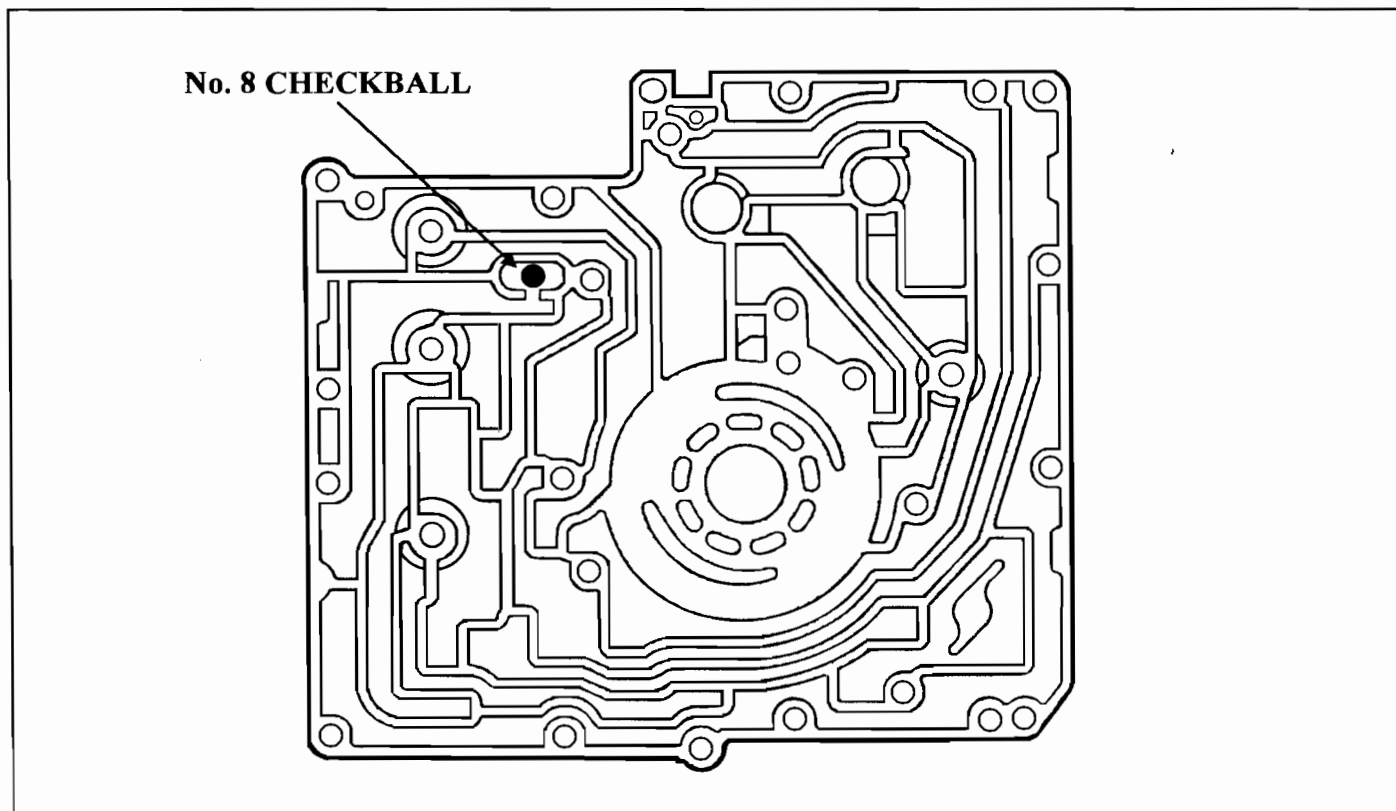
Figure 1

COMPLAINT: The AX4N transaxle, after rebuild, may exhibit a condition of a no 2-3 upshift and/or no engine braking in manual low.

CAUSE: One cause for this condition may be that the No. 8 checkball, located in the pump is missing, or off location (See Figure 1). A missing checkball in this location causes direct clutch oil to exhaust through the 1-2 shift valve, causing the transaxle to remain in second gear. In manual low, direct clutch oil, used for engine braking exhausts through the 2-3 capacity modulator valve and the 1-2 shift valve.

CORRECTION: Install the number 8 checkball in the location shown in Figure 1.

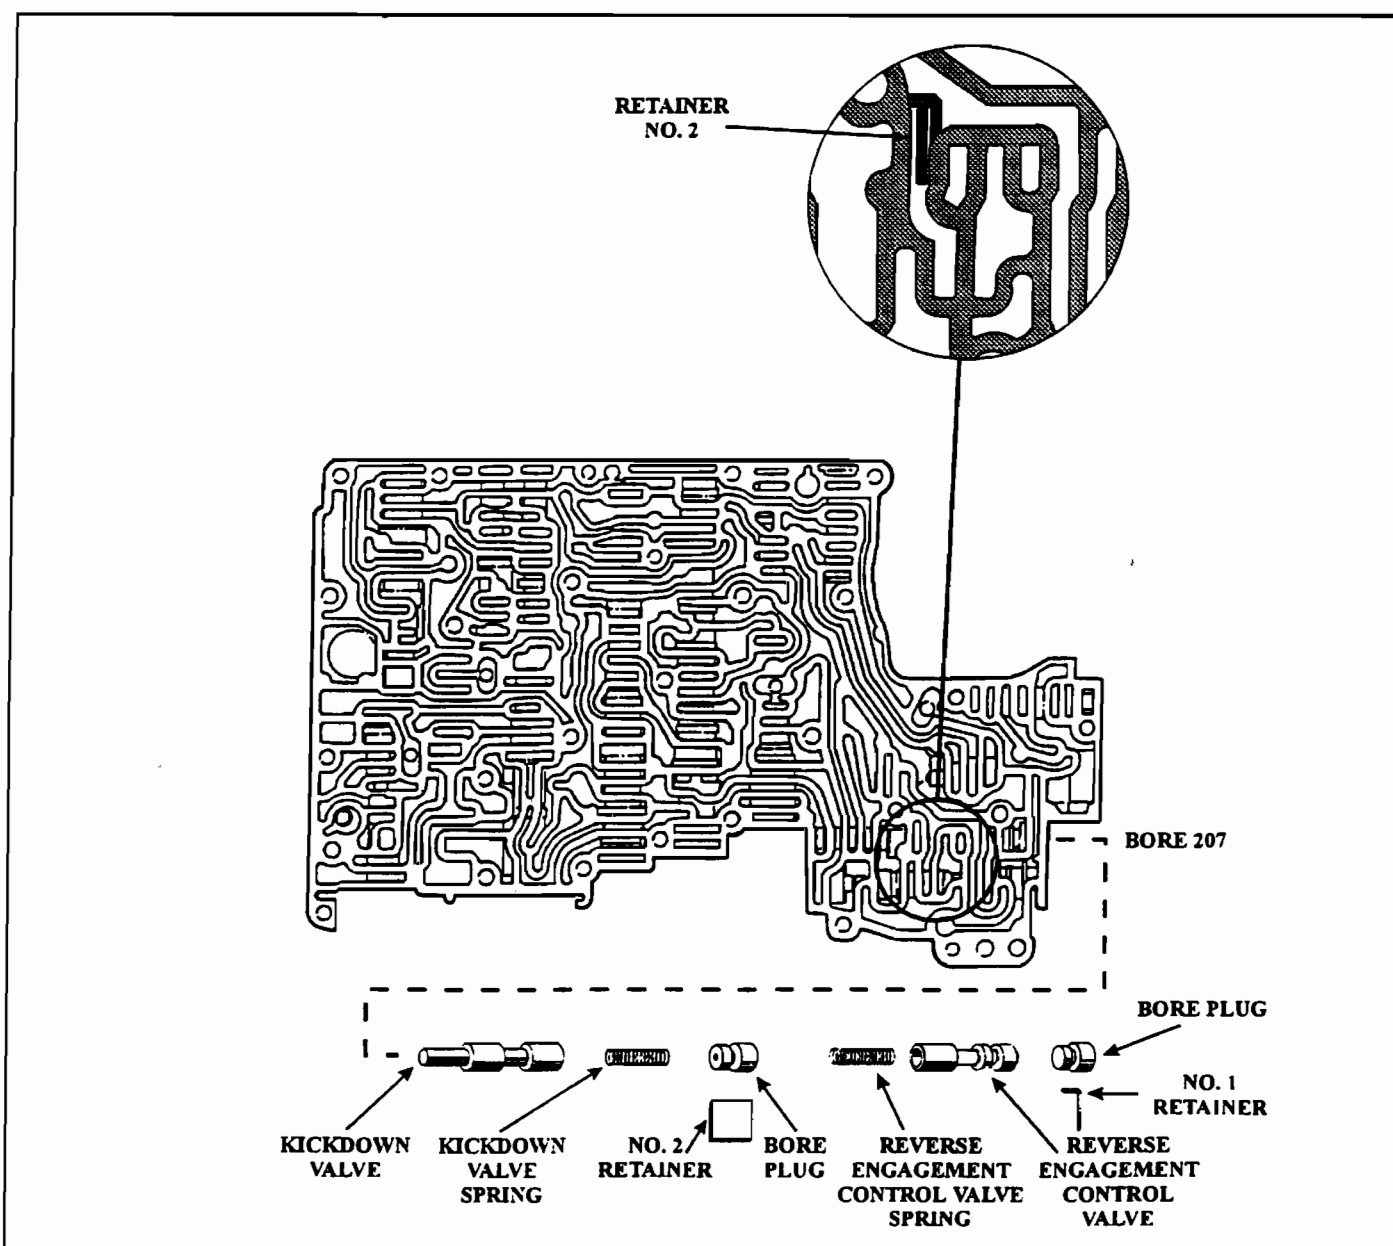
Figure 1

CAUSE: The cause may be, the Number 2 retainer missing or off location.

CORRECTION: Position the Number 2 retainer in the valve body in the location shown in Figure 1.

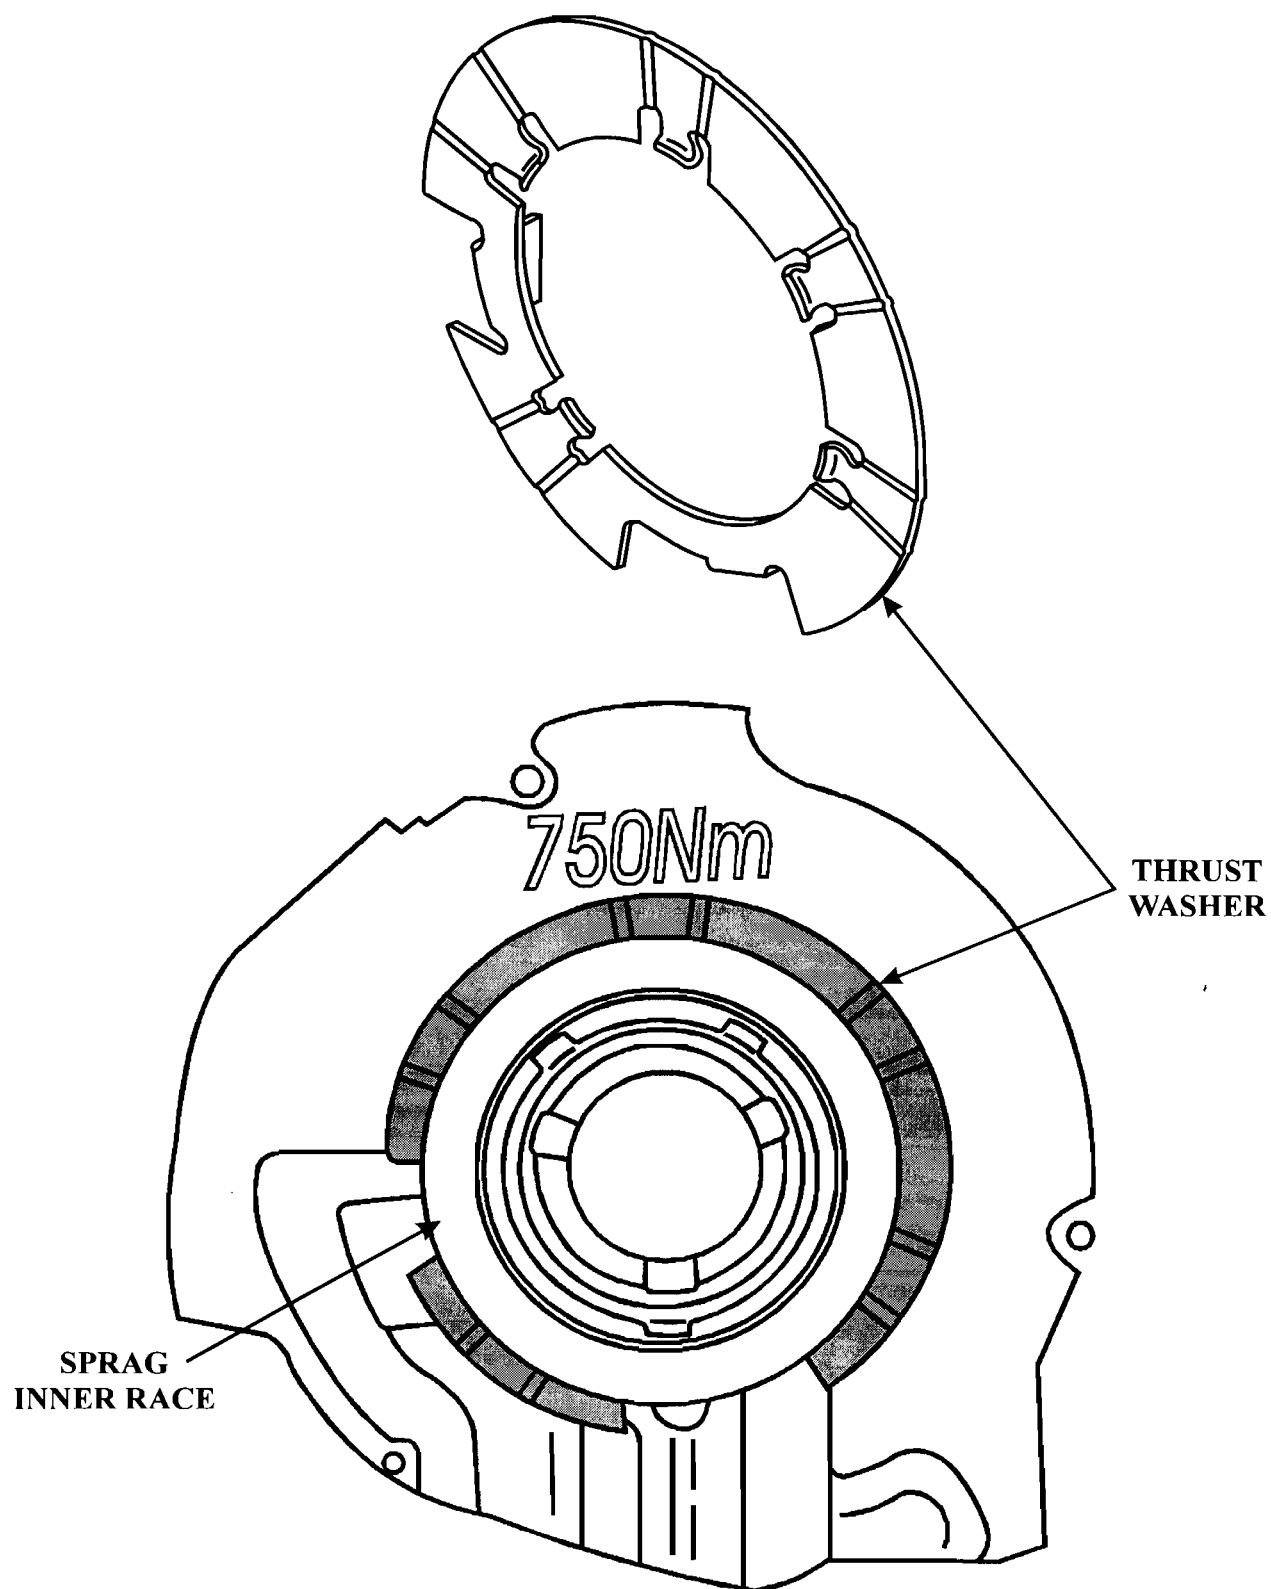
Figure 1

COMPLAINT: The thrust washer behind the rear sprag inner race on the 4.0L models, equipped with the A4LD transmission, is prone to damage and/or wear beyond use, and required buying a complete case to get the washer in the past (See Figure 1).

CAUSE: This thrust washer was not serviced by Ford Motor Company.

CORRECTION: The rear case thrust washer for the 4.0L engine models equipped with the A4LD, is now available from Aftermarket sources (See Figure 1).
Following is the service procedure to remove the rear sprag inner race from the case, and replace the rear case thrust washer:

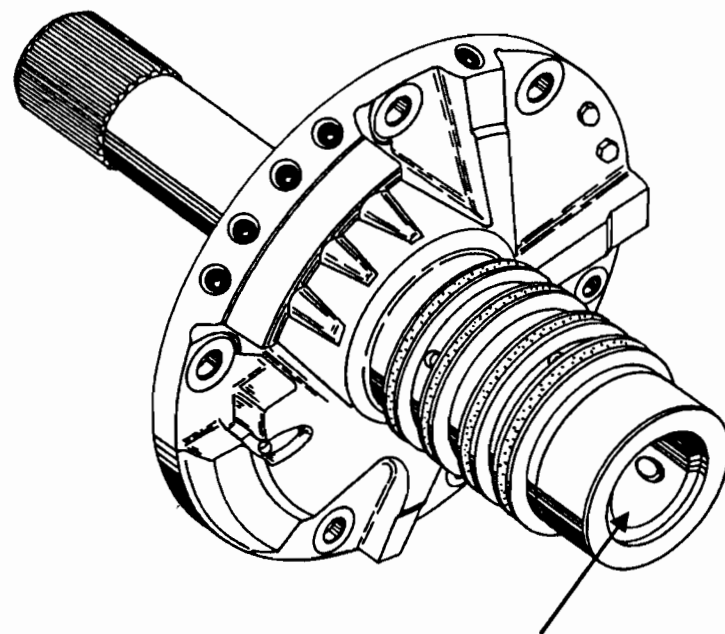
Figure 1
Automatic Transmission Service Group

COMPLAINT: Before or after overhaul, premature planetary gear failure occurs.

INSPECT FOR "SEALING RING" WEAR OR SCORING

1. Inspect "Turbine Shaft" sealing rings and the sleeve area in the rear of the pump cover for wear. Apply compressed air into hole "A" in turbine shaft and ensure the air exit's through hole "B" freely. (See Figure 1)

2. Inspect the bushing in the rear of the turbine shaft for wear or scoring. Ensure that the bushing clearance to the Underdrive clutch hub shaft is no more than .003" to .006." (See Figure 1)

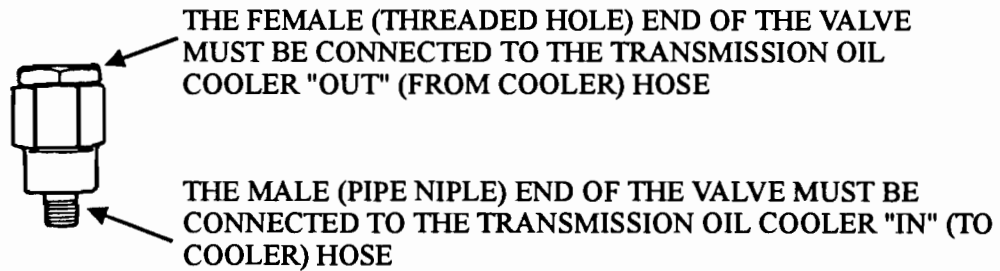
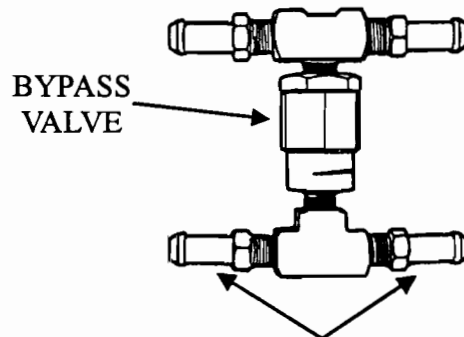
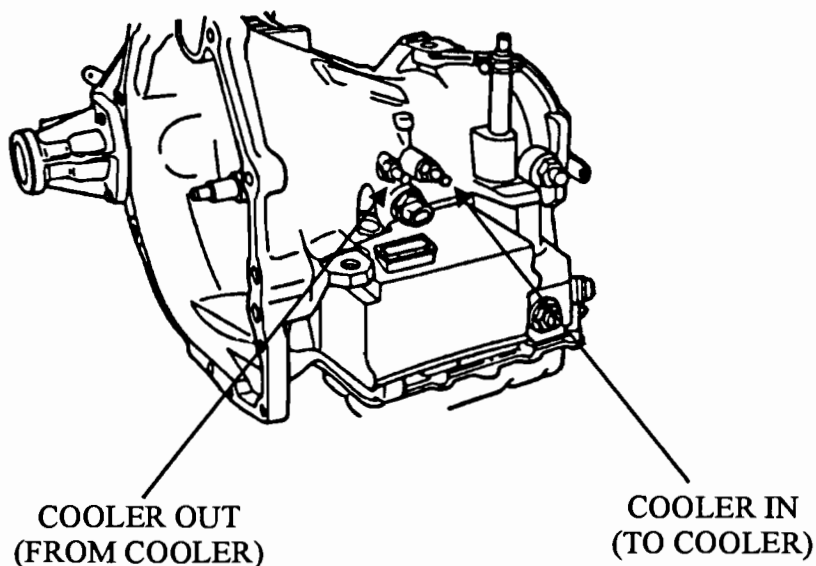
Figure 7

THIS SIDE OF THE BYPASS VALVE ASSEMBLY "MUST" BE CONNECTED TO THE TRANSMISSION OIL "IN" (TO COOLER) HOSE

NOTE: THE BYPASS VALVE IS DIRECTIONAL. IF IT IS NOT CONNECTED TO THE TRANSAXLE OIL COOLER HOSES IN THE CORRECT OIL FLOW DIRECTION, THE BYPASS VALVE WILL NOT FUNCTION AND MAY CAUSE PLANETARY FAILURE.

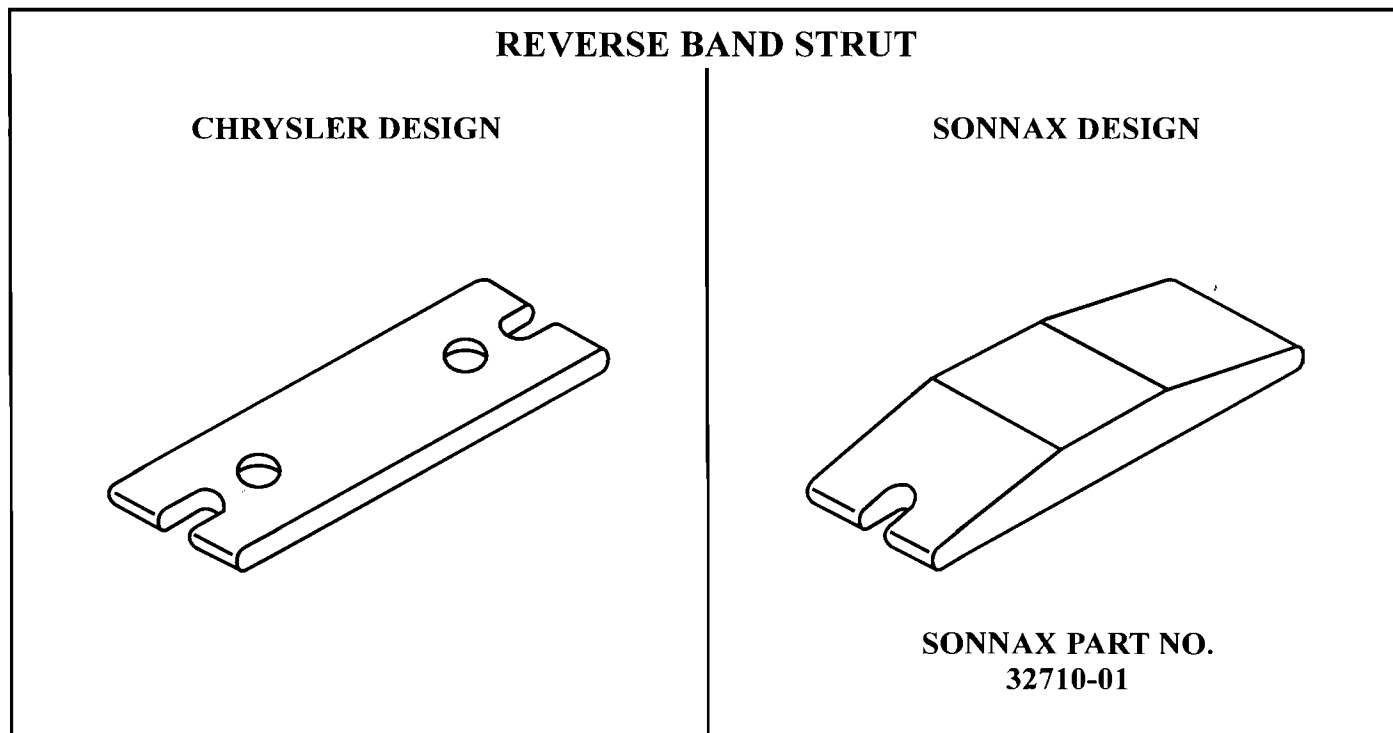
Figure 1

CHRYSLER A470 SERIES REVERSE BAND STRUT BREAKAGE

CORRECTION: There is now a new design reverse band strut available from Aftermarket Suppliers for the Chrysler A404 Series transaxle, that has a thicker cross-section in the middle to provide much greater resistance to bending, and is manufactured out of a high quality hardened alloy steel that has a much higher yield strength than the original equipment material. This new design reverse band strut is manufactured by Sonnax, and is available under Sonnax part number 32710-01 (See Figure 1).
